EME N-35 EOL
2011

RE: Termination Request
EME N-35 EOL: UL/N, Sec. 35, T19S, R36E
RICE Operating Company – Eunice Monument Eumont SWD System

**RICE OPERATING COMPANY
JUNCTION BOX FINAL REPORT**

EME N-35 EOL

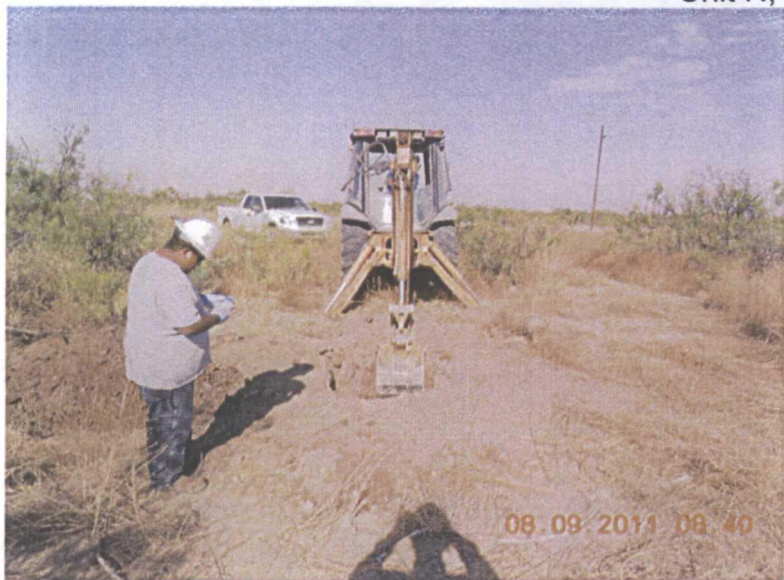
8.9.11

Excavating site, facing west

General Description of Remedial Action: This junction box and line were eliminated during the pipeline replacement/upgrade program. After the former junction box was removed, an investigation was conducted using a backhoe to collect soil samples at regular intervals producing a 10x10x12 ft deep excavation. Chloride field tests were performed on soil samples which yielded low chloride. Organic vapors were measured using a PID which low concentrations. The excavated soil was blended on site and representative composite samples were collected from the excavation walls, the excavation bottom, and the blended backfill. The samples were sent to a commercial laboratory for analysis of chloride and TPH. Lab analysis yielded low chloride concentrations and TPH concentrations within NMOCD guidelines. The excavation was backfilled with the blended soil to ground surface and contoured to the surrounding area. On 12/20/2011, the site was seeded with a blend of native vegetation and is expected to return to a productive capacity.

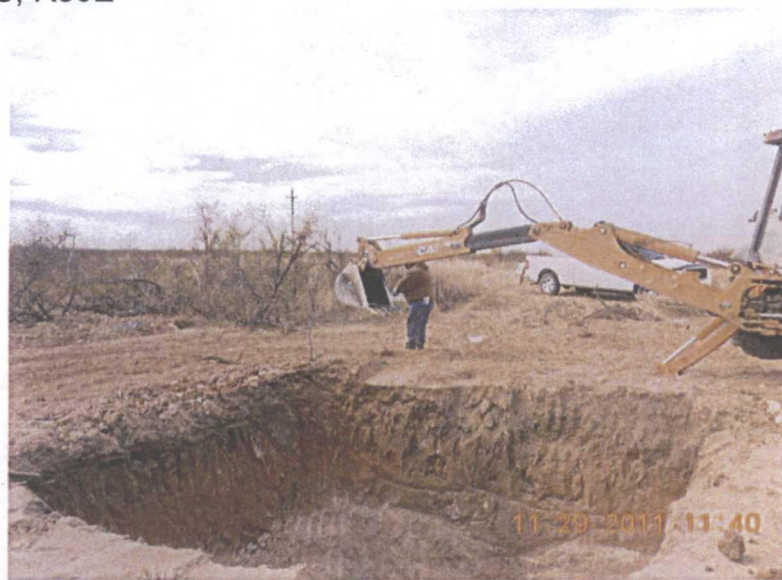
11.29.11

Collecting sample, facing southwest

FINAL ANALYTICAL RESULTS: Sample Date _____ 11/29/2011 _____ Sample Depth _____ 12' _____

Sample Location	PID (field) ppm	GRO mg/kg	DRO mg/kg	Chloride mg/kg
4-WALL COMP.	5.6	<50.0	392	272
BOTTOM COMP.	39.7	<50.0	603	32
BLENDED BACKFILL	5.9	<50.0	295	48

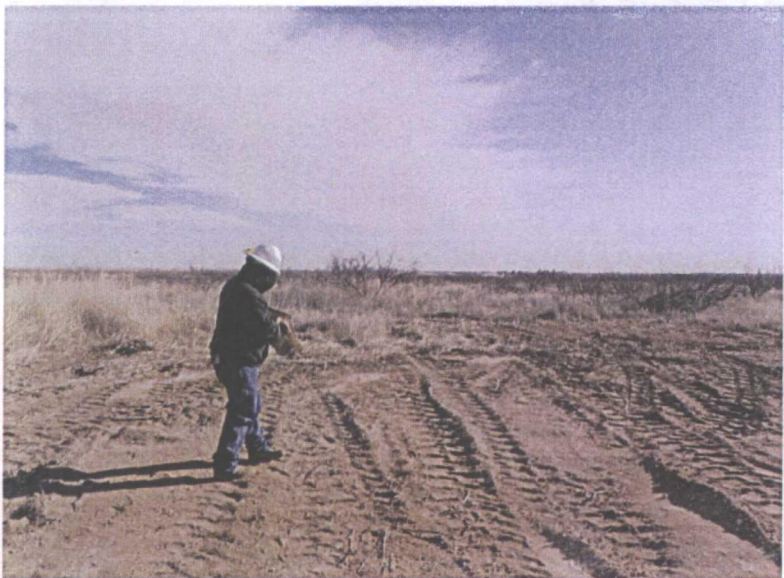
12.20.11

Seeding site, facing east

Custom seed mix <input checked="" type="checkbox"/>	Prescribed mix <input type="checkbox"/>	Seed mix name: 8 lbs Blue Grama / 8lbs Winter Wheat	Seeding date: 12/20/2011
Broadcast <input checked="" type="checkbox"/>			
Method: By Hand			
Soil conditions during seeding: Dry <input checked="" type="checkbox"/> Damp <input type="checkbox"/> Wet <input type="checkbox"/>			
Photos attached <input type="checkbox"/>	Observations: Raked Seed.		
Number of photos:

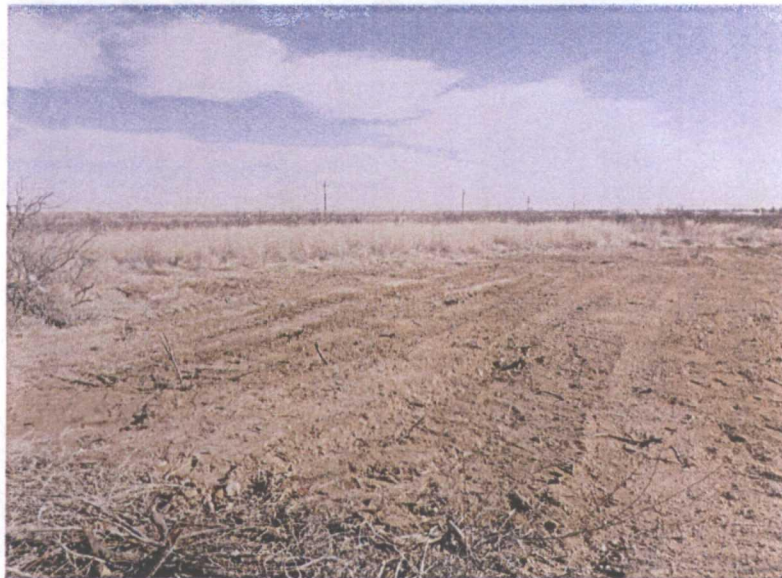
12.20.11

Site complete, facing west

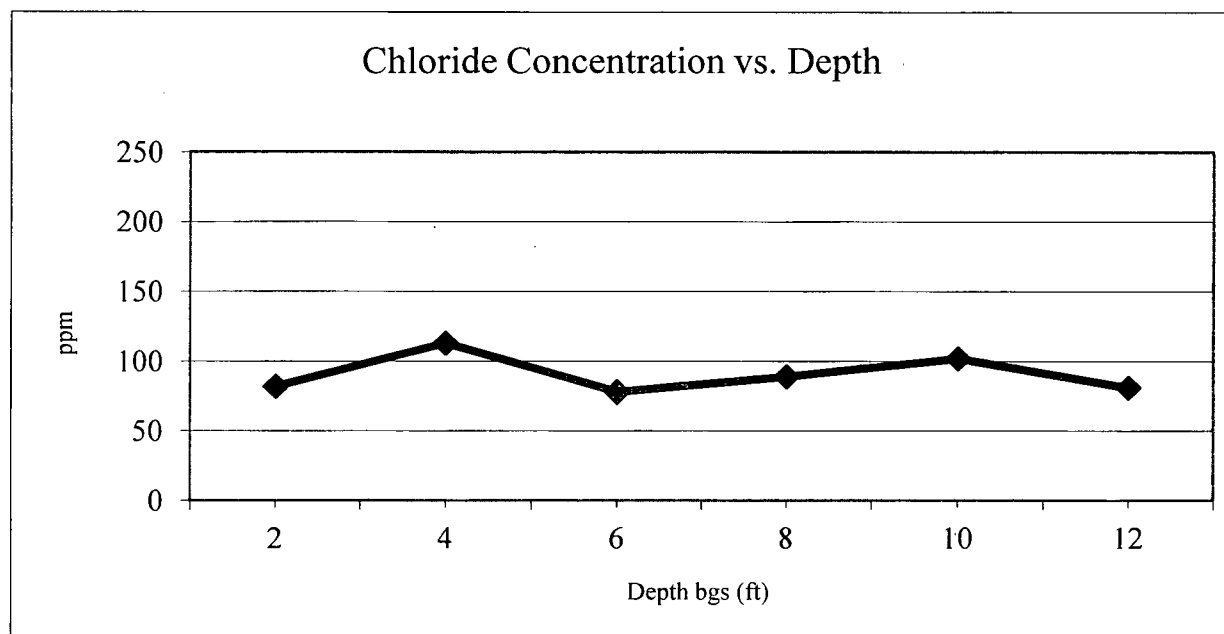
EME N-35 EOL

Backhoe samples at 5' east of the junction (source)

Depth bgs (ft)	[Cl ⁻] ppm
2	82
4	113
6	78
8	89
10	102
12	81

Groundwater = 64 ft

CHLORIDE FIELD TESTS		
LOCATION	DEPTH	mg/kg
background	6"	149
4-WALL Comp	n/a	215
Bottom Comp	12'	148
Blended Backfill	n/a	112
Vertical delineation trench at 5' east of the former junction (source)	2'	82
	4'	113
	6'	78
	8'	89
	10'	102
	12'	81
