RE: Termination Request  
EME P-4 EOL: UL/P, Sec. 4, T20S, R36E  
RICE Operating Company – Eunice Monument Eumont SWD System

**RICE OPERATING COMPANY  
JUNCTION BOX FINAL REPORT**

# EME P-4 EOL

Unit P, Section 4, T20S, R36E

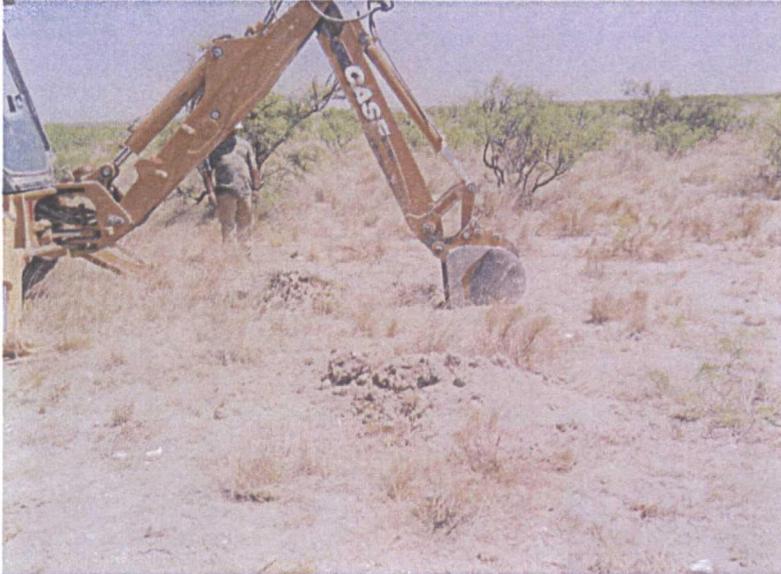
5.25.11

Digging source vertical, facing north

**General Description of Remedial Action:** This junction and line were eliminated during the pipeline replacement/upgrade program. After the former junction box was removed, an investigation was conducted using a backhoe to collect soil samples at regular intervals creating a 3X7X7-ft. deep excavation. Chloride field tests performed on each sample yielded concentrations similar to that of the background sample. Organic vapors were measured using a PID, which yielded low concentrations. The deepest sample, 7 ft. BGS, was sent to a commercial laboratory for analysis of chloride and TPH, which confirmed low concentrations of each. The excavation was backfilled with excavated soil to ground surface and contoured to the surrounding area. On 7/8/2011, the site was seeded with a blend of native vegetation and is expected to return to a productive capacity at a normal rate.

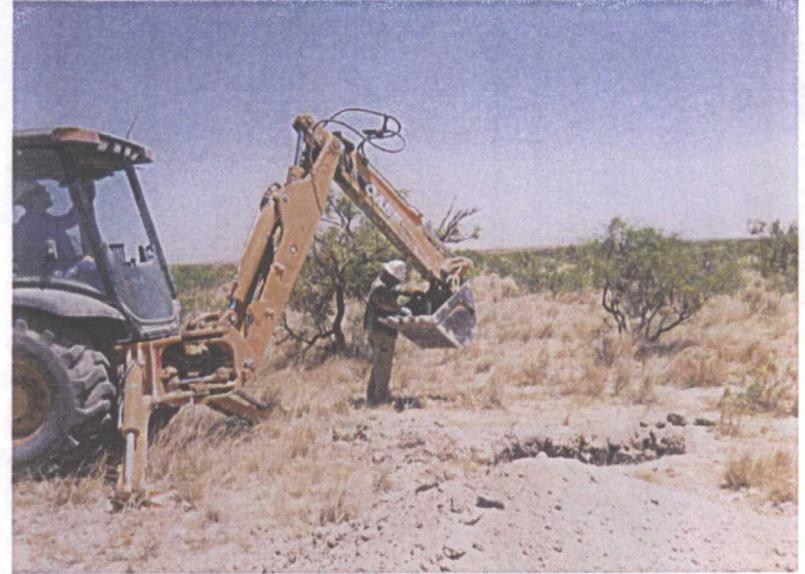
5.25.11

Collecting sample, facing north

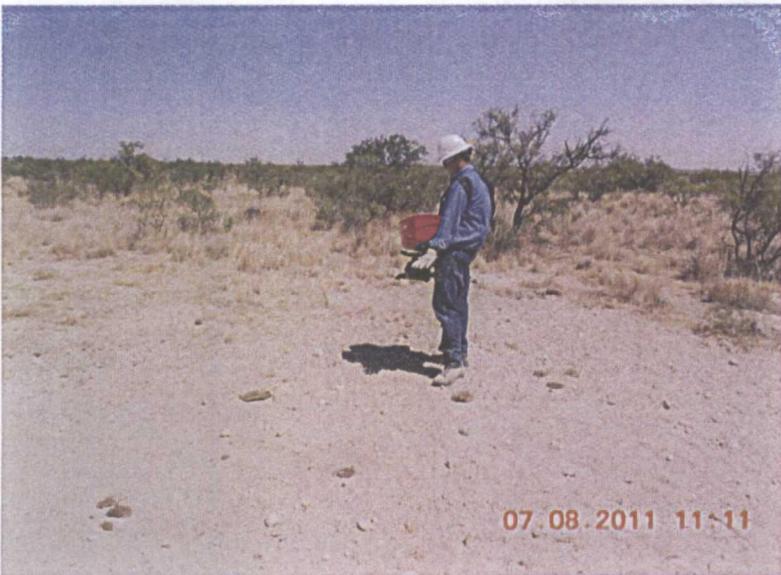
7.8.11

Spreading seed, facing east

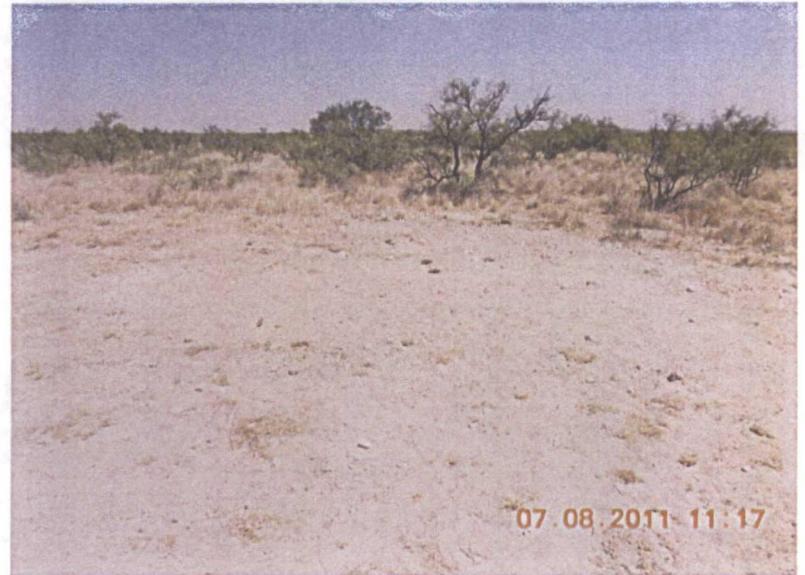
7.8.11

Site complete, facing north

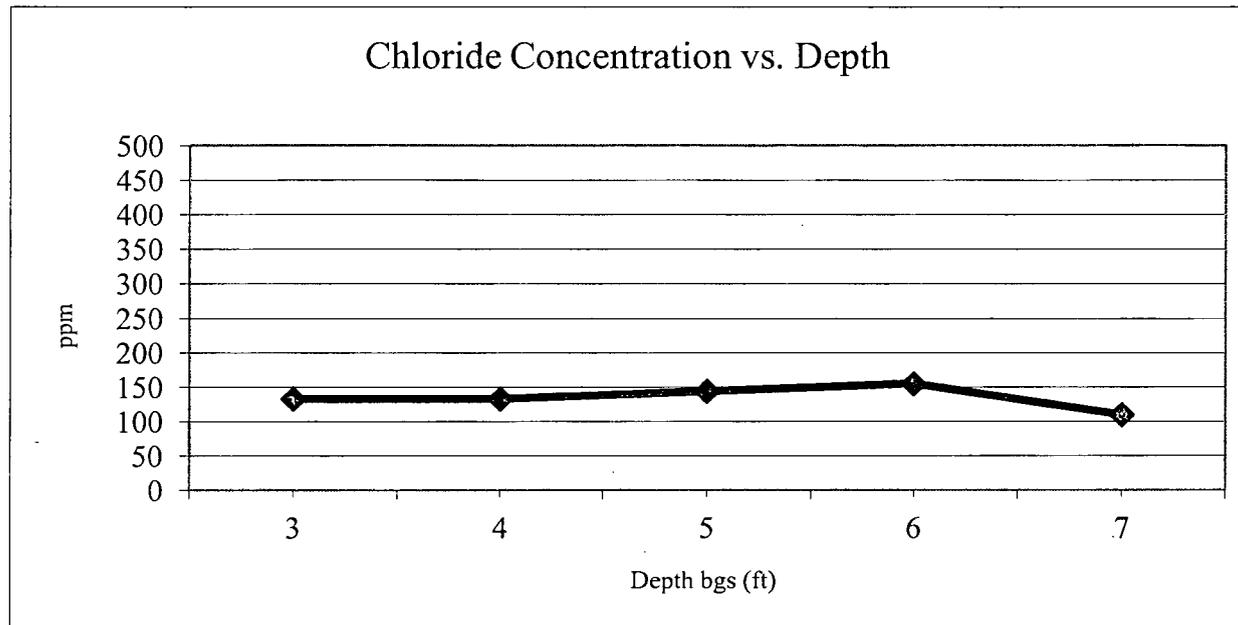
*Backhoe samples at junction (source)*

Depth, bgs (ft)	[Cl <sup>-</sup> ] ppm
3	133
4	133
5	144
6	155
7	110

Groundwater = 40 ft

CHLORIDE FIELD TESTS		
LOCATION	DEPTH	mg/kg
background	6"	122
vertical delineation trench at the junction (source)	3'	133
	4'	133
	5'	144
	6'	155
	7'	110
