Vacuum C-36 EOL  
2011

**RICE OPERATING COMPANY  
JUNCTION BOX DISCLOSURE\* REPORT**

# Vacuum C-36 EOL

Unit C, Section 36, T17S, R34E

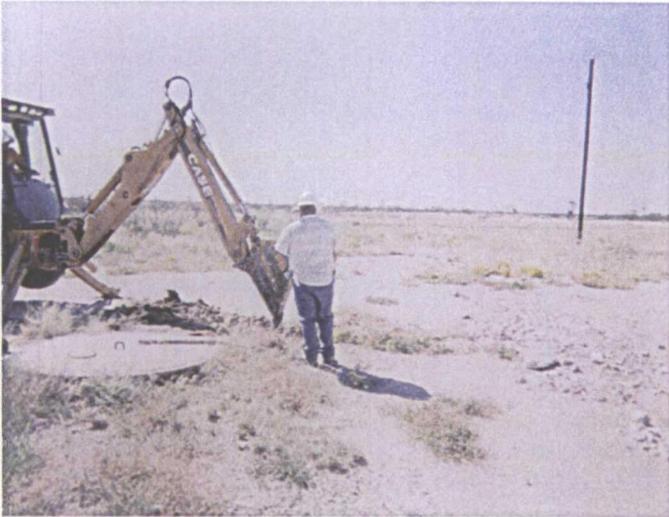
Excavating/sampling source, facing west 10.7.10

**General Description of Remedial Action:** This junction was eliminated during the Vacuum SWD system abandonment program. An investigation was conducted at the former junction box site using a backhoe to collect soil samples at regular intervals producing a 5x3x4-ft deep excavation. The site could not be excavated any deeper due to extremely compacted subsoil materials. Chloride field tests performed on each sample yielded elevated concentrations that did not relent with depth. Organic vapors were measured using a PID which yielded relatively low concentrations. A total of 5 yards of soil was hauled to a NMOCD approved disposal facility. The excavation was backfilled with imported soil to ground surface. On 10/11/2010, the site was seeded with a blend of native vegetation and is expected to return to a productive capacity at a normal rate. To further investigate the depth of chloride, a soil bore was initiated on 7/25/2011. The boring was advanced to a total depth of 12-ft. below ground surface with soil samples collected at regular intervals. Chloride field tests were performed on each sample and organic vapors were measured using a PID. The 12-ft. sample was taken to a commercial laboratory for analysis of chloride and TPH, which yielded low TPH and chloride concentration that did not decrease with depth. The bore was plugged with bentonite to ground surface. NMOCD was notified of potential groundwater impact on 4/10/2012.

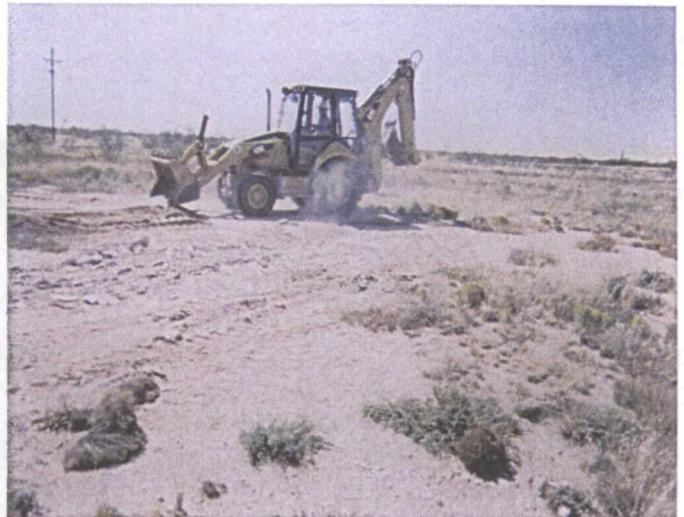
Spreading imported soil, facing south 10.11.10

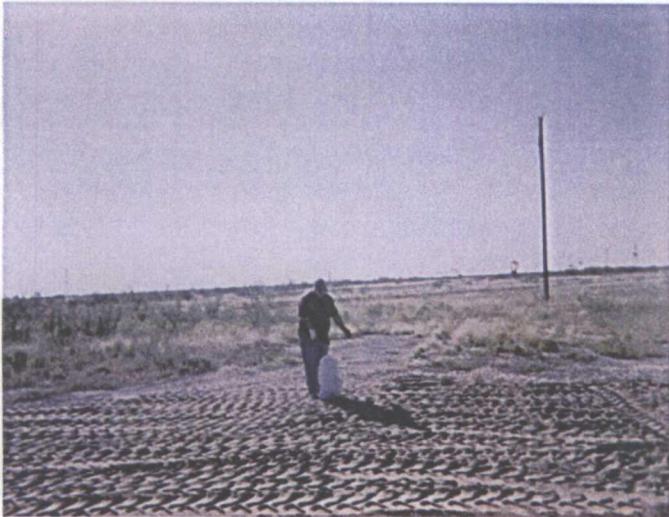
Seeding site, facing west 10.11.10

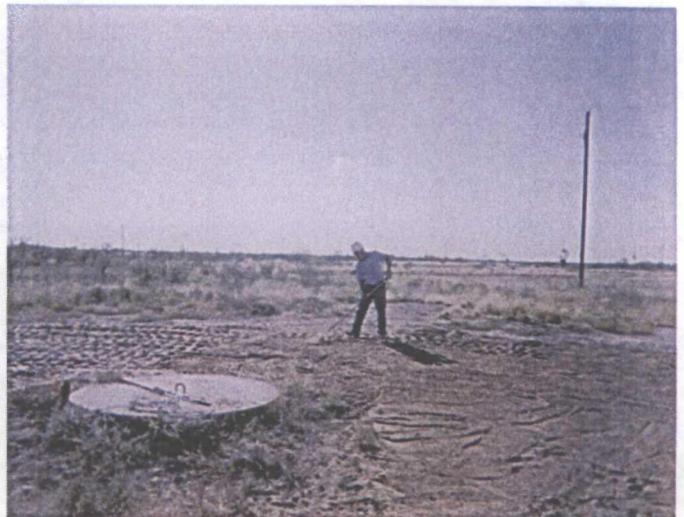
Raking seed, facing west 10.11.10

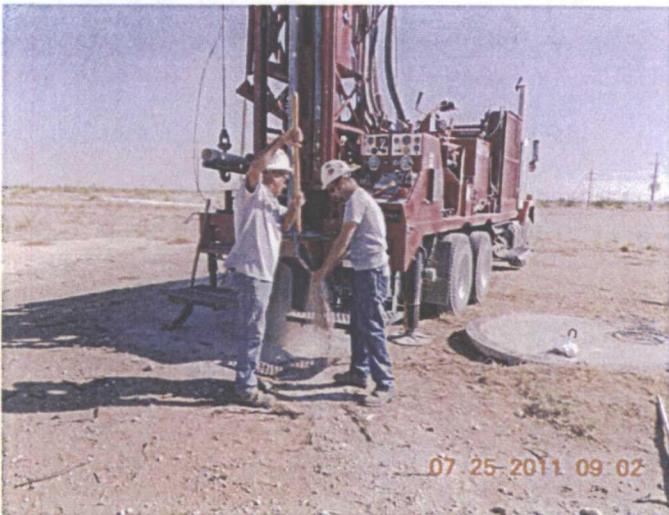
Sampling drill cuttings, facing south 7.25.11

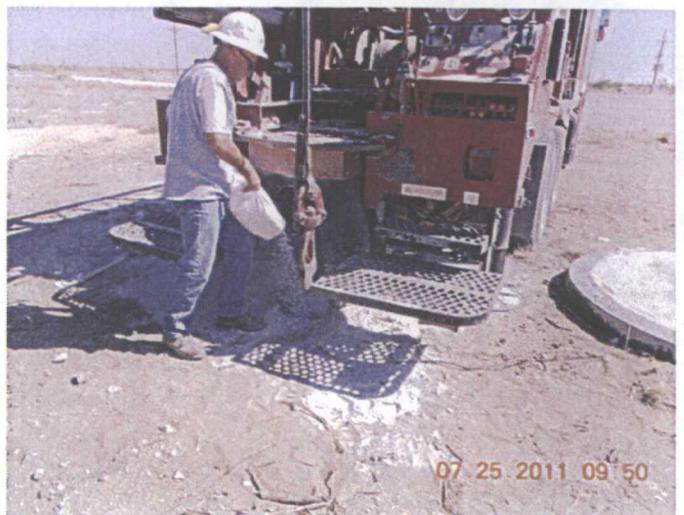
Plugging the soil bore in total with bentonite, facing south 7.25.11

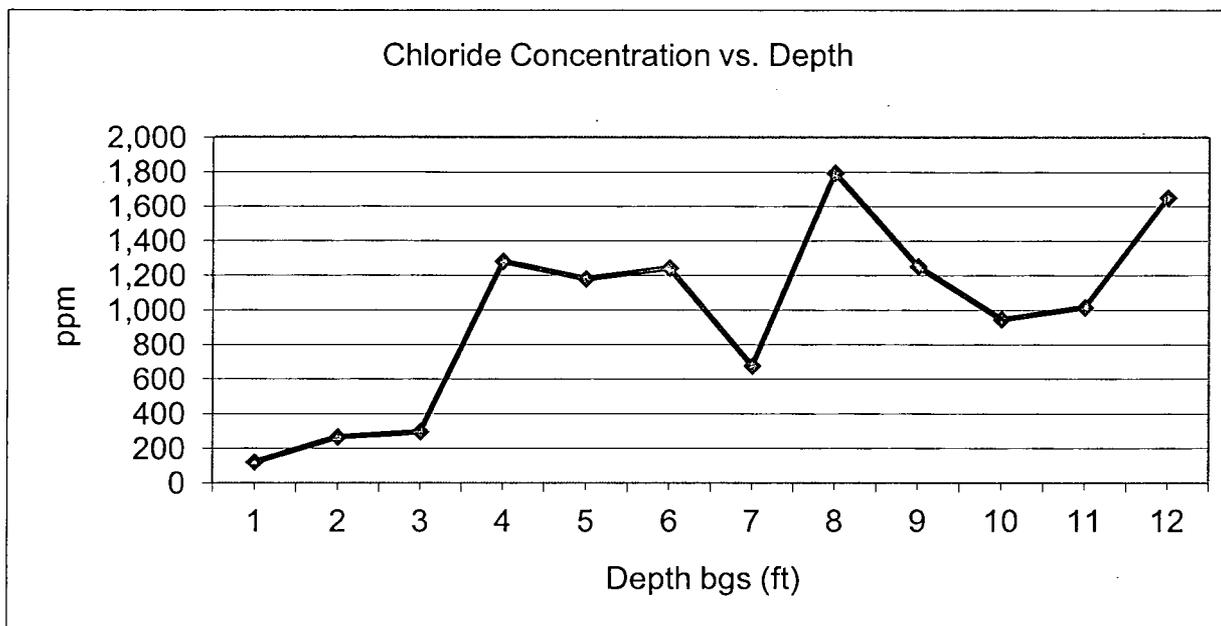
Soil bore samples at the source

Depth bgs (ft)	[Cl] ppm
1	121
2	266
3	296
4	1,282
5	1,181
6	1,244
7	677
8	1,795
9	1,253
10	947
11	1,016
12	1651

Groundwater = 107 ft
