BD Jct. B-7

**RICE OPERATING COMPANY
JUNCTION BOX DISCLOSURE* REPORT**

Unit B, Section 7, T22S, R38E

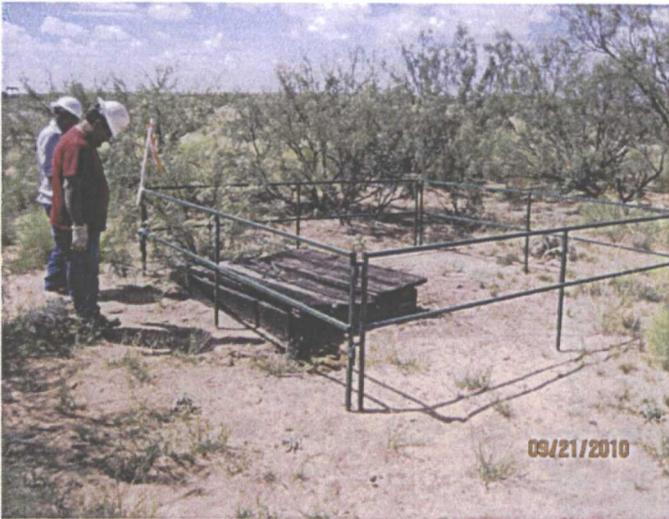
Site prior to excavation, facing west 9.21.10

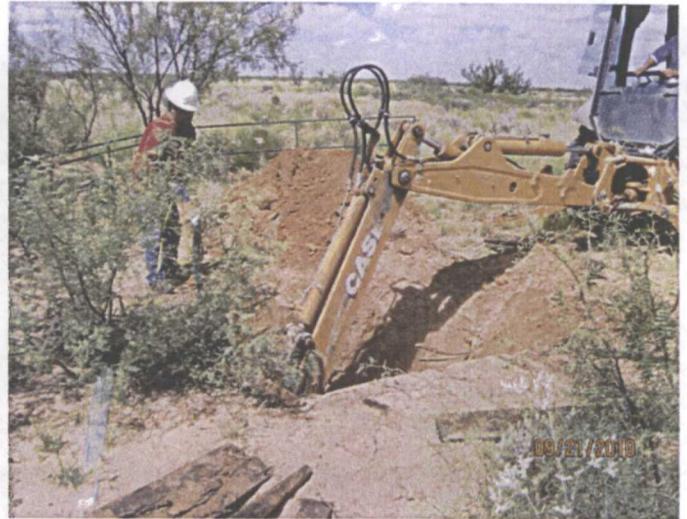
Excavating source, facing north 9.21.10

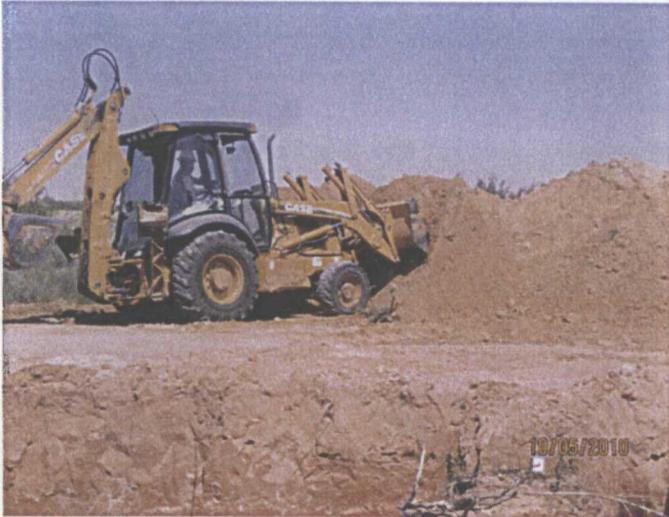
Blending backfill, facing north 10.05.10

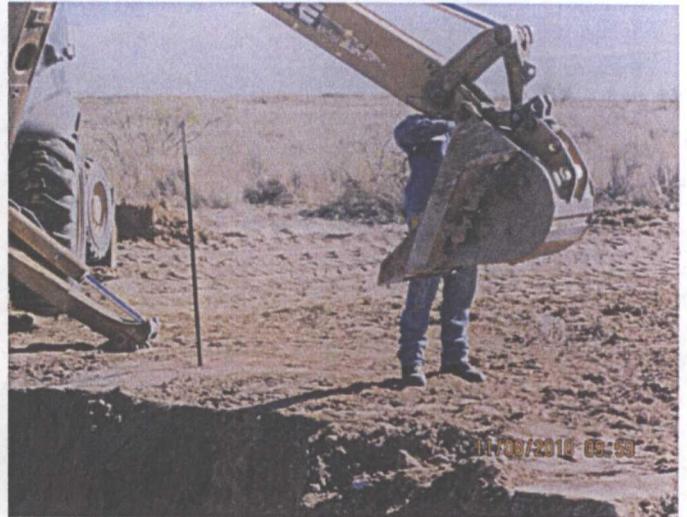
Collecting sample, facing east 11.08.10

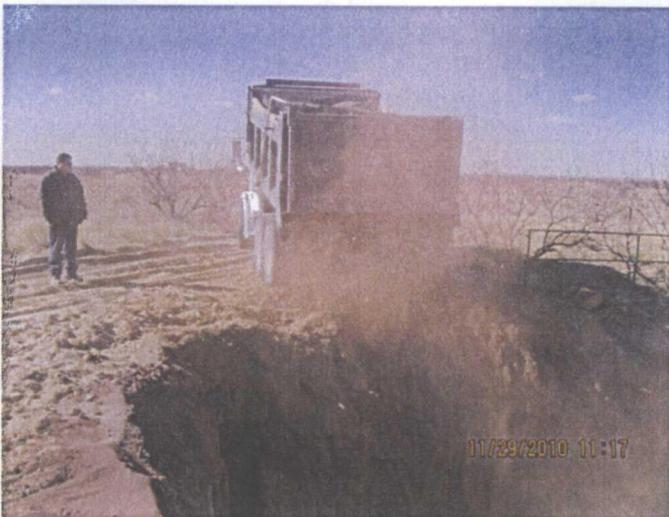
Importing clay for liner, facing east 11.29.10

laboratory for analysis of chloride and TPH. A 1-ft. thick clay liner was installed from 12-11-ft BGS with a compaction test performed on 11/29/10. A total of 60 cubic yards of impacted soil was hauled to a NMOCD approved facility for disposal. The excavation was backfilled with the blended soil to ground surface and was contoured to the surrounding area. The site was seeded with a blend of native vegetation and is expected to return to a productive capacity at a normal rate. To further investigate the depth of chloride, a soil bore was initiated on 4/13/2011. The boring was advanced to a total depth of 55-ft. BGS with soil samples collected at regular intervals. Chloride field tests were performed on each sample and organic vapors were measured using a PID. The 30-ft. and 55-ft. samples were taken to a commercial laboratory for analysis of chloride and TPH, which yielded low TPH and chloride concentrations that did not decrease with depth. The bore was plugged with bentonite to ground surface. On 1/6/2012, the site was seeded with a blend of native vegetation and is expected to return to a productive capacity at a normal rate. NMOCD was notified of potential groundwater impact on 3/12/2012.

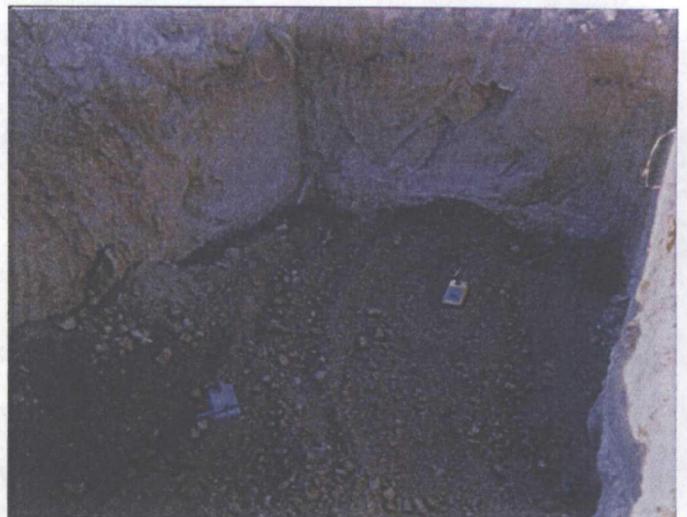
Performing clay compaction test, facing east 11.29.10

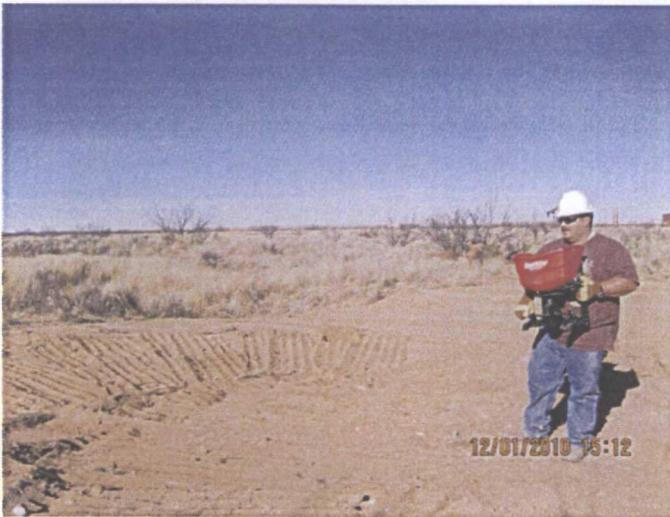
Seeding site, facing west

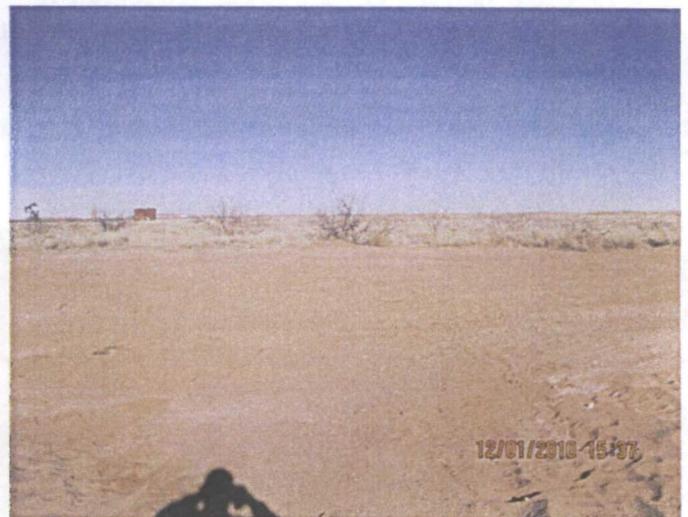
Completed site, facing east

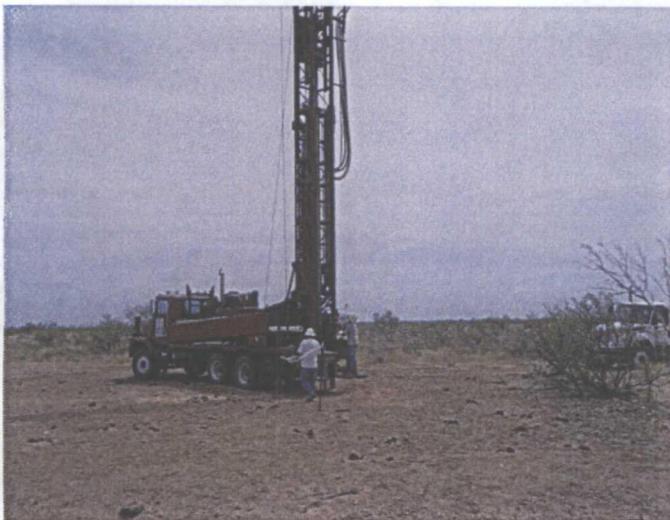
Drilling SB 1, facing south

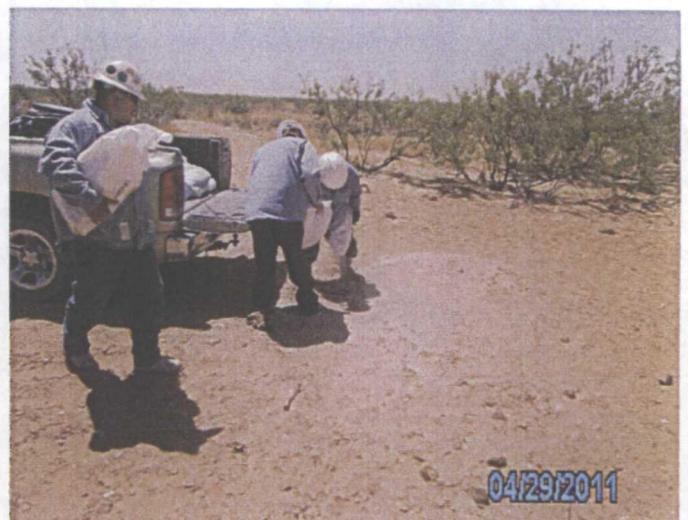
Plugging the SB in total with bentonite, facing south

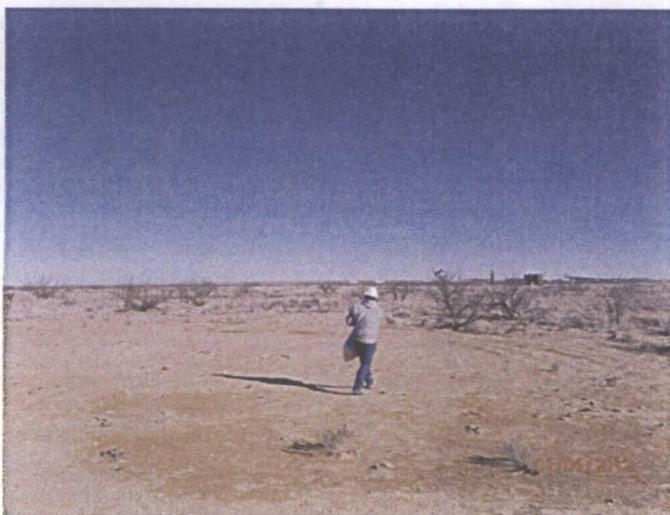
Reseeding site, facing north

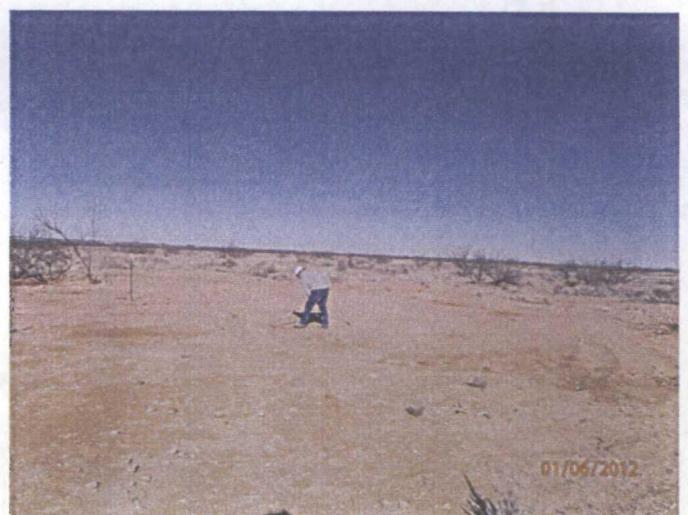
Raking in seed, facing west

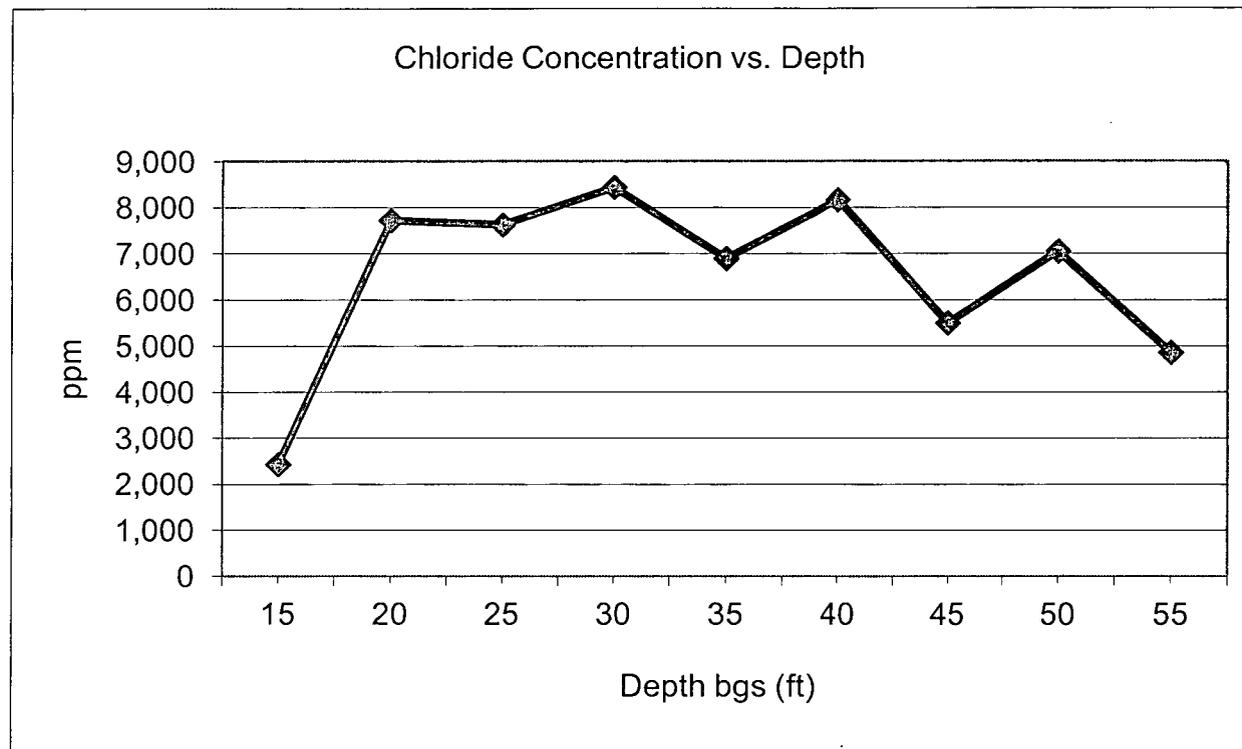
Soil Bore samples at 8 ft southeast of the junction (source)

Depth bgs (ft)	[Cl ⁻] ppm
15	2,426
20	7,719
25	7,623
30	8,437
35	6,889
40	8,165
45	5,499
50	7,051
55	4,861

Groundwater = 55 ft
