BD Jct. K-32

**RICE OPERATING COMPANY  
JUNCTION BOX DISCLOSURE\* REPORT**

Unit K, Section 32, T22S, R38E

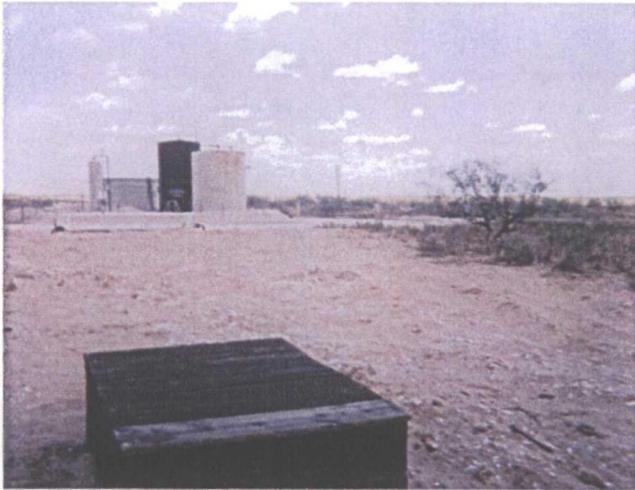
Site prior to excavation, facing east 7/21/2011

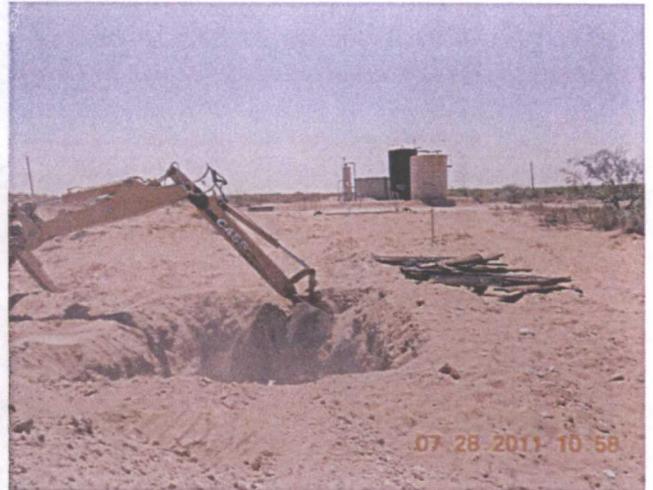
Excavating, facing east 7/28/2011

**General Description of Remedial Action:** An investigation was conducted using a backhoe to collect soil samples at regular intervals producing a 20x15x12-ft excavation. Chloride field tests performed on each sample yielded elevated concentrations. Organic vapors were measured using a PID which yielded low concentrations. 84 cubic yards of excavated soil was hauled to a NMOCD approved facility. The remaining excavated soil was blended on site and representative composite samples of the excavation bottom, the excavation walls, and the blended backfill were sent to a commercial laboratory for analysis of chloride and TPH. The

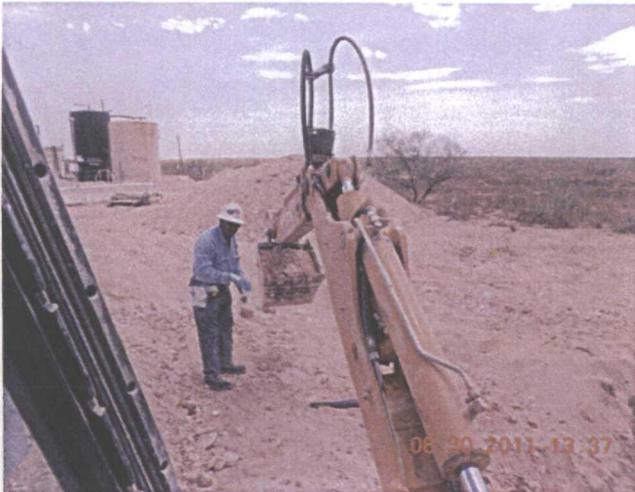
Sampling, facing east 8/30/2011

Procure 5-point composite sample of bottom and 4-point composite sample of sidewalls. TPH and Chloride laboratory test results completed by using an approved lab and testing procedures pursuant to NMOCD guidelines.

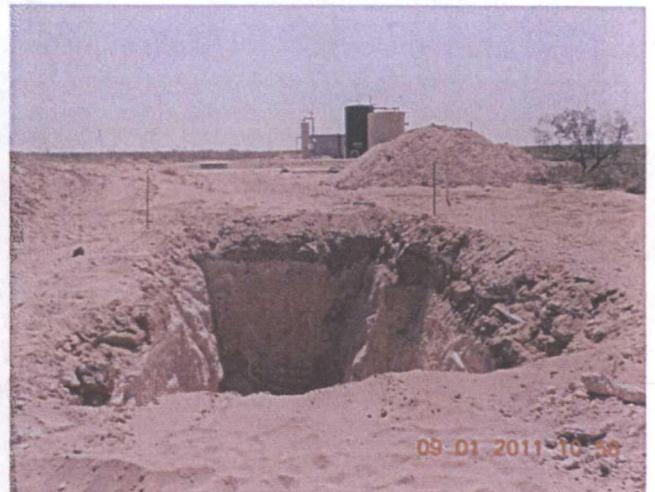
Completed excavation and new watertight junction box, facing east 9/1/2011

excavation was backfilled with excavated soil to ground surface and contoured to the surrounding area. On 9/30/2011 and 11/10/11, the site was seeded with a blend of native vegetation and is expected to return to a productive capacity at a normal rate. A new water tight junction box was built 143-ft. east. NMOCD was notified of potential groundwater impact on 3/12/2012.

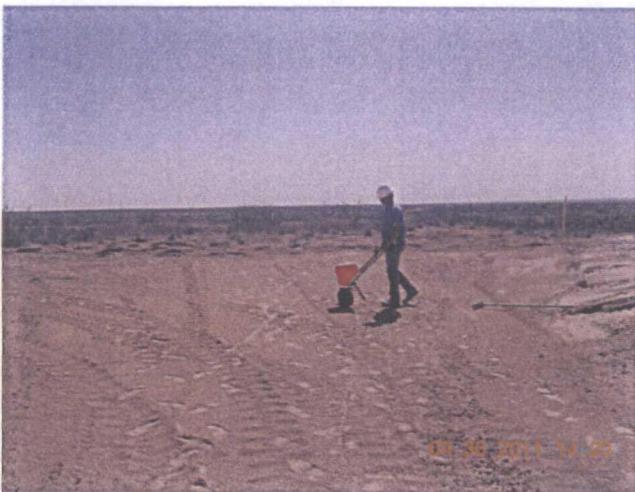
Seeding site, facing north 9/30/2011

Custom seed mix <input checked="" type="checkbox"/>	Prescribed mix <input type="checkbox"/>	Seed mix name: 5 lbs. blue grama and side oats grass seed mix	Seeding date: 9/30/2011
Broadcast <input checked="" type="checkbox"/>			
Method: Broadcast spreader			
Soil conditions during seeding: Dry <input checked="" type="checkbox"/> Damp <input type="checkbox"/> Wet <input type="checkbox"/>			
Photos attached <input checked="" type="checkbox"/>	Observations:		
Number of photos:

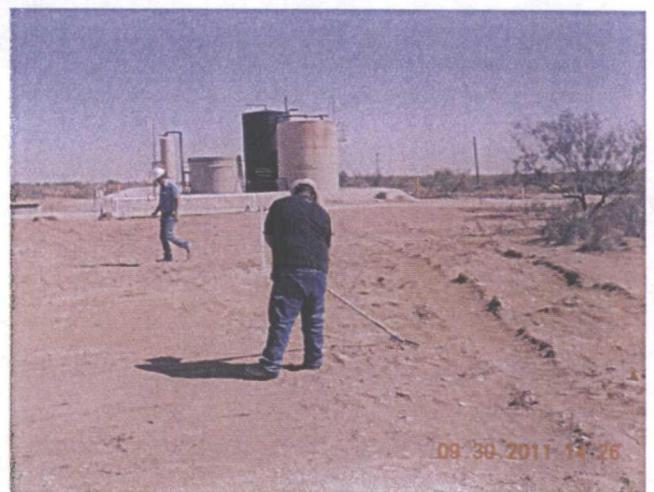
Reseeding site, facing east 11/10/2011

Custom seed mix <input checked="" type="checkbox"/>	Prescribed mix <input type="checkbox"/>	Seed mix name: 6 lbs. Boyd Johnston Grass Seed	Seeding date: 11/10/2011
Broadcast <input checked="" type="checkbox"/>			
Method: Broadcast spreader			
Soil conditions during seeding: Dry <input checked="" type="checkbox"/> Damp <input type="checkbox"/> Wet <input type="checkbox"/>			
Photos attached <input checked="" type="checkbox"/>	Observations:		
Number of photos:

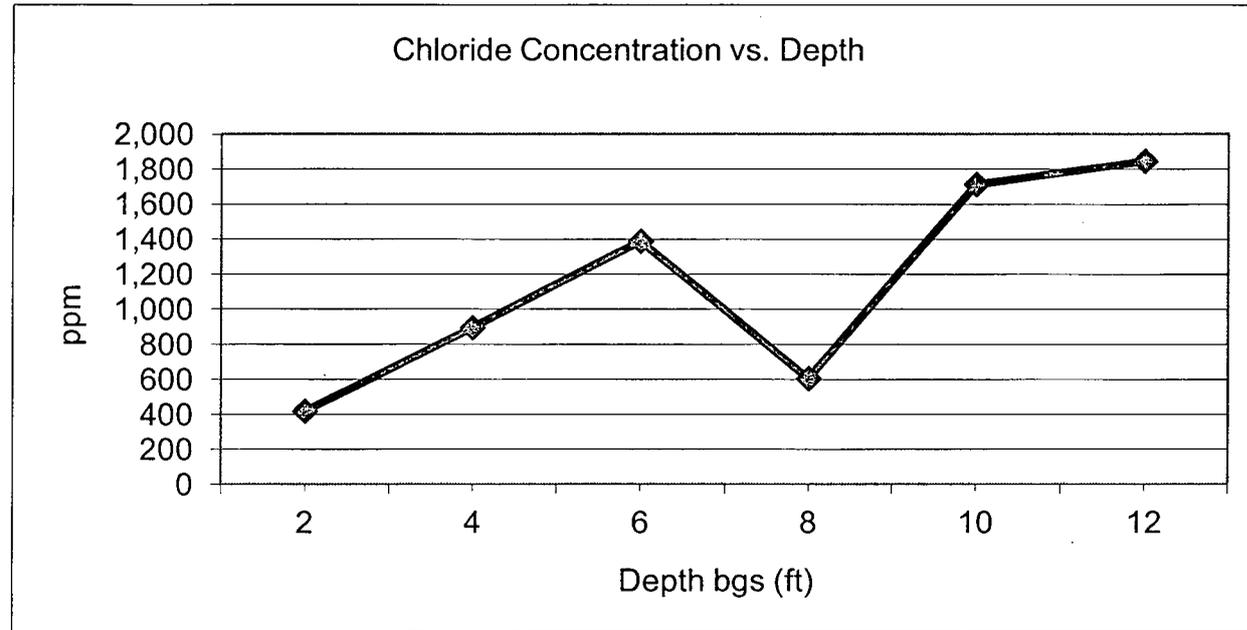
# BD Jct. K-32

Backhoe samples at 5 ft South of the junction (source)

Depth bgs (ft)	[Cl] ppm
2	419
4	895
6	1,389
8	606
10	1,714
12	1,847

Groundwater = 154 ft

LOCATION	DEPTH	mg/kg
4-wall comp.	N/A	852
bottom comp.	12'	556
blended backfill	N/A	343
background	6"	93
vertical delineation trench at 5' south of source	2'	419
	4'	895
	6'	1,389
	8'	606
	10'	1,714
	12'	1,847
