BD L-20 EOL  
2011

**RICE OPERATING COMPANY  
JUNCTION BOX DISCLOSURE\* REPORT**

# BD L-20 EOL

Unit L, Section 20, T22S, R37E

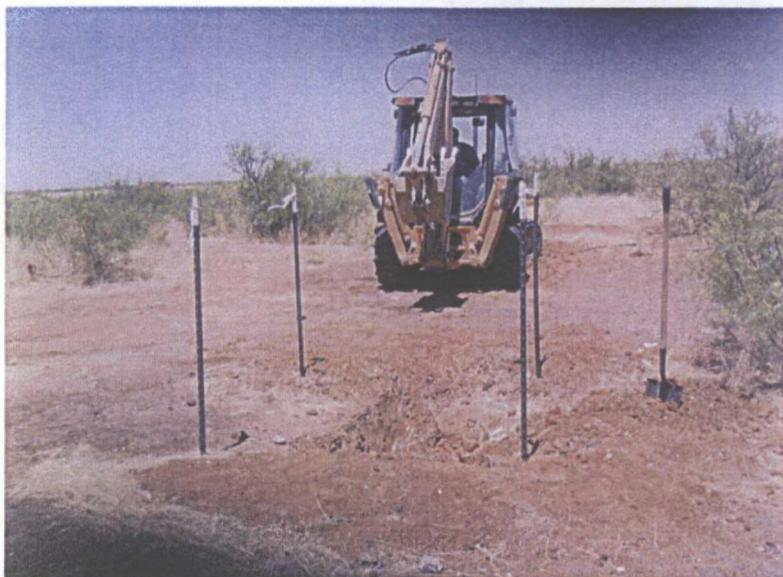
Site prior to excavation, facing north 5.3.11

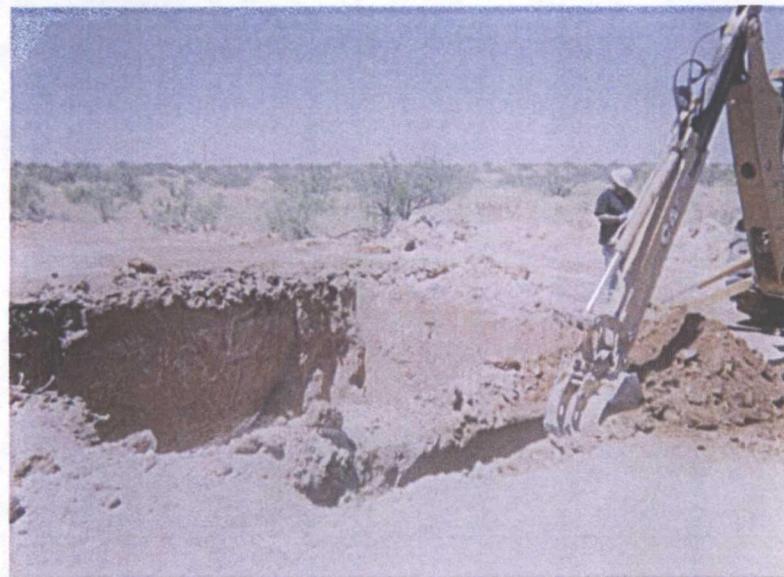
Excavating site, facing north 5.3.11

**General Description of Remedial Action:** This junction and line were eliminated during the pipeline replacement/upgrade program. After the former junction box was removed, an investigation was conducted using a backhoe to collect soil samples at regular intervals producing a 30x30x12-ft excavation. Chloride field tests performed on each sample yielded elevated concentrations that did not relent with depth. Organic vapors were measured using a PID which yielded low concentrations. The excavated soil was blended on site and representative composite samples of the excavation bottom, the excavation walls, and the blended backfill were sent to a commercial laboratory for analysis of chloride and TPH. The blended backfill was returned to the excavation to 4.5 ft. below ground surface (BGS). On 6/25/2011, a 20-mil reinforced plastic liner was installed at 4.5-ft. BGS and the excavation was backfilled with the remaining blended soil to ground surface and contoured to the surrounding area. A total of 36 cubic yards of soil was transported to a NMOCD approved disposal facility. On 6/27/2011, the site was seeded with a blend of native vegetation and is expected to return to a productive capacity at a normal rate. To further investigate the depth of chloride presence, a soil bore was initiated on 6/29/2011 10 ft north of the source. The boring was advanced to a depth of 51 ft. BGS with soil samples collected at regular intervals between 15-51 ft. Chloride field tests were performed on each sample and organic vapors were measured using a PID. The 21 ft. and 51 ft. samples were taken to a commercial laboratory for analysis of chloride and TPH. The entire bore hold was plugged with bentonite to ground surface. NMOCD was notified of potential groundwater impact on 3/16/2012.

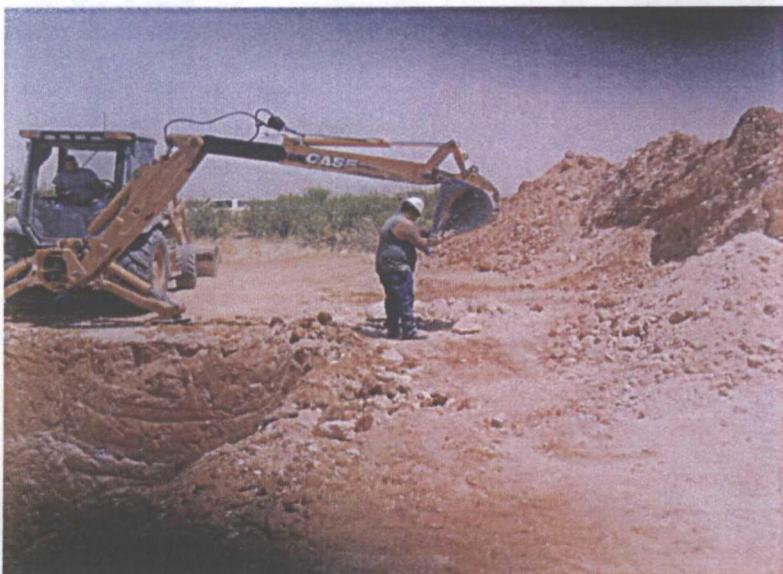
Collecting final samples, facing north 5.24.11

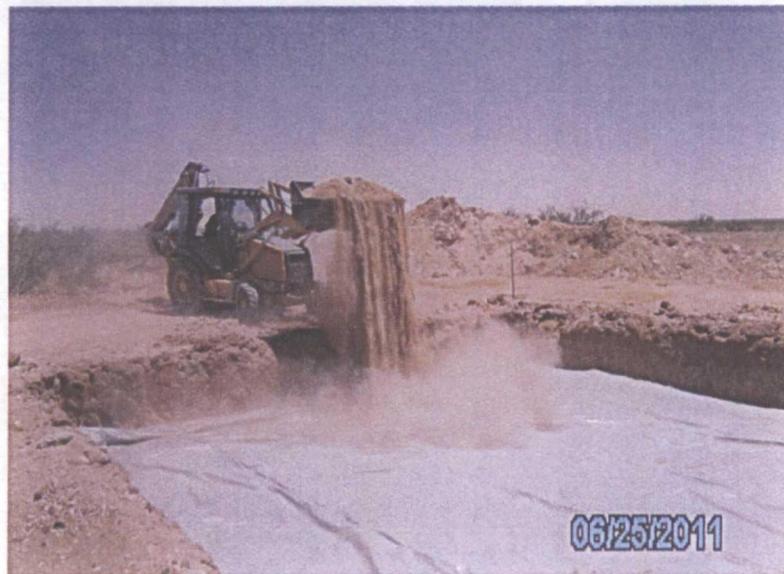
Backfilling above installed plastic liner, facing north 6.25.11

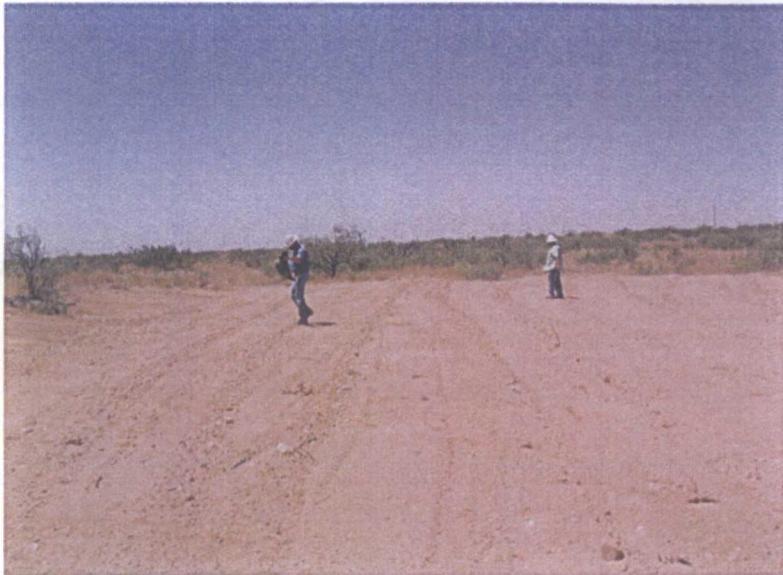
Seeding site, facing south

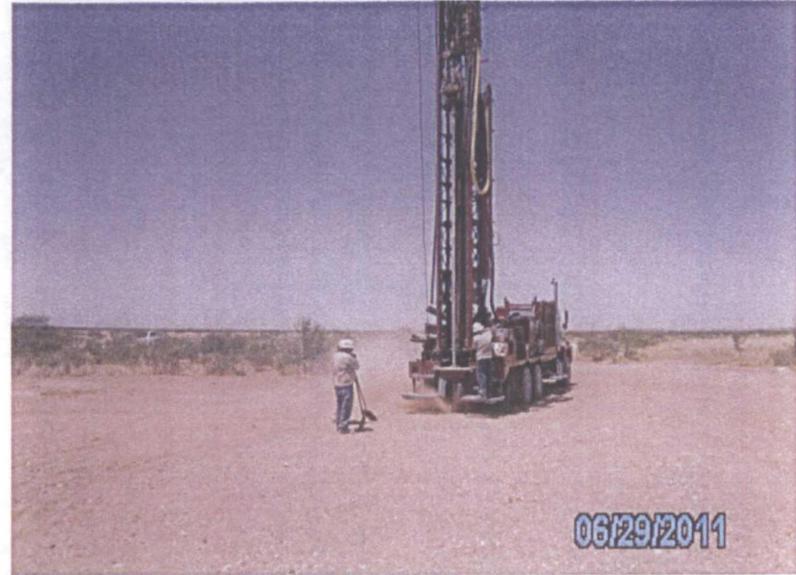
Drilling SB-1, facing north

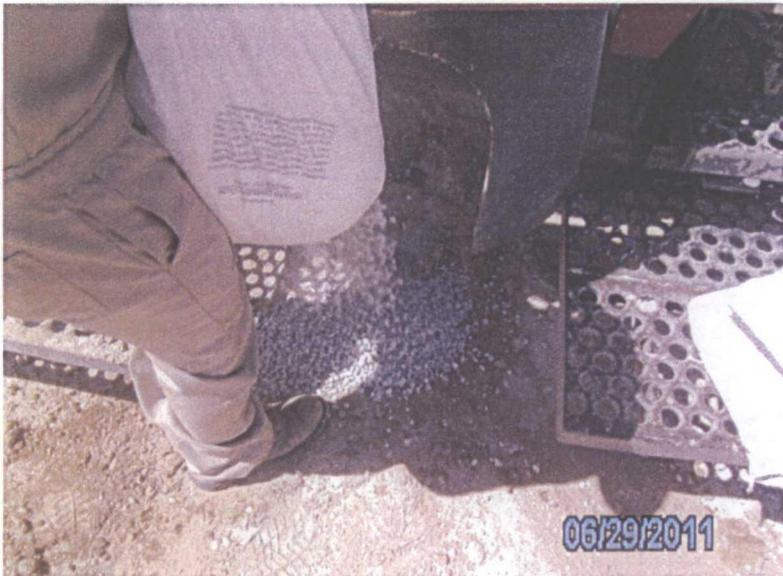
Plugging SB-1 with bentonite, facing north

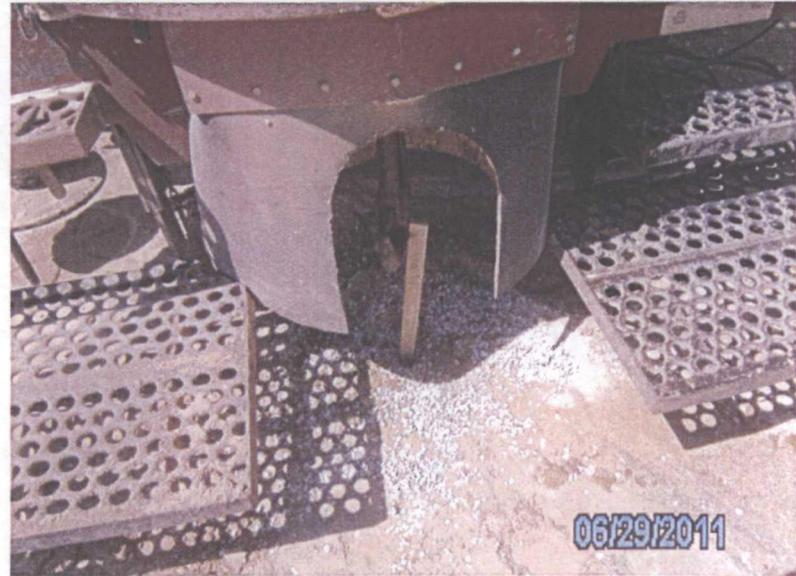
SB-1 plugged, facing north

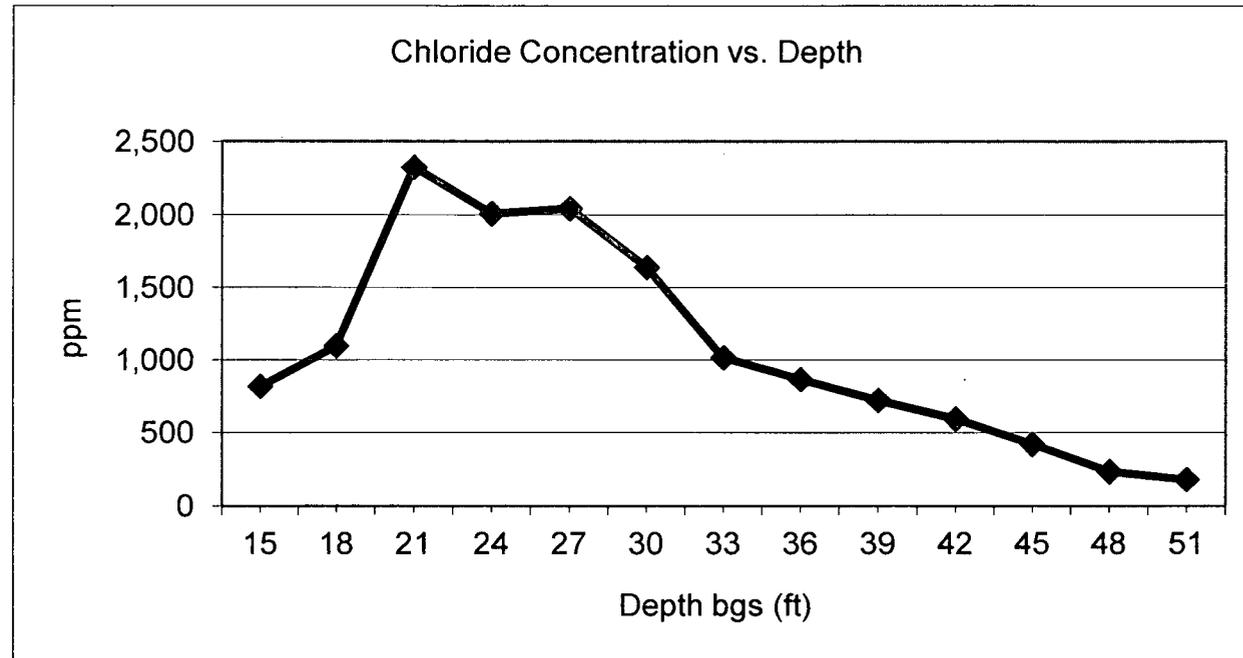
SB-1 samples at 10' north of source.

Depth bgs. (ft)	[Cl <sup>-</sup> ] ppm
15	818
18	1,098
21	2,325
24	2,008
27	2,042
30	1,639
33	1,016
36	865
39	721
42	594
45	419
48	232
51	178

Groundwater = 92 ft
