**RICE OPERATING COMPANY
JUNCTION BOX DISCLOSURE* REPORT**

| SWD SYSTEM | JUNCTION | UNIT | SECTION | TOWNSHIP | RANGE | COUNTY | BOX DIMENSIONS - FEET | | |
|---|---|---|---|---|---|---|---|---|---|
| Blinebry-Drinkard (BD) | O-29-2 vent | O | 29 | 22S | 38E | Lea | Eliminated | | |

BD O-29-2 vent

Unit O, Section 29, T22S, R38E

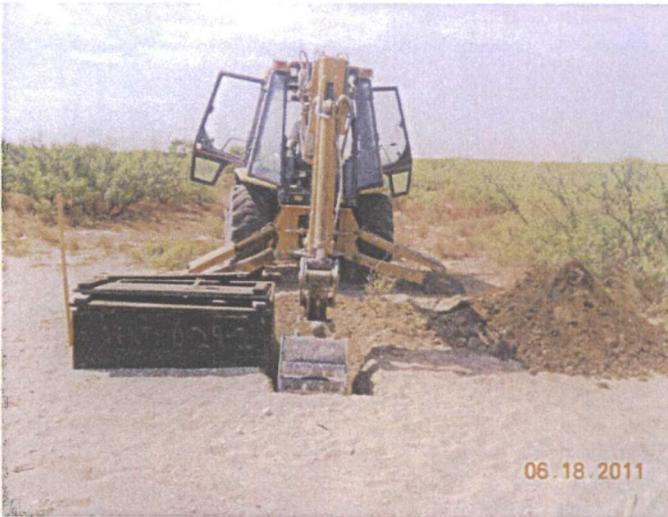
Excavating initial, facing south 6/18/2011

General Description of Remedial Action: This junction was eliminated during the pipeline replacement/upgrade program. After the former junction box was removed, an investigation was conducted using a backhoe to collect soil samples at regular intervals producing a 30x30x12-ft excavation. Chloride field tests performed on each sample yielded elevated concentrations that did not relent with depth. Organic vapors were measured using a PID which yielded low concentrations. The excavated soil was blended on site and representative composite samples of the excavation bottom, the excavation walls, and the blended backfill were sent to a commercial laboratory for analysis of chloride and TPH. The blended backfill was returned to the excavation to a depth of 4-ft BGS. On 7/27/2011, a 20-mil reinforced liner was installed at 4-ft BGS and the excavation was backfilled with the clean imported soil to ground surface and contoured to the surrounding area. The remaining excavated soil was properly disposed of at an NMOCD approved facility. On 11/10/2011, the site was seeded with a blend of native vegetation and is expected to return to a productive capacity at a normal rate. NMOCD was notified of potential groundwater impact on 12/22/2011.

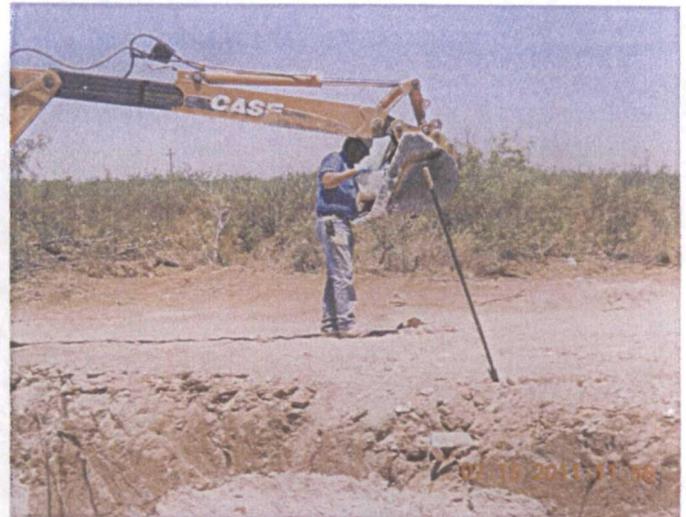
Collecting a soil sample, facing northwest 7/15/2011

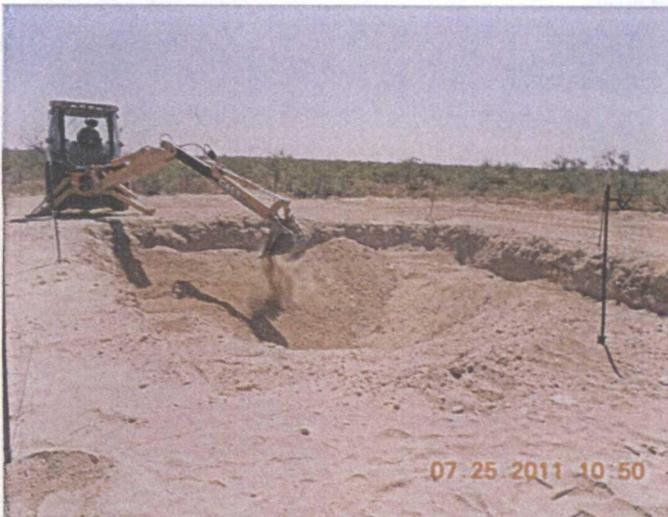
30 x 30-ft excavation being backfilled up to 4-ft BGS, facing east 7/25/2011

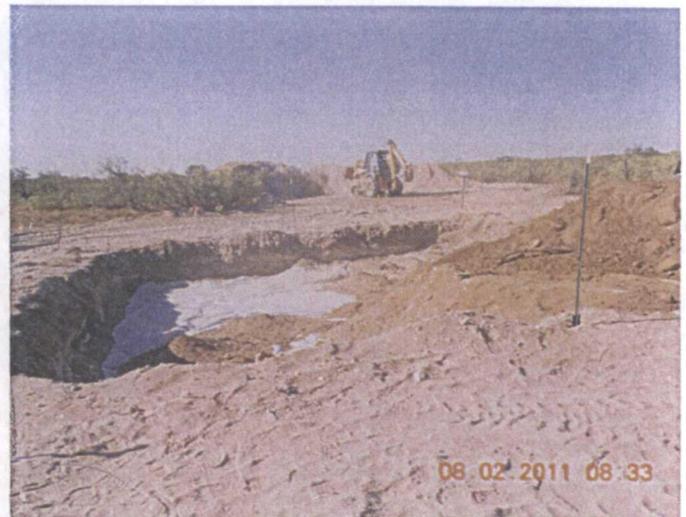
Backfilling above liner with imported soil, facing north 8/2/2011

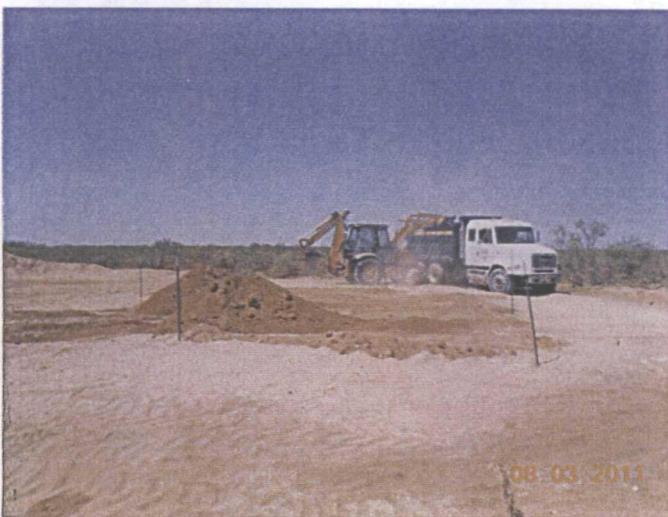
Exporting soil, facing southwest 8/3/11

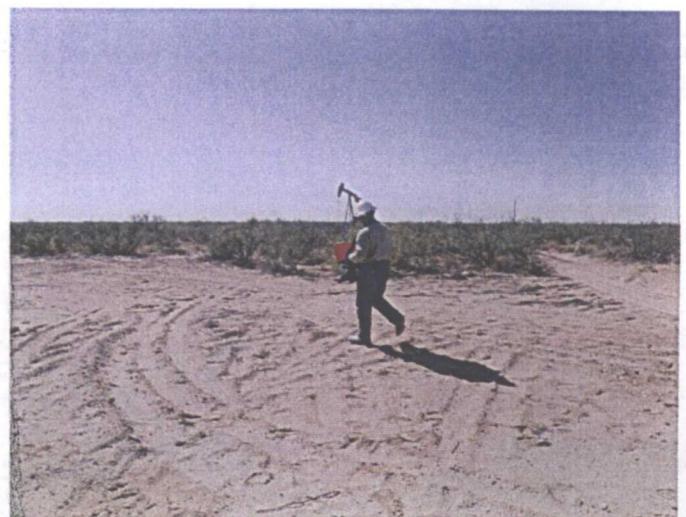
Seeding site, facing south 11/10/11

| Custom seed mix <input checked="" type="checkbox"/> | Prescribed mix <input type="checkbox"/> | Seed mix name: Pecos District Mix | Seeding date: 11/10/2011 |
| Broadcast <input checked="" type="checkbox"/> 13.5 LBS OF BOYD JOHNSTON MIX | | | |

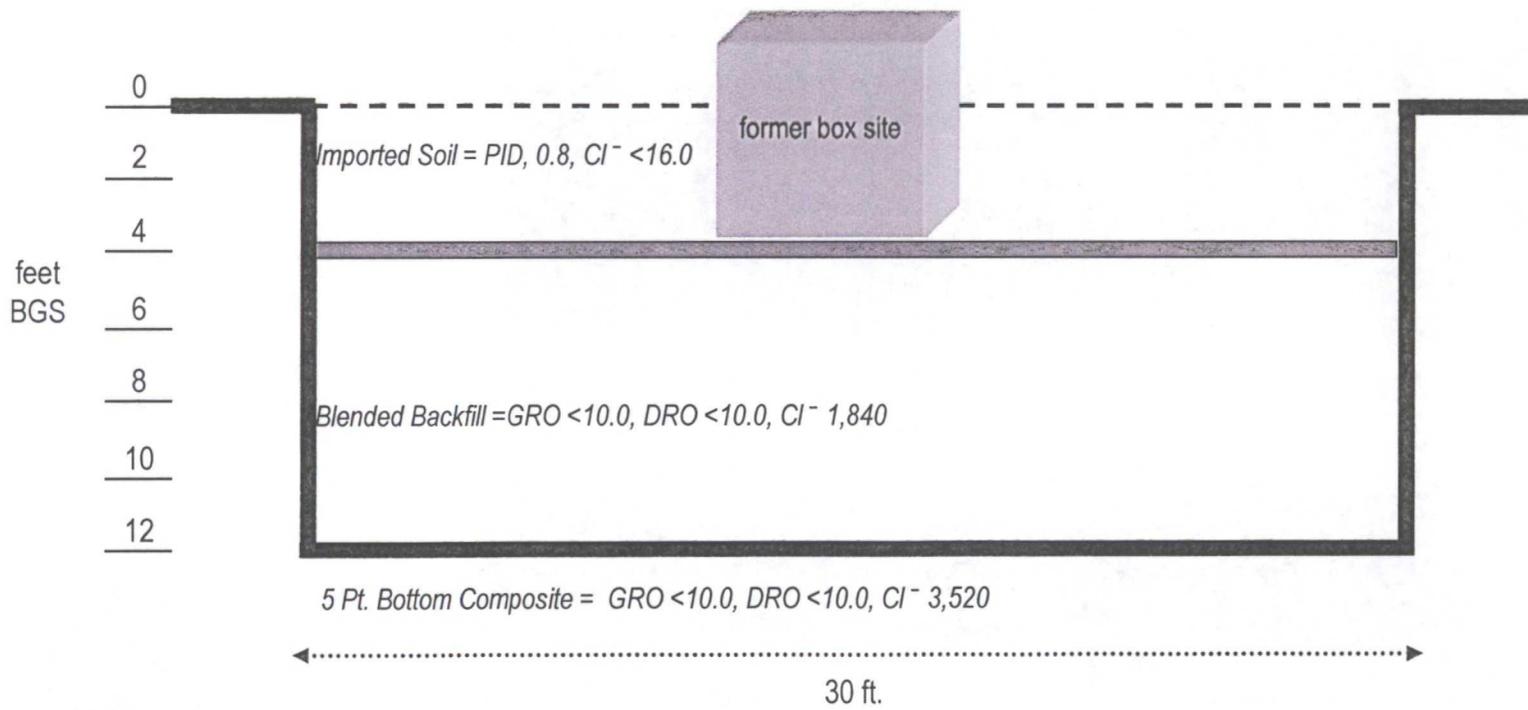
Excavation Cross-Section

Soil Excavated 400.0 cubic yards Excavation Length 30 Width 30 Depth 12 feet

BD O-29-2 vent
Unit 'O', Sec. 29, T22S, R38E

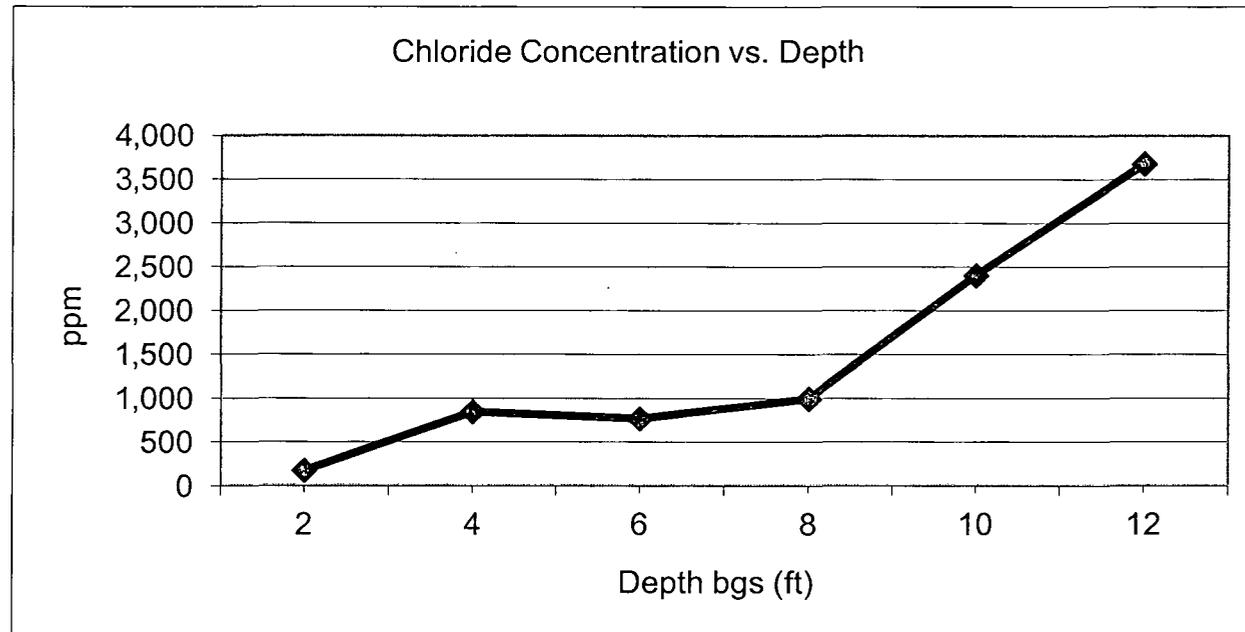
Backhoe samples at 10 ft East of the junction (source)

Groundwater = 124 ft

| LOCATION | DEPTH | mg/kg |
|---|---|---|
| vertical delineation trench at 10' east of source | 2' | 175 |
| | 10' | 2,403 |
| | 12' | 3,680 |
