RE: Termination Request  
BD Jct. C-7: UL/C, Sec. 7, T22S, R38E  
RICE Operating Company – Blinebry-Drinkard SWD System

**RICE OPERATING COMPANY  
JUNCTION BOX FINAL REPORT**

# BD Jct. C-7

Unit C, Section 7, T22S, R38E

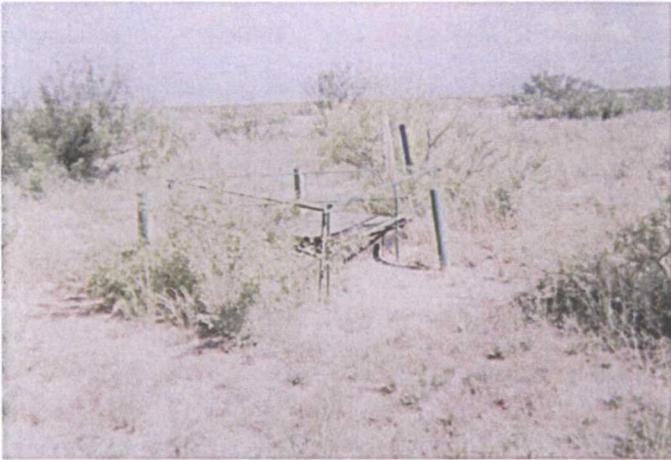
Site prior to excavation, facing north 9.21.10

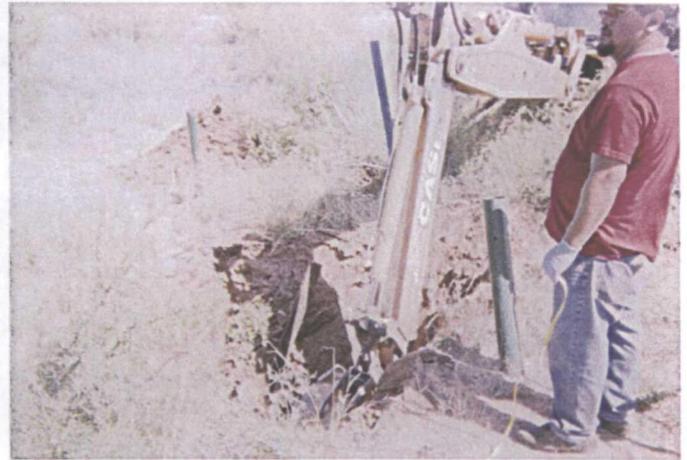
Excavating source, facing north 9.21.10

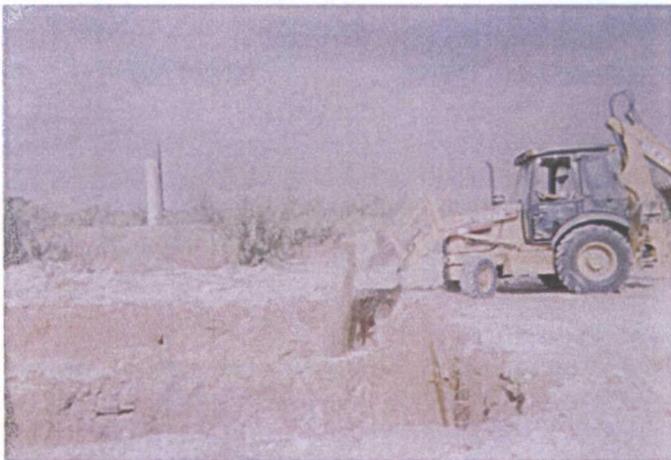
Backfilling site, facing west 10.06.10

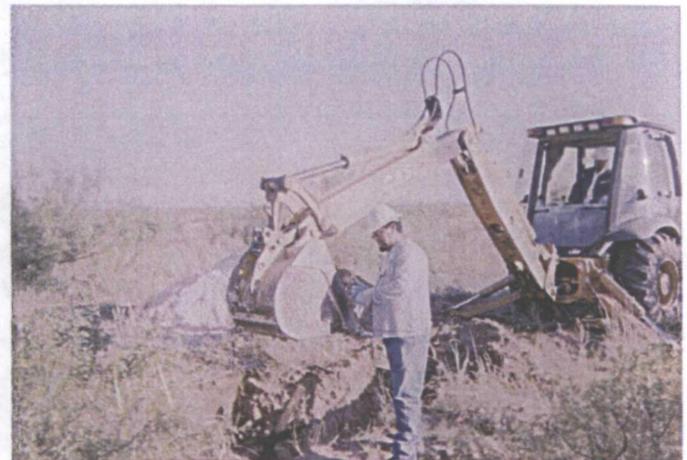
Collecting a sample, facing north 10.11.10

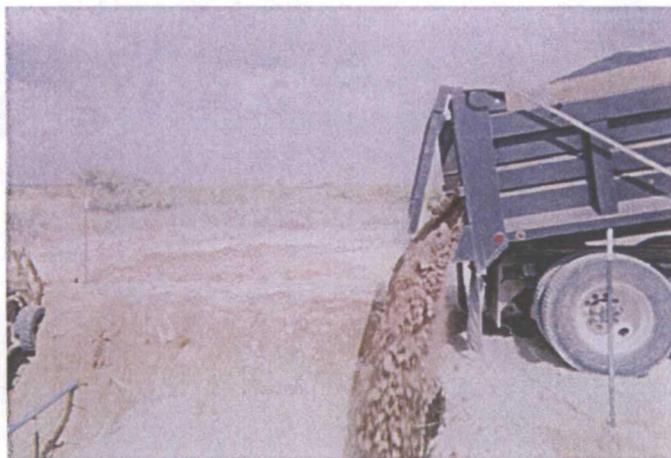
Importing clay for liner, facing north 10.21.10

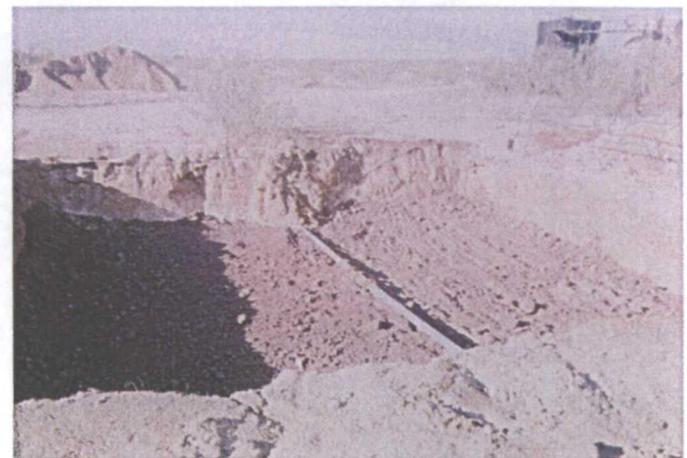
Installed clay liner at 6-ft. BGS, facing southwest 10.22.

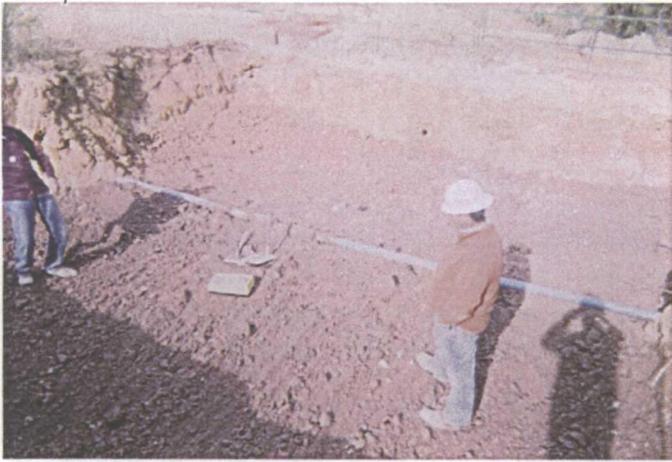
Performing clay compaction test, facing northwest  
10.22.10

Test No.	Location	Dry Density % Max	% Moisture	Depth
SG 1	Pit - 6' N. & 8' W. of SE Corner	91.5	15.9	FSG

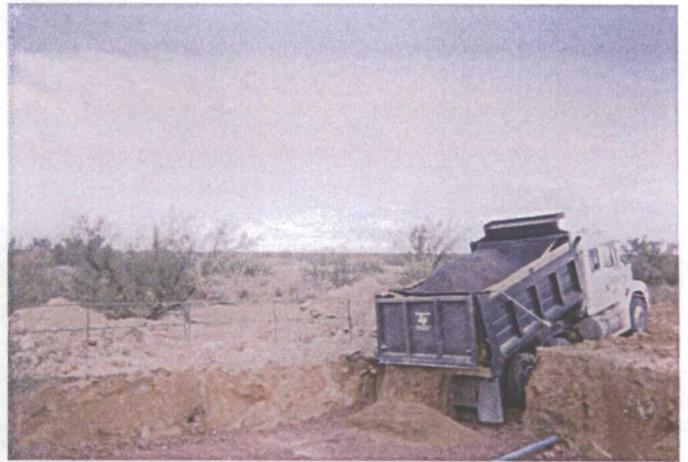
Backfilling above clay liner, facing northwest  
10.22.11

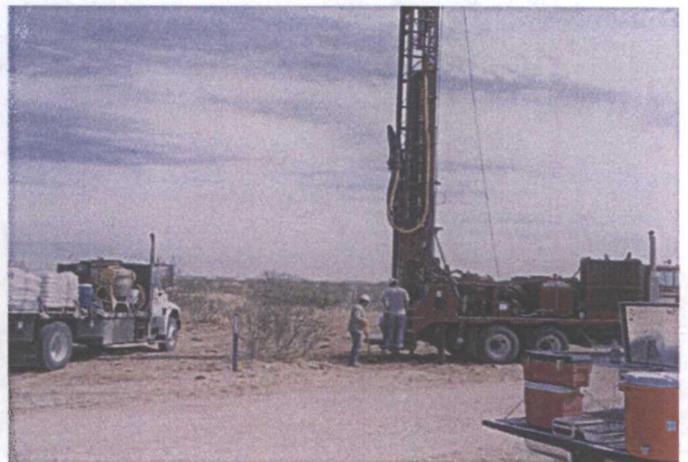
Drilling SB-1, facing northeast  
4.13.11

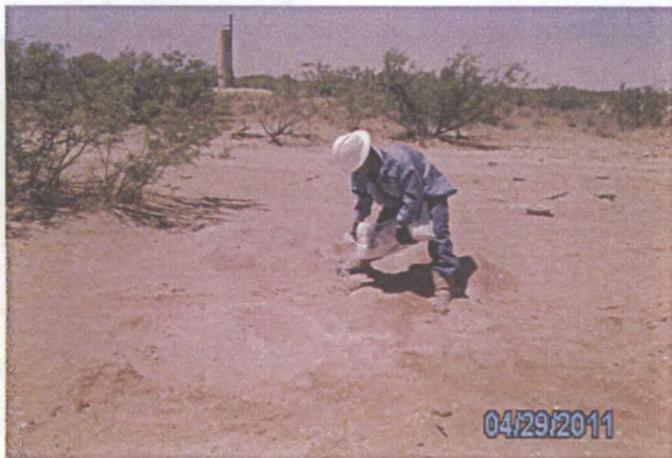
Plugging SB-1 with bentonite, facing west  
4.29.11

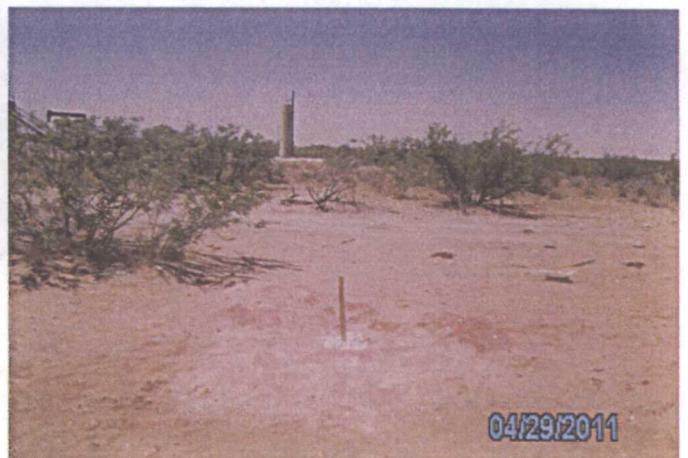
Completed SB-1, facing west  
4.29.11

On Monday April 18, 2011 soil bore #1 at the BD Junction C-7, Lea County T22S, R38E, Sec 7 Unit Letter C was checked with a Solinist Water Level Meter for water accumulation within the borehole. The meter indicated no water within the borehole to the total depth of 70.51 feet.
