WORKPLANS

**RE: ICP REPORT
JUSTIS E-26
UNIT "E", SEC. 26, T24S, R37E
LEA COUNTY, NEW MEXICO
NMOCD #1R0423-07**

RICE Operating Company (ROC) has retained Tetra Tech, Inc. (Tetra Tech) to address potential environmental concerns at the Justis SWD System E-26 site. ROC is the service provider (agent) for the Justis SWD System and has no ownership of any portion of the pipeline, well or facility. The Justis SWD system is owned by a consortium of oil producers, System Parties, who provide all operating capital on a percentage ownership/usage basis. In general, project funding is not forthcoming until NMOCD approves the work plan. Therefore, your timely review of this submission is requested.

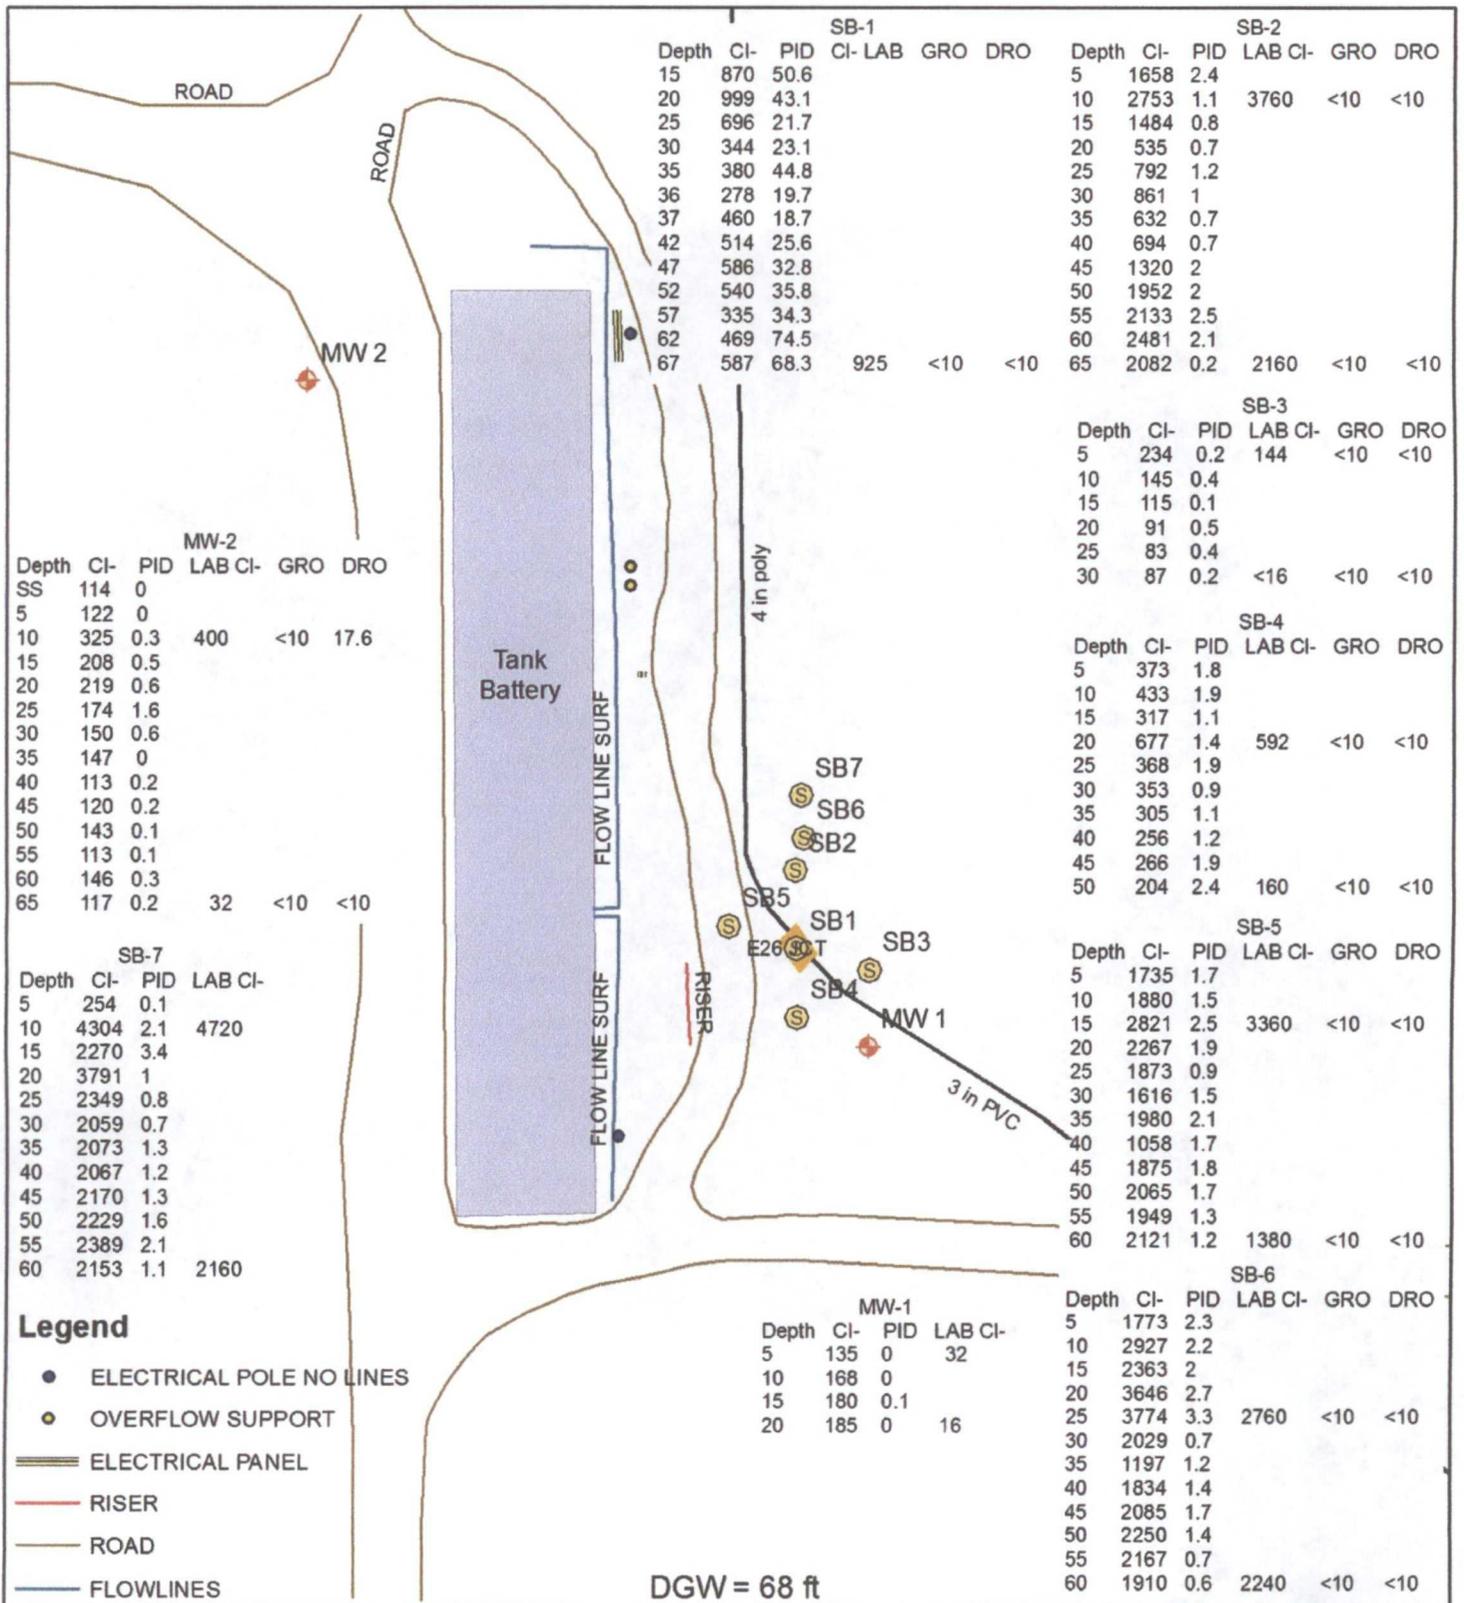
Figure 3

Justis E-26

LEGALS: UL/E sec. 26
T24S R37E

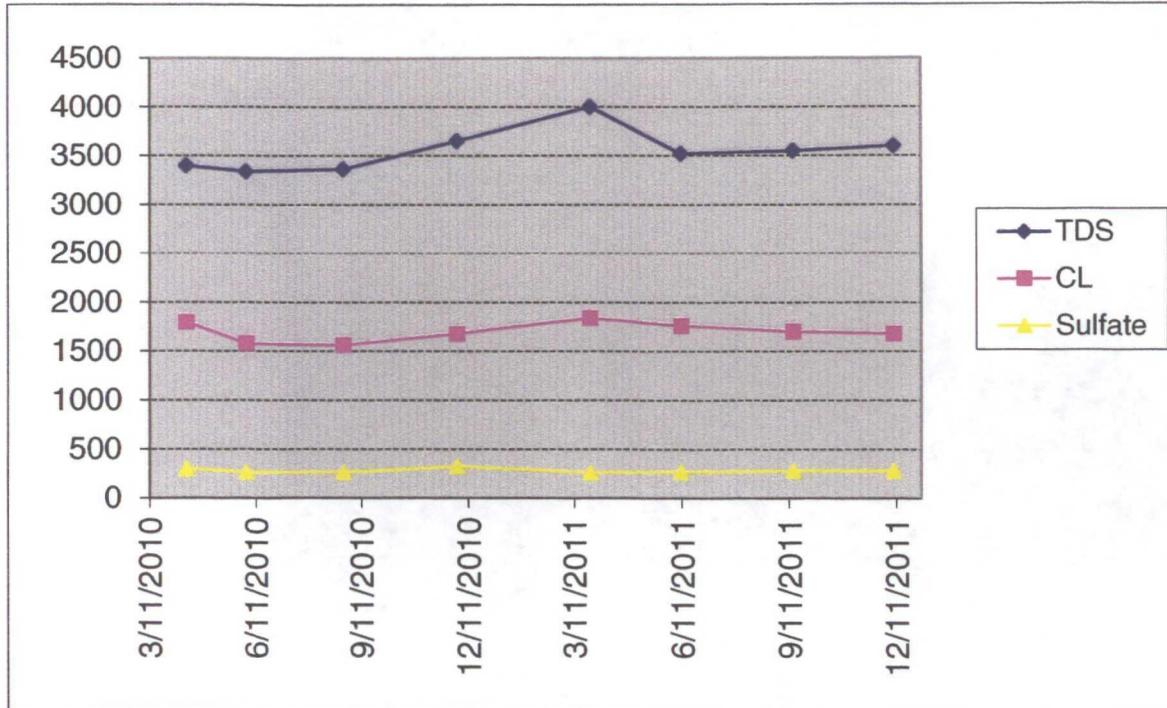
Graph 1
Rice Operating Company
MW-1
Justis E-26
Lea County, New Mexico

MW	Depth to Water	Total Depth	Well Volume	Volume Purged	Sample Date	Cl mg/L	TDS mg/L	Benzene mg/L	Toluene mg/L	Ethyl Benzene mg/L	Total Xylenes mg/L	Sulfate mg/L	Comments
1	67.93	78.65	1.70	10.0	04/11/10	1800	3400	<0.001	<0.001	<0.001	<0.003	299	Clear no odor
1	67.92	78.65	1.70	10.0	06/02/10	1580	3340	<0.001	<0.001	<0.001	<0.003	265	Clear no odor
1	67.99	78.65	1.70	10.0	08/26/10	1560	3360	<0.001	<0.001	<0.001	<0.003	260	Clear no odor
1	68.02	78.65	1.70	10.0	12/01/10	1680	3650	<0.001	<0.001	<0.001	<0.003	324	Clear no odor
1	68.02	78.64	1.70	10.0	03/24/11	1840	4000	<0.001	<0.001	<0.001	<0.003	260	Clear no odor
1	68.03	78.64	1.70	10.0	06/10/11	1760	3520	<0.001	<0.001	<0.001	<0.003	266	Clear no odor
1	68.06	78.64	1.70	10.0	09/14/11	1700	3550	<0.001	<0.001	<0.001	<0.003	281	Clear no odor
1	68.13	78.64	1.70	10.0	12/08/11	1680	3600	<0.001	<0.001	<0.001	<0.003	281	Clear no odor
1	68.05	78.64	1.70	10.0	03/08/12	1860	3920	<0.001	<0.001	<0.001	<0.003	292	Clear no odor

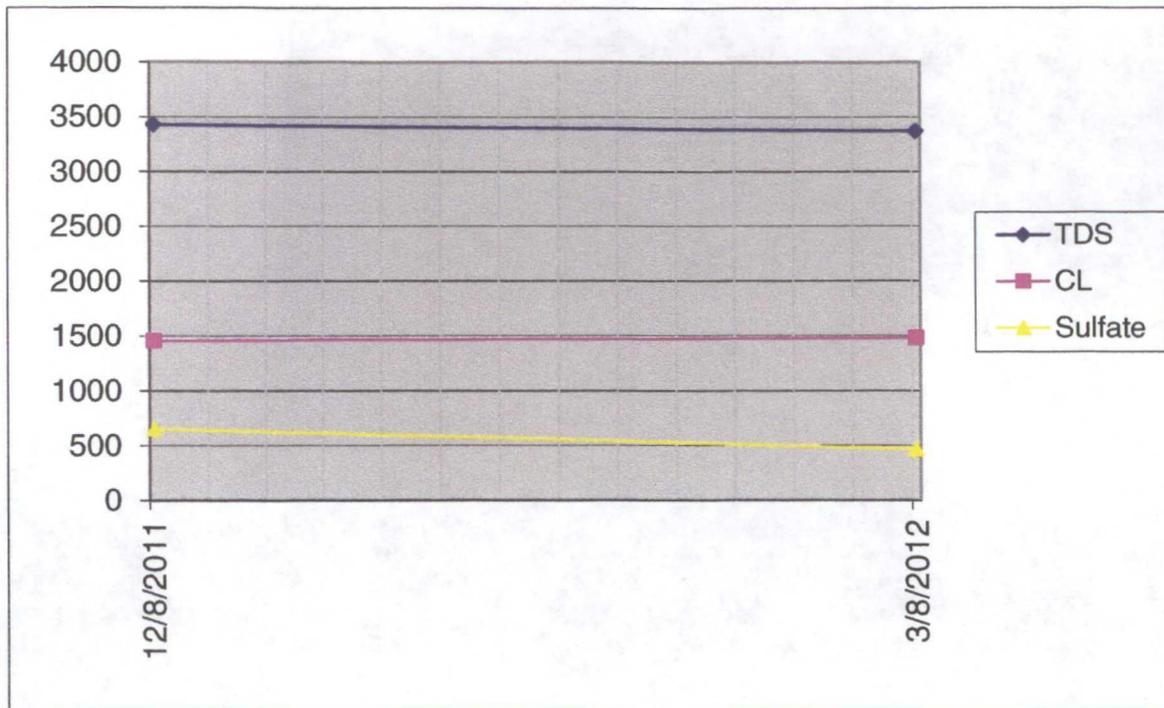
Graph 2
 Rice Operating Company
 MW-2
 Justis E-26
 Lea County, New Mexico

MW	Depth to Water	Total Depth	Well Volume	Volume Purged	Sample Date	Cl mg/L	TDS mg/L	Benzene mg/L	Toluene mg/L	Ethyl Benzene mg/L	Total Xylenes mg/L	Sulfate mg/L	Comments
2	68.28	78.64	1.70	10.0	12/08/11	1460	3430	<0.001	<0.001	<0.001	<0.003	652	Clear no odor
2	68.23	78.64	1.70	10.0	03/08/12	1480	3370	<0.001	<0.001	<0.001	<0.003	465	Clear no odor

On October 24, 2011, a second up-gradient monitor well (MW-2) was installed northwest of the former junction box. Chloride analytical results for the well were 1,460 mg/L, which is consistent with the results in source well MW-1. This indicates an up-gradient source contributing chlorides to the groundwater. See attached Table 2 for groundwater analytical results.
