CLOSURE

RE: Termination Request
BD M-29 EOL: UL/M, Sec. 29, T22S, R38E
RICE Operating Company – Blinbry-Drinkard SWD System

**RICE OPERATING COMPANY
JUNCTION BOX FINAL REPORT**

BD M-29 EOL

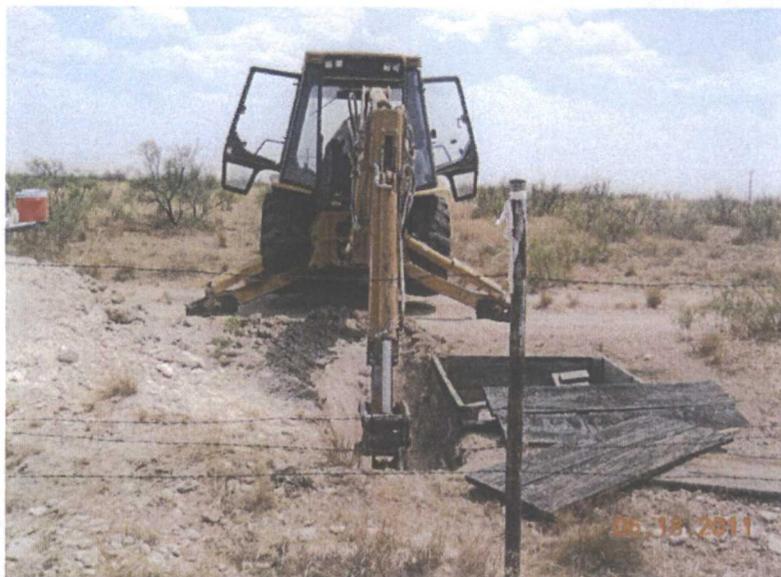
6.18.11

Digging vertical, facing south

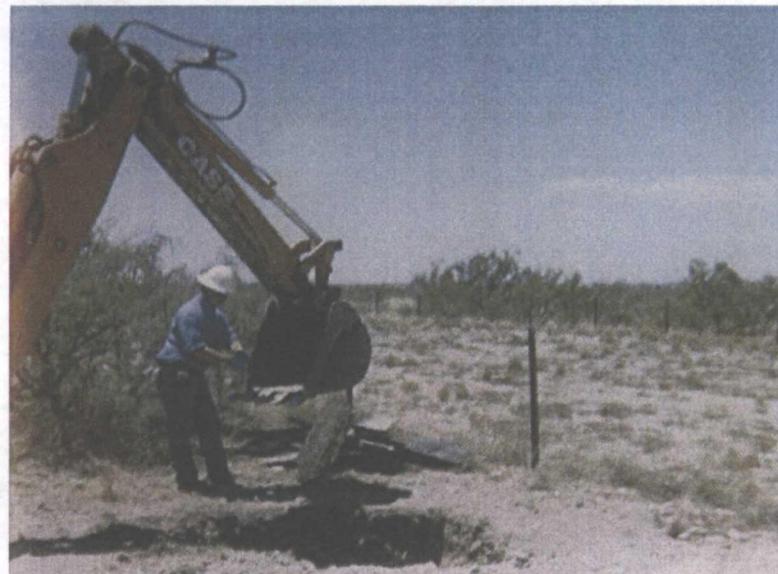
6.27.11

Collecting sample, facing northwest

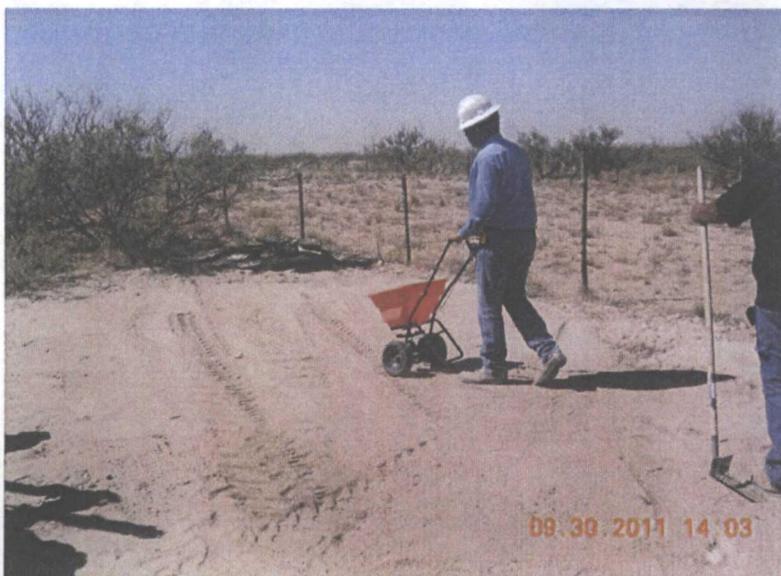
9.30.11

Seeding site, facing northwest

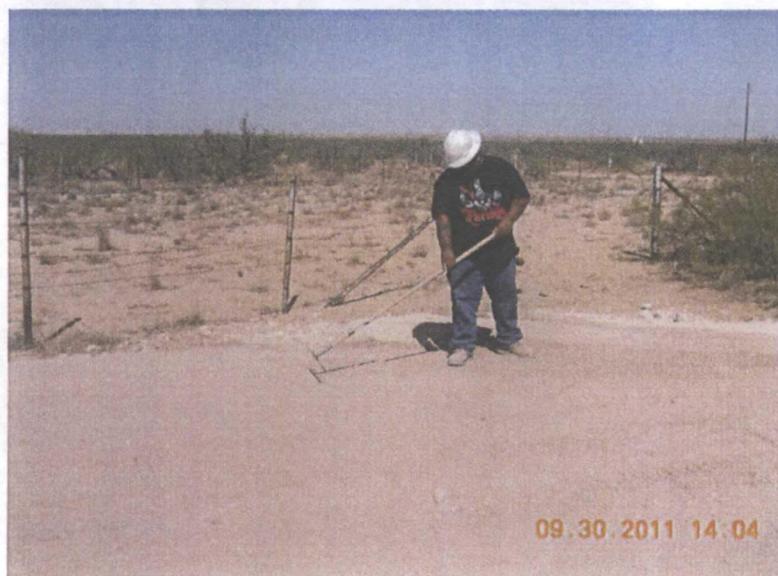
9.30.11

Raking site, facing northeast
