RE: Termination Request
BD Jct. P-2: UL/P, Sec. 2, T23S, R37E
RICE Operating Company – Blinebry-Drinkard SWD System

**RICE OPERATING COMPANY
JUNCTION BOX FINAL REPORT**

BD Jct. P-2

Unit P, Section 2, T23S, R37E

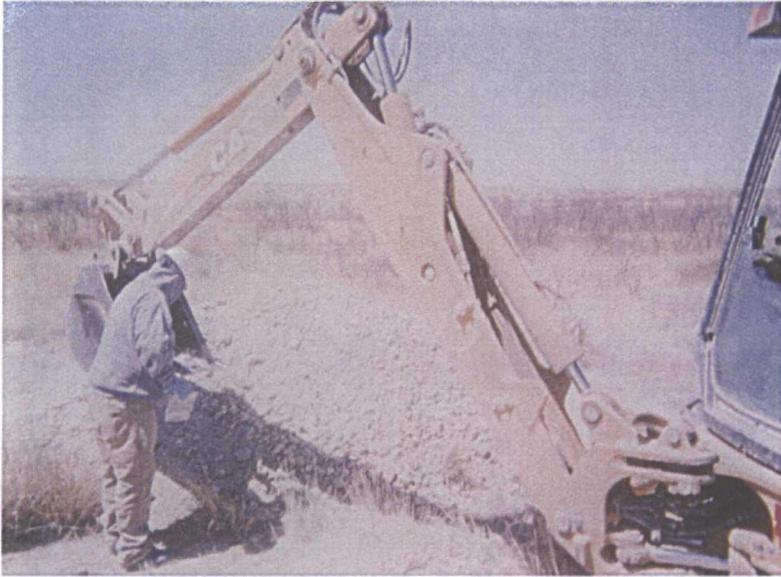
4.4.11

Collecting sample, facing west

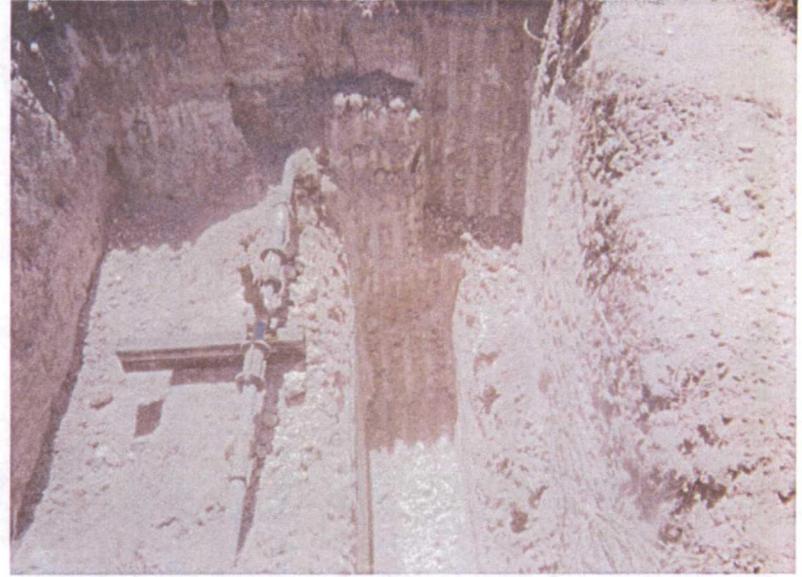
4.4.11

Final Excavation

General Description of Remedial Action: This junction was eliminated during the pipeline replacement/upgrade program. After the former junction box was removed, an investigation was conducted using a backhoe to collect soil samples at regular intervals creating a 5X3X10-ft. deep excavation. Chloride field tests performed on each sample yielded concentrations similar to that of the background sample. Organic vapors were measured using a PID, which yielded low concentrations. The deepest sample, 10 ft. BGS, was sent to a commercial laboratory for analysis of chloride and TPH, which confirmed low concentrations of each. The excavation was backfilled with excavated soil to ground surface and contoured to the surrounding area. On 11/10/2011, the site was seeded with a blend of native vegetation and is expected to return to a productive capacity at a normal rate.

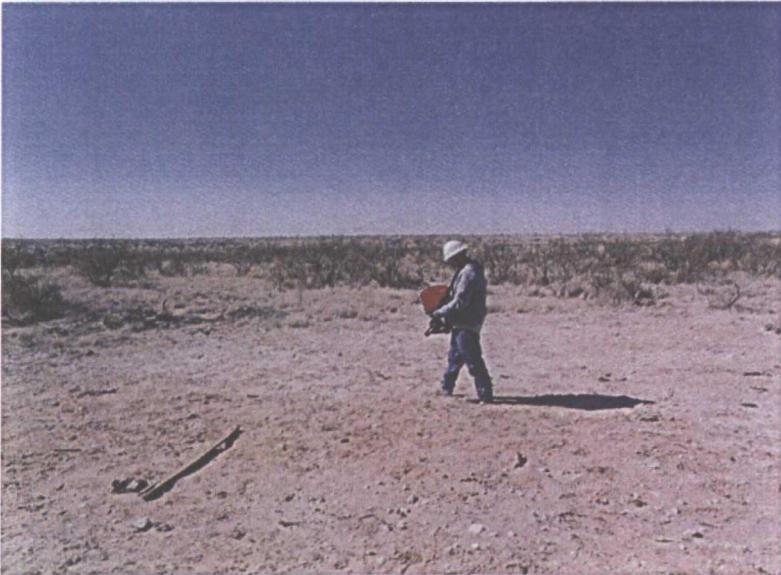
11.10.11

Spreading seed, facing south

Custom seed mix <input checked="" type="checkbox"/>	Prescribed mix <input type="checkbox"/>	Seed mix name: 2 lbs. Boyd Johnston Mix	Seeding date: 11/10/2011
Broadcast <input checked="" type="checkbox"/>			
Method: Portable Seeder			
Soil conditions during seeding: Dry <input checked="" type="checkbox"/> Damp <input type="checkbox"/> Wet <input type="checkbox"/>			
Photos attached <input checked="" type="checkbox"/>	Observations:		
Number of photos: 2

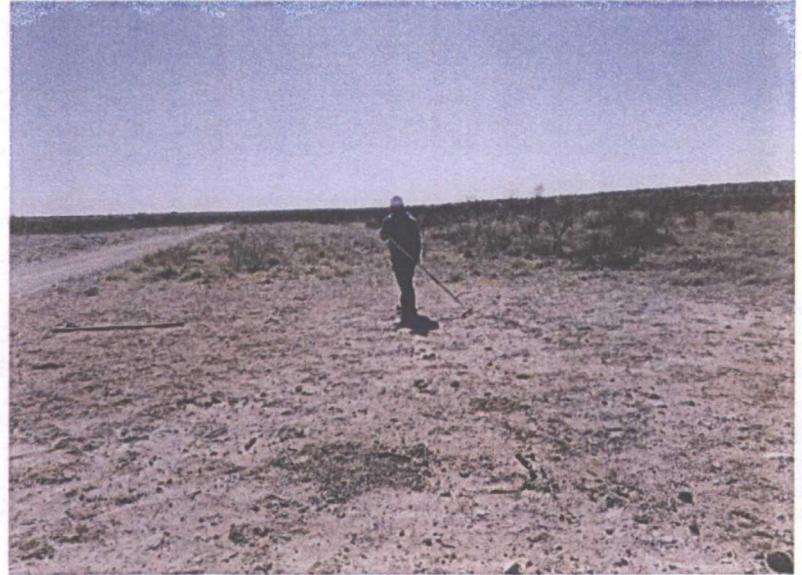
11.10.11

Raking in seed, facing east

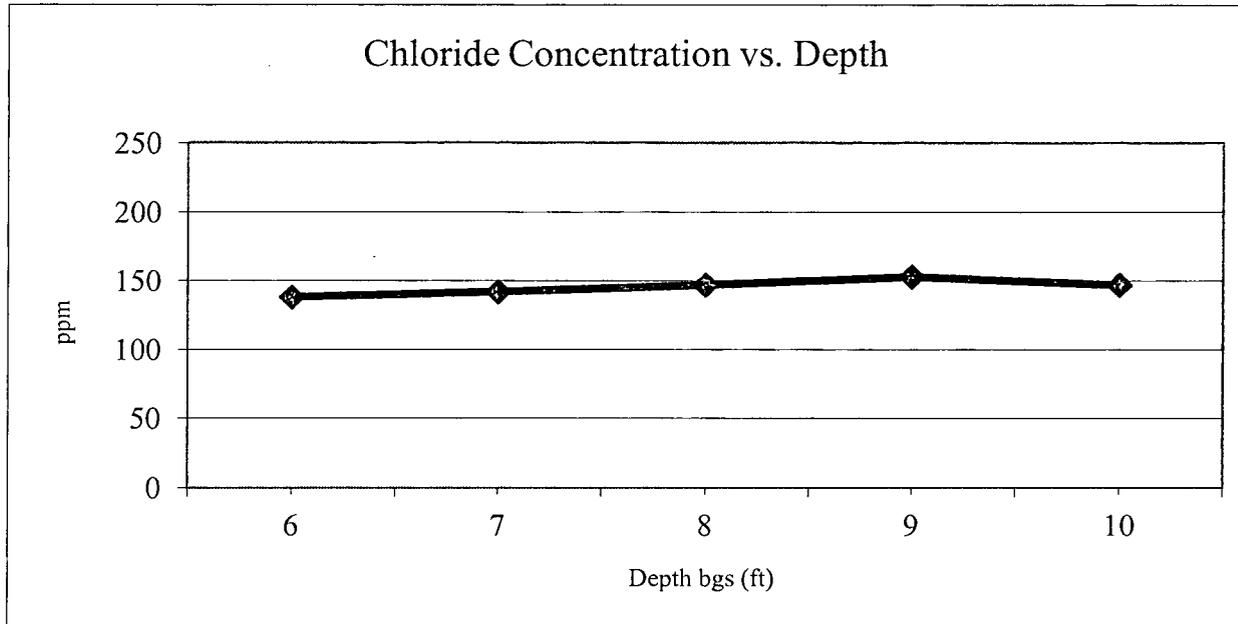
BD Jct. P-2

Backhoe samples at junction (source)

Depth bgs (ft)	[Cl ⁻] ppm
6	138
7	142
8	147
9	153
10	147

Groundwater = 64 ft
