RE: Termination Request  
BD Jct. G-36: UL/G, Sec. 36, T22S, R37E  
RICE Operating Company – Blinebry-Drinkard SWD System

**RICE OPERATING COMPANY  
JUNCTION BOX FINAL REPORT**

# BD Jct. G-36

Unit G, Section 36, T22S, R37E

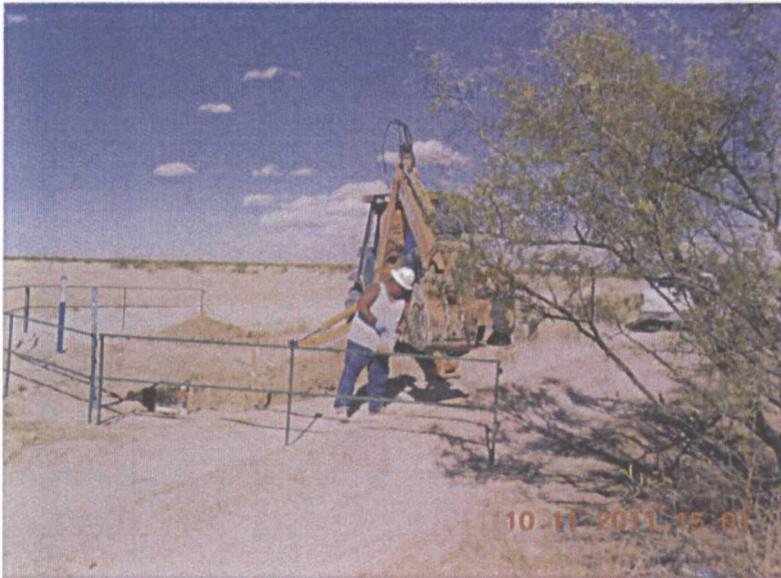
10.11.11

Collecting sample, facing north

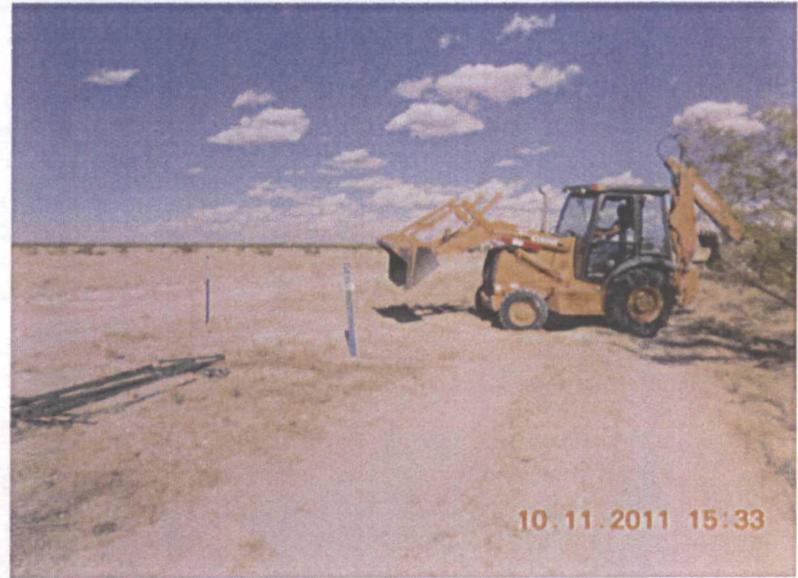
10.11.11

Backfilling site, facing north

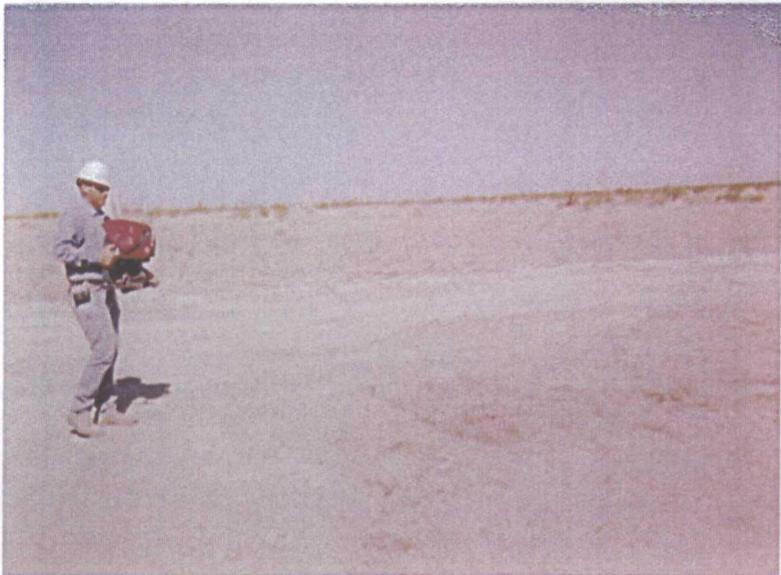
10.20.11

Spreading seed, facing north

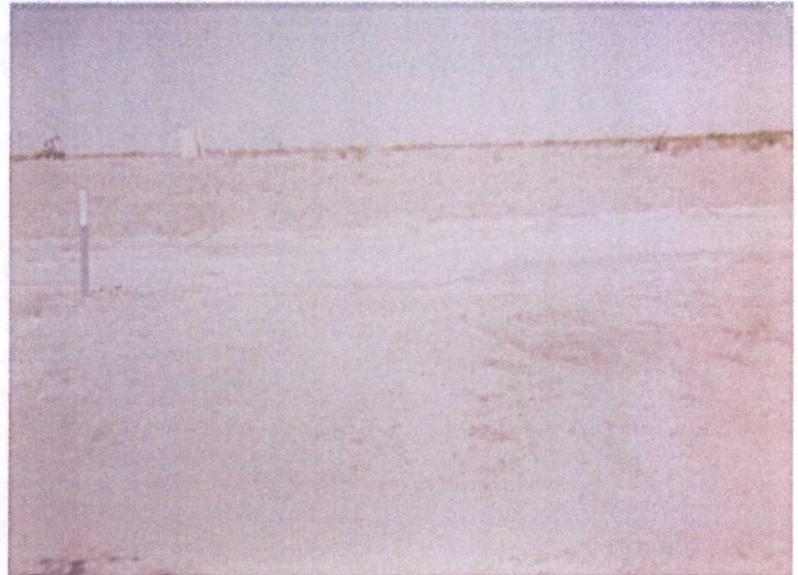
10.20.11

Site complete, facing north

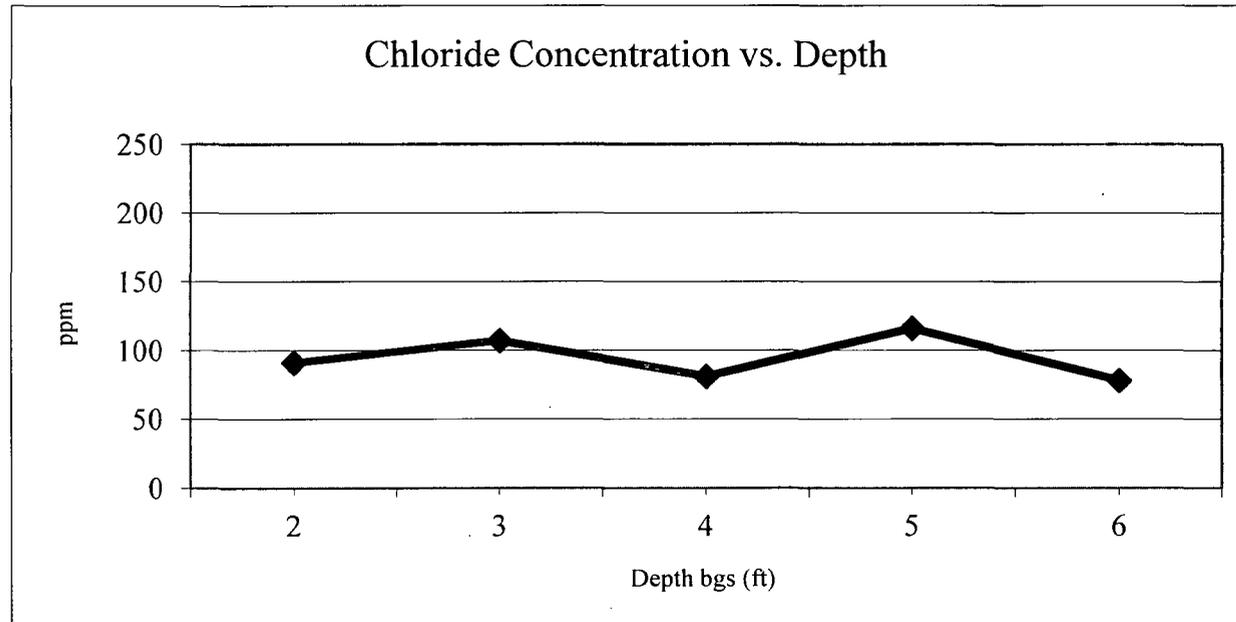
# CHLORIDE CONCENTRATION CURVE

*Backhoe samples at junction (source)*

Depth bgs. (ft)	[Cl <sup>-</sup> ] ppm
2	91
3	107
4	81
5	116
6	78

Groundwater = 41 ft
