BD Jct. H-11-1
2011

CLOSURE

RE: Termination Request
BD Jct. H-11-1: UL/H, Sec. 11, T23S, R37E
RICE Operating Company – Blinebry-Drinkard SWD System

**RICE OPERATING COMPANY
JUNCTION BOX FINAL REPORT**

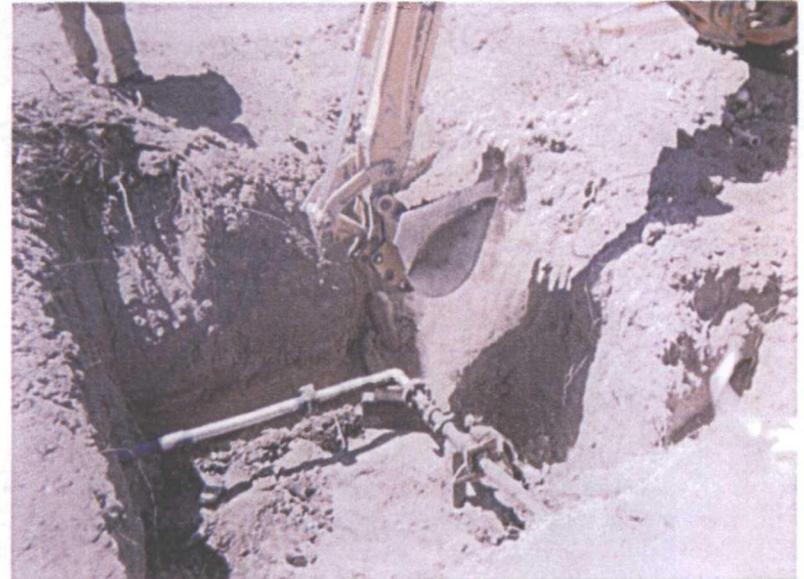
Excavating site

4/16/2011

General Description of Remedial Action: This junction was eliminated during the pipeline replacement/upgrade program. After the former junction box was removed, an investigation was conducted using a backhoe to collect soil samples at regular intervals producing a 20x15x12-ft excavation. Chloride field tests performed on each sample yielded elevated concentrations. Organic vapors were measured using a PID which yielded low concentrations. The excavated soil was blended on site and representative composite samples of the excavation bottom, the excavation walls, and the blended backfill were sent to a commercial laboratory for analysis of chloride and TPH. The blended backfill was returned to the excavation to 5-ft. below ground surface (BGS). On 6/3/2011, a 20 mil reinforced plastic liner was installed at 5-ft. BGS and the excavation was backfilled with the remaining blended soil to ground surface and contoured to the surrounding area. On 6/7/2011, the site was seeded with a blend of native vegetation and is expected to return to a productive capacity at a normal rate. To further investigate the depth of chloride presence, a soil bore was initiated on 10/26/2011. The boring was advanced to a depth of 45-ft. BGS with soil samples collected every 5-ft. between 15-45-ft. Chloride field tests were performed on each sample and organic vapors were measured using a PID. The 20-ft. and 45-ft. samples were taken to a commercial laboratory for analysis of chloride and TPH. Red bed clay was encountered at 20-ft. BGS which indicated the bottom of the aquifer. Since no groundwater was encountered, the bore was advanced to 65-ft BGS and packed open to allow any possible groundwater to accumulate. On 10/31/2011, Arc Environmental was on site to gauge the bore for groundwater accumulation. They found no water in the bore. The entire bore hole was plugged with bentonite to ground surface.

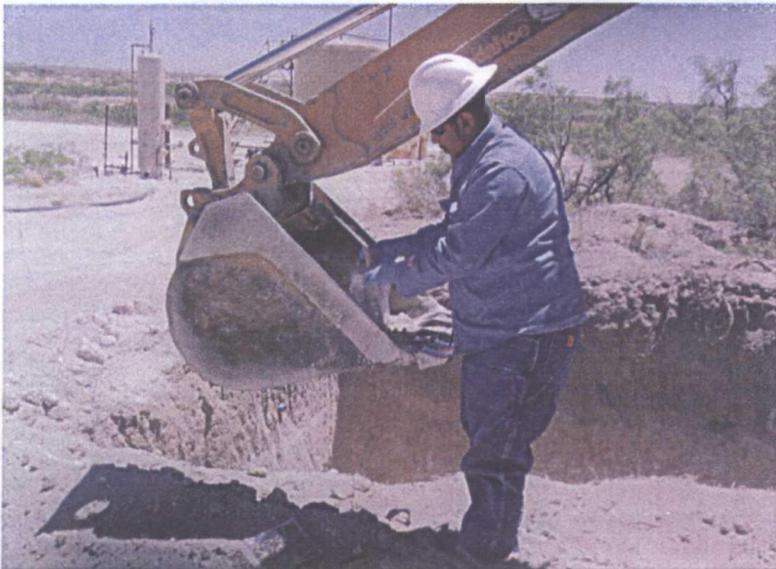
Collecting sample, facing south

5/11/2011

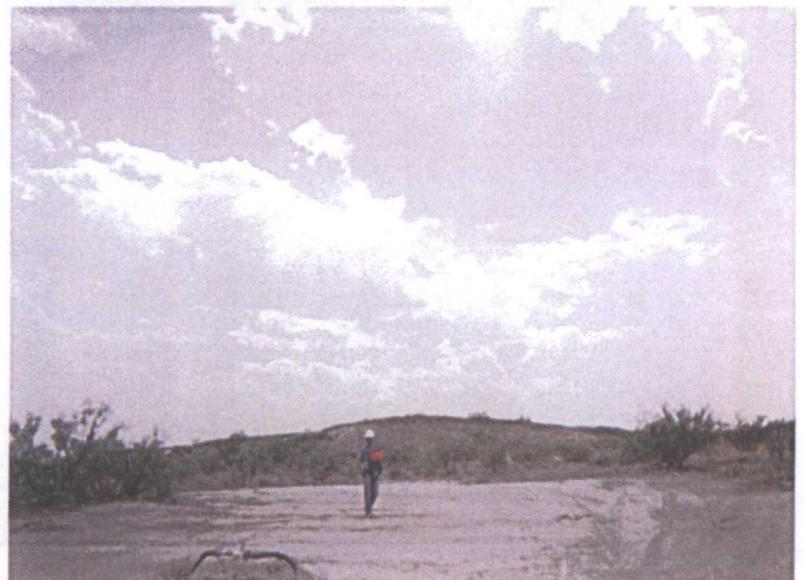
Seeding site, facing west

6/7/2011

site was seeded with a blend of native vegetation and is expected to return to a productive capacity at a normal rate.

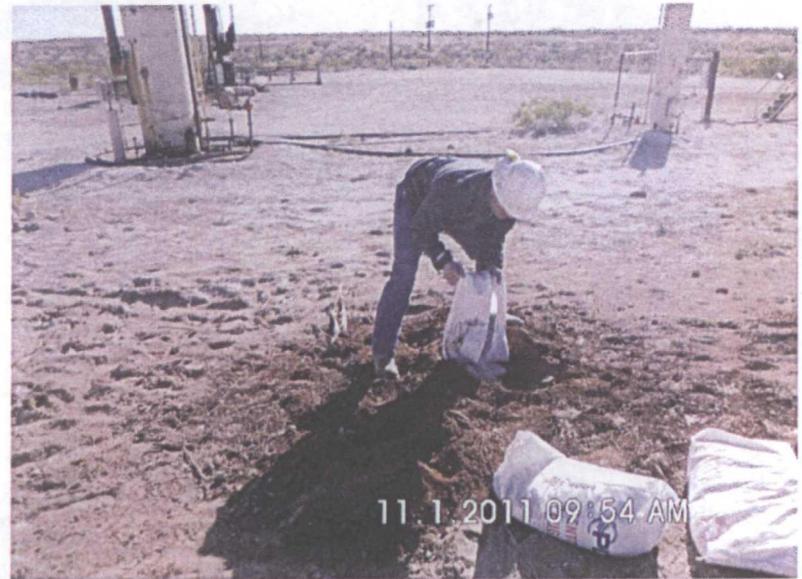
Plugging SB-1, facing east

11/1/2011

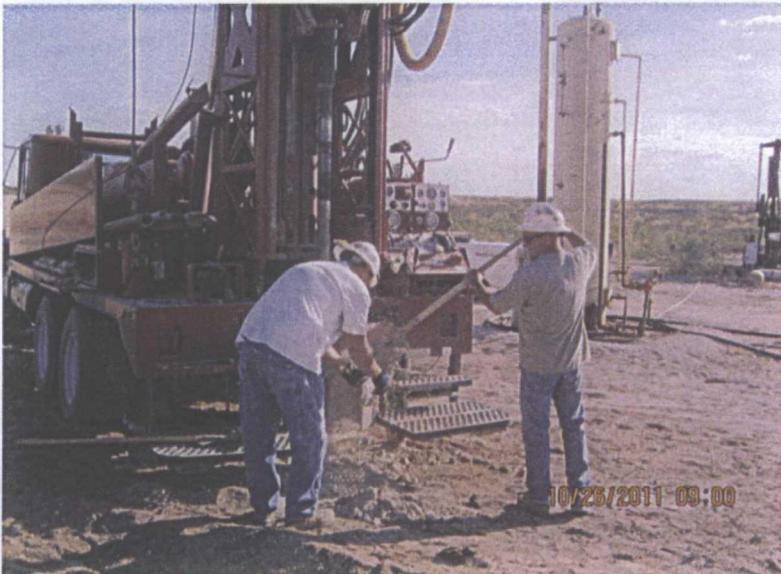
Collecting sample, facing northeast

10/26/2011
