RE: Termination Request  
BD Jct. H-7: UL/H, Sec. 7, T22S, R38E  
RICE Operating Company – Blinebry-Drinkard SWD System

**RICE OPERATING COMPANY  
JUNCTION BOX FINAL REPORT**

# BD Jct. H-7

Unit H, Section 7, T22S, R38E

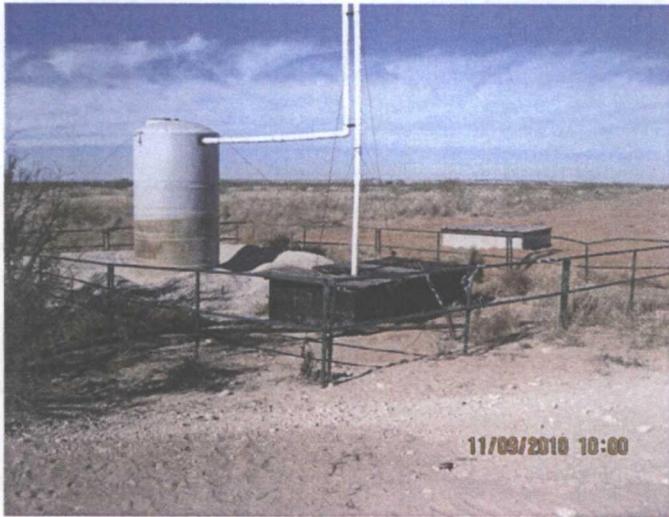
Site prior to excavation, facing west 11.9.10

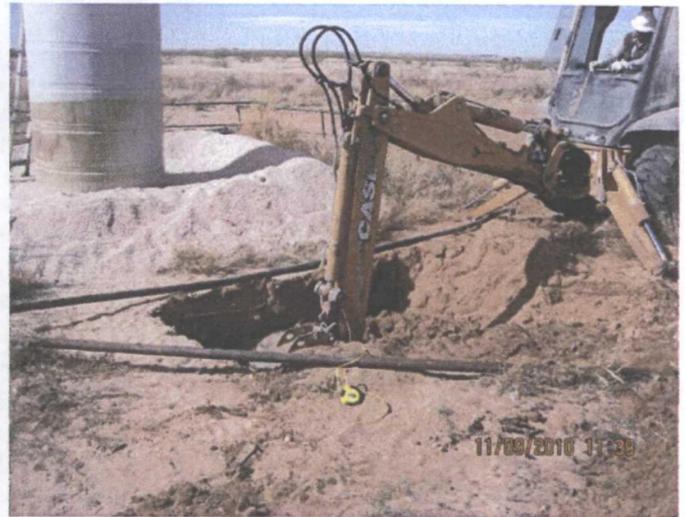
Excavating source, facing west 11.9.10

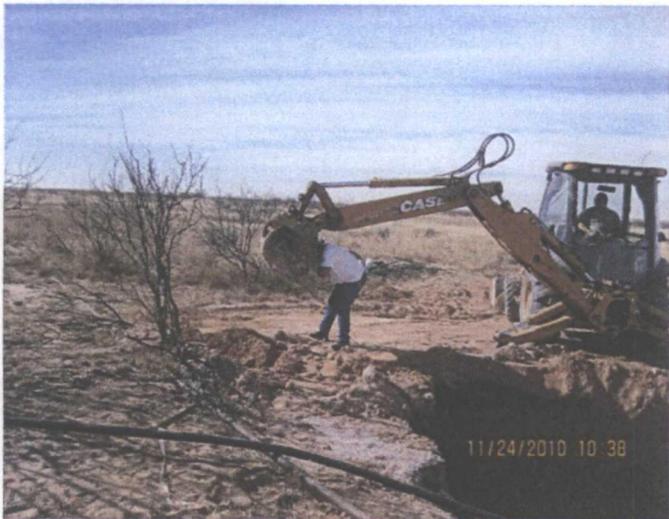
Collecting a sample, facing west 11.24.10

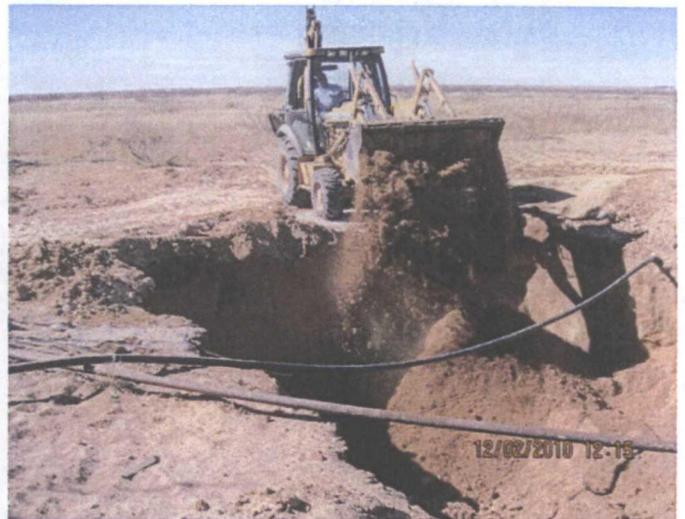
Backfilling site, facing north 12.2.10

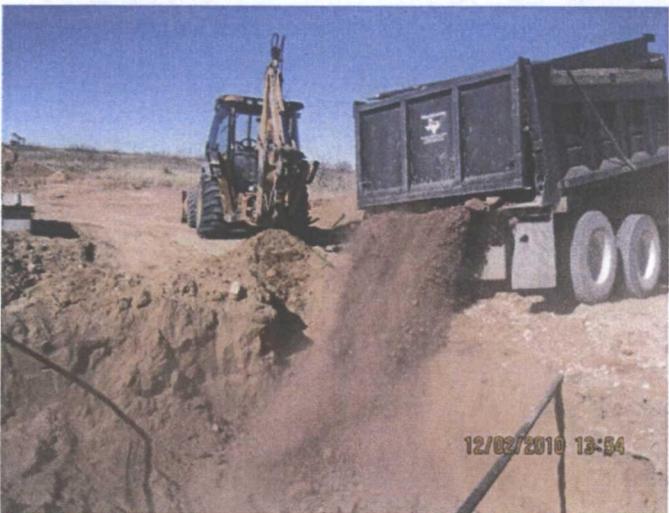
Importing clay for liner, facing north 12.2.10

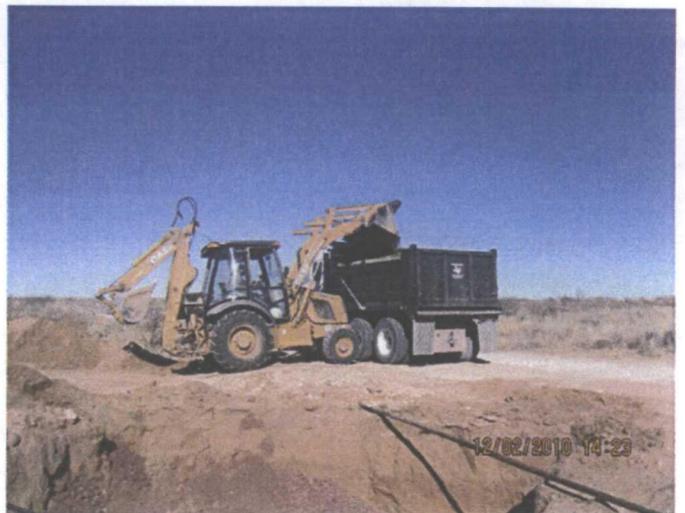
Exporting soil, facing northeast 12.2.10

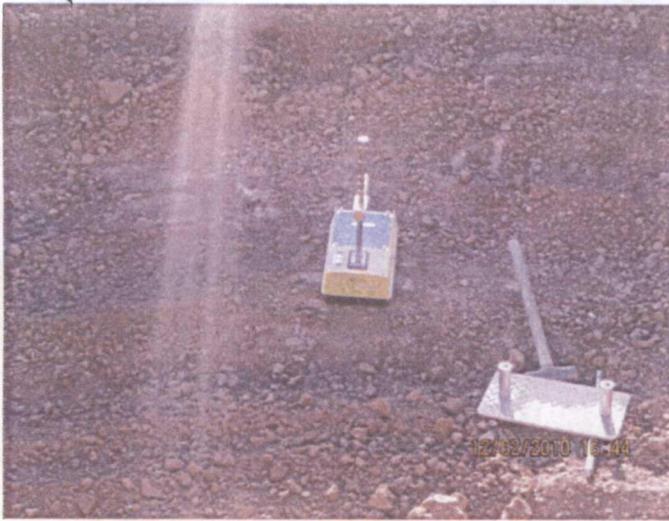
Performing clay compaction test 12.2.10

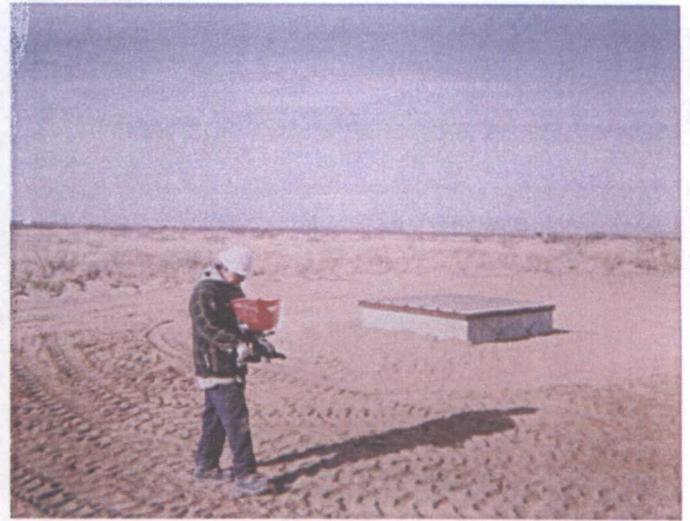
Seeding site, facing south 12.26.10

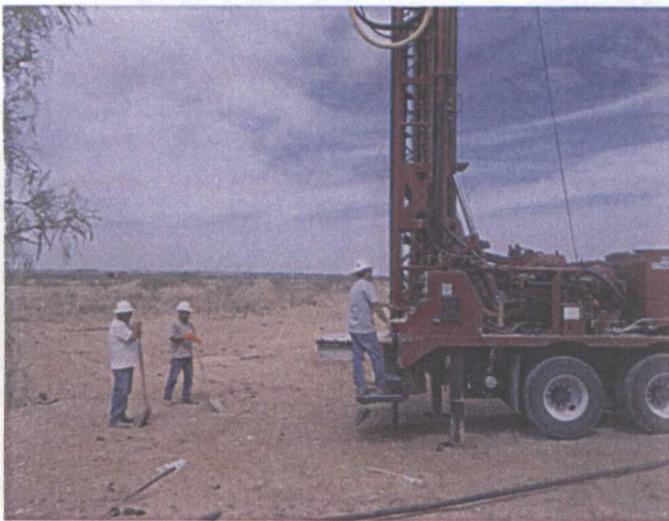
Drilling SB-1, facing west 4.13.11

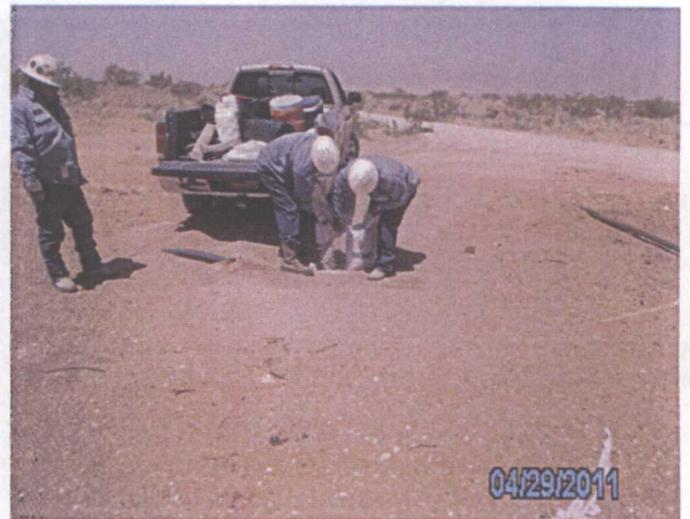
Plugging SB-1 with bentonite, facing west 4.29.11

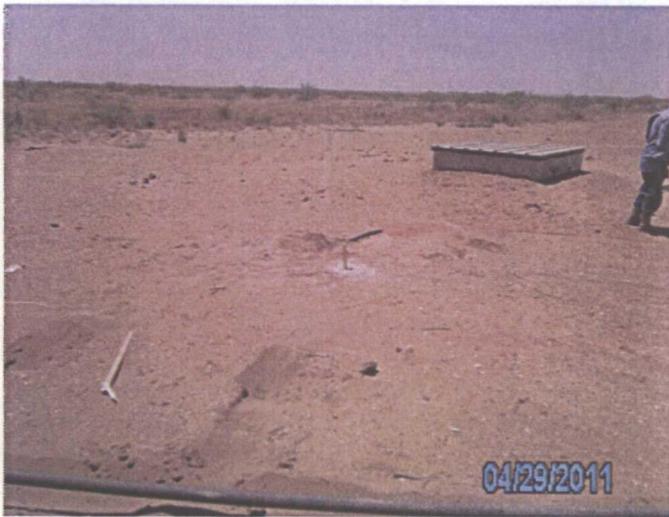
Completed SB-1, facing west 4.29.11

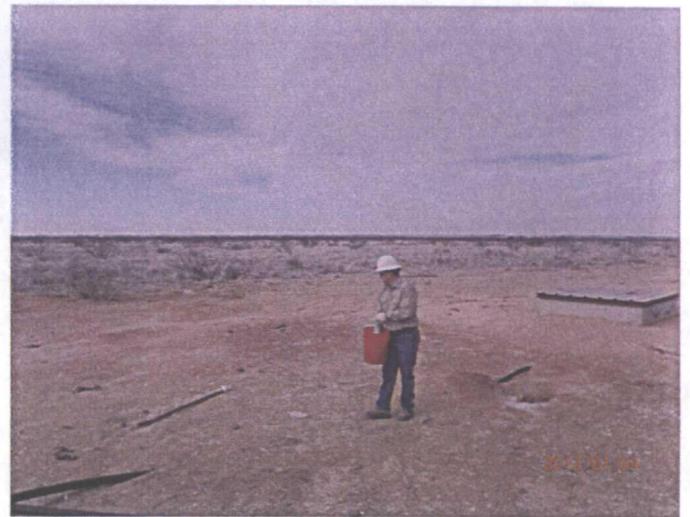
Seeding site with new junction box in background, facing southeast 1.4.12

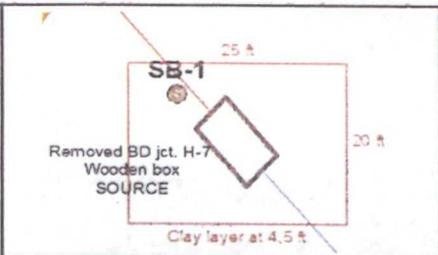
**Comments:** Located 9 ft north-west of the former junction box site.  
 All samples from cuttings.  
 DRAFTED BY: L. Weinheimer  
 TD = 55 ft  
 GW = none

Depth (feet)	chloride field tests	LAB	PID	Description	Lithology	Well Construction
				Brown fine sand mix with caliche		
15 ft	422		0.8			
				Light brown fine sand with small caliche fragments		
20 ft	1040		0.3			
				Tan very fine sand		
25 ft	5000		0.3			
30 ft	4485		0.1			
				Red very fine sandy clay		
35 ft	5939		0.2			
40 ft	6490	CF-5800 GRO <10 DRO <10	0.6			
45 ft	2475		0.4			
				Red clay		
50 ft	2376	CF-2200 GRO <10 DRO 10.6	0.1			
55 ft				NO SAMPLE TAKEN RED BED CLAY

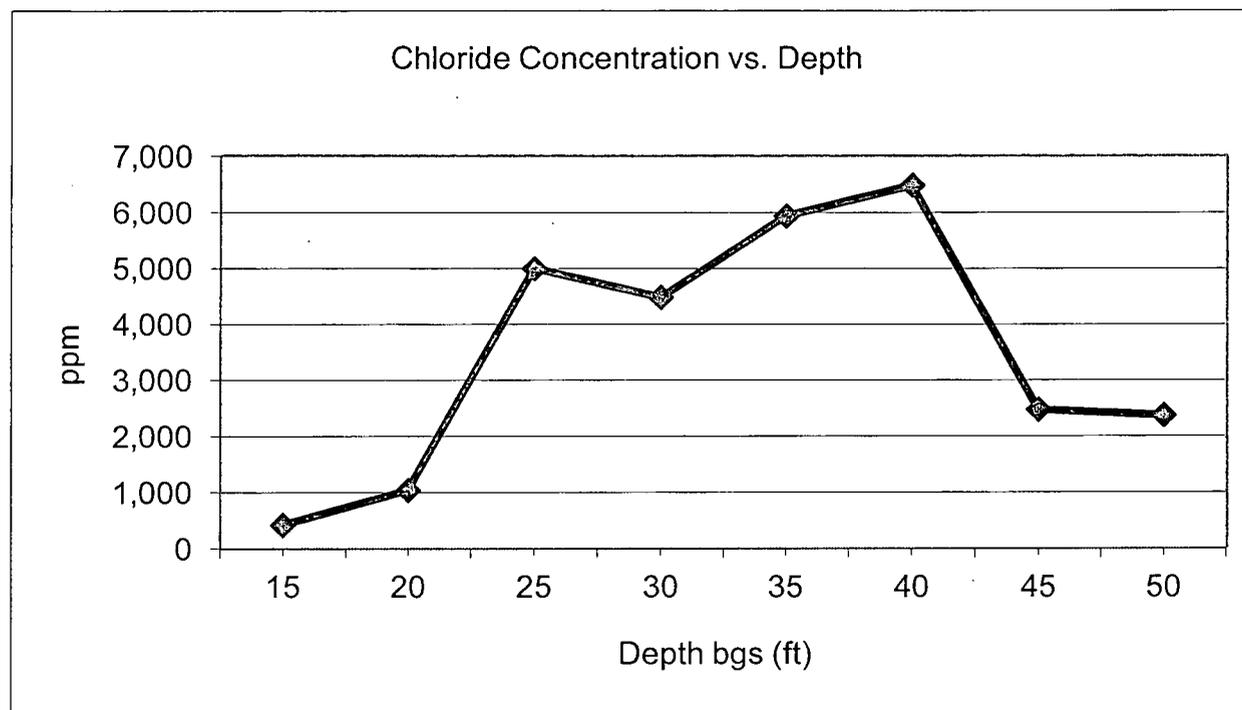
Soil Bore samples at 9 ft northwest of the junction (source)

Depth bgs (ft)	[Cl] ppm
15	422
20	1,040
25	5,000
30	4,485
35	5,939
40	6,490
45	2,475
50	2,376

Groundwater = None
