RE: Termination Request  
BD Jct. I-11-2: UL/I, Sec. 11, T22S, R37E  
RICE Operating Company – Blinebry-Drinkard SWD System

**RICE OPERATING COMPANY  
JUNCTION BOX FINAL REPORT**

# BD Jct. I-11-2

Unit I, Section 11, T22S, R37E

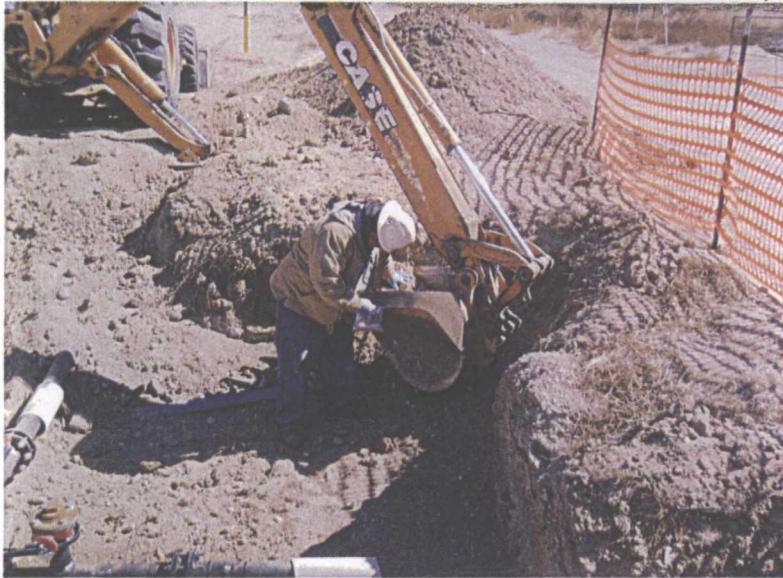
2/10/2011

Collecting sample, facing north

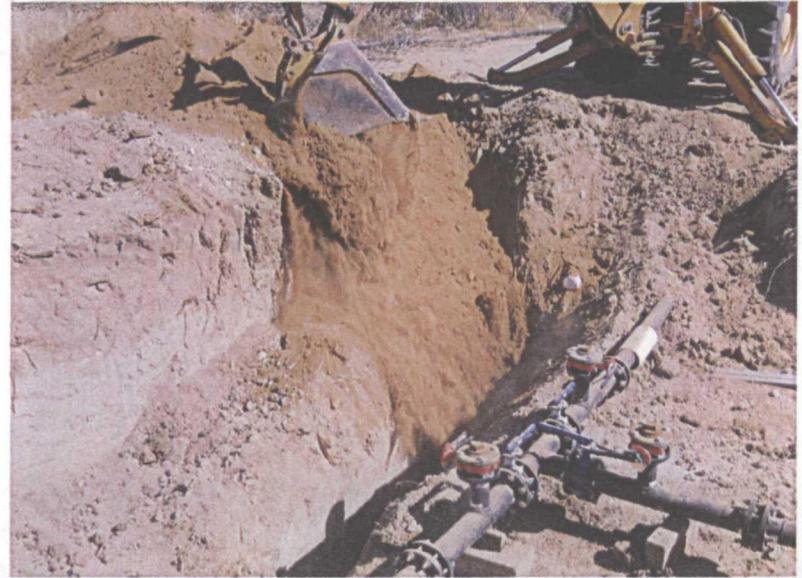
2/11/2011

Backfilling site, facing south

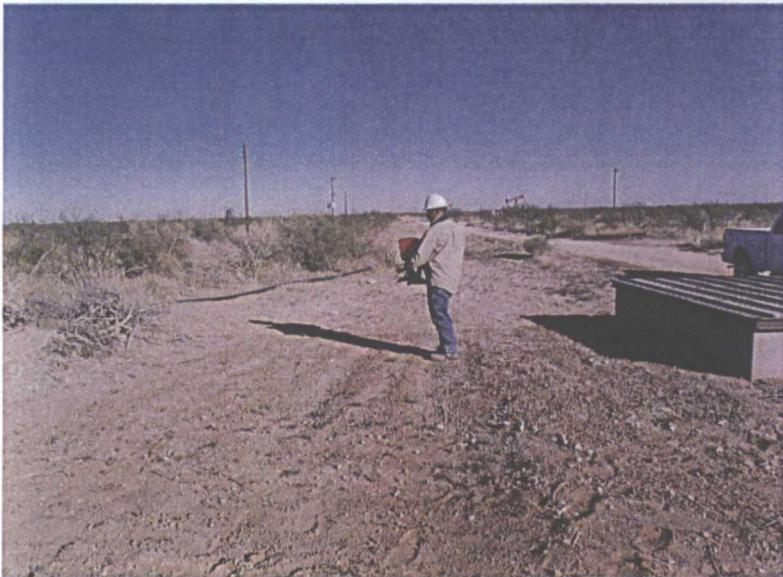
11/10/2011

Seeding site, facing north

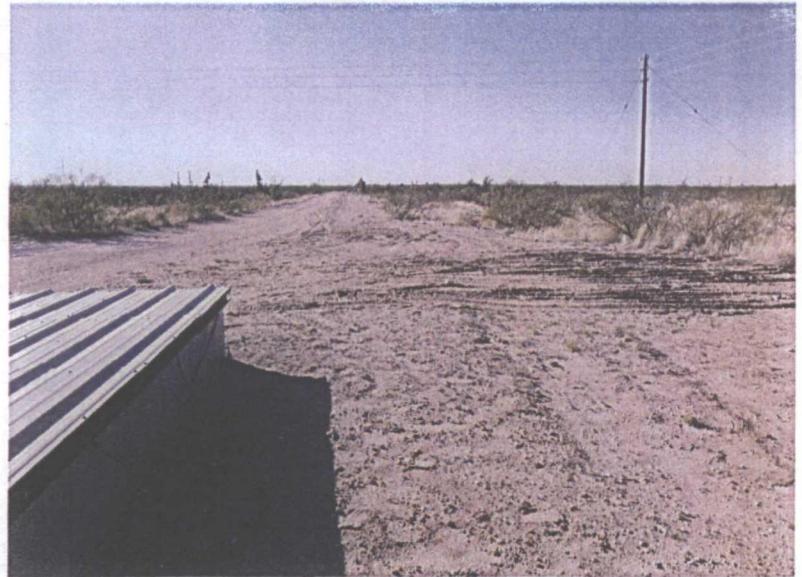
11/10/2011

Site complete with new water tight junction box installed, facing south

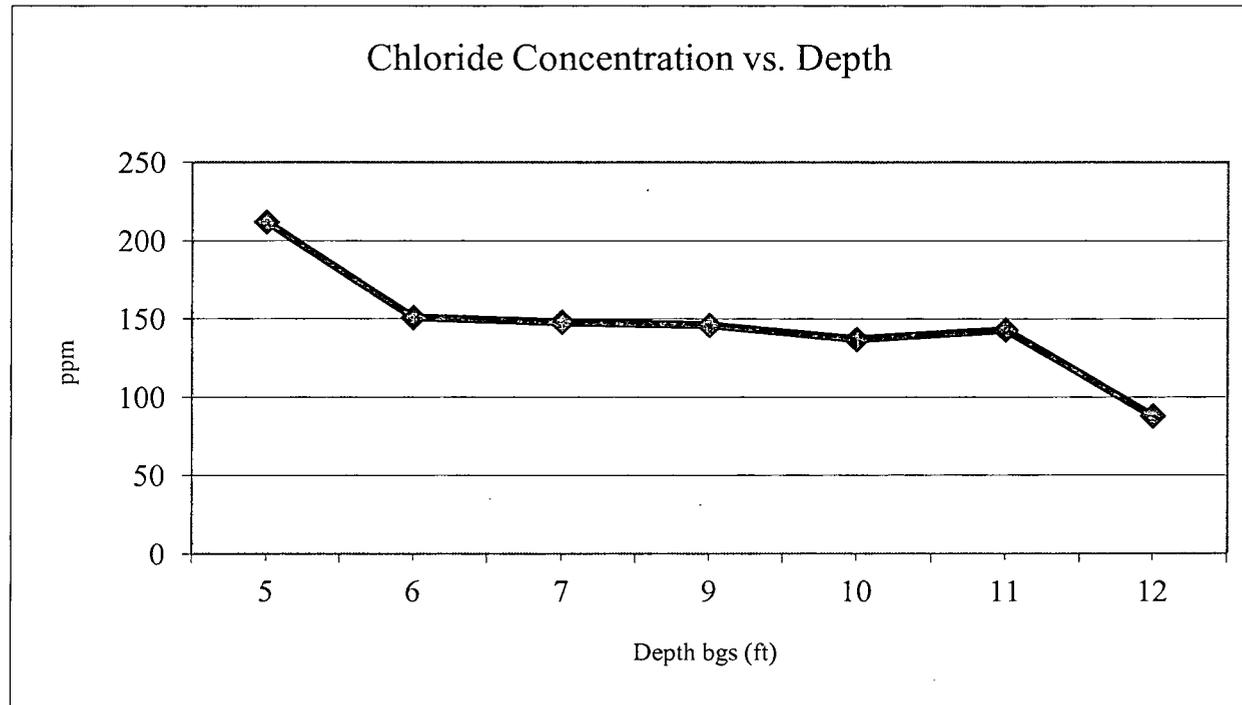
# CHLORIDE CONCENTRATION CURVE

*Backhoe samples at junction (source)*

Depth bgs (ft)	[Cl] ppm
5	212
6	151
7	148
9	146
10	137
11	143
12	88

Groundwater = 59 ft
