**RE: Vadose Zone Remediation & Termination Request for the Rice Operating Company's
EME Jct G-18 Site
Unit Letter G, Section 18, T19S, R37E, NMPM, Lea County, New Mexico
Remediation Plan (1R427-162) Further Information Required**

**RE: Vadose Zone Remediation and Termination Request
Rice Operating Company – EME SWD System
EME jct. G-18 (1R427-162): UL/G sec. 18 T19S R37E**

**EME Jct. G-18 (1R427-162)
Unit G, Section 18, T19S, R37E**

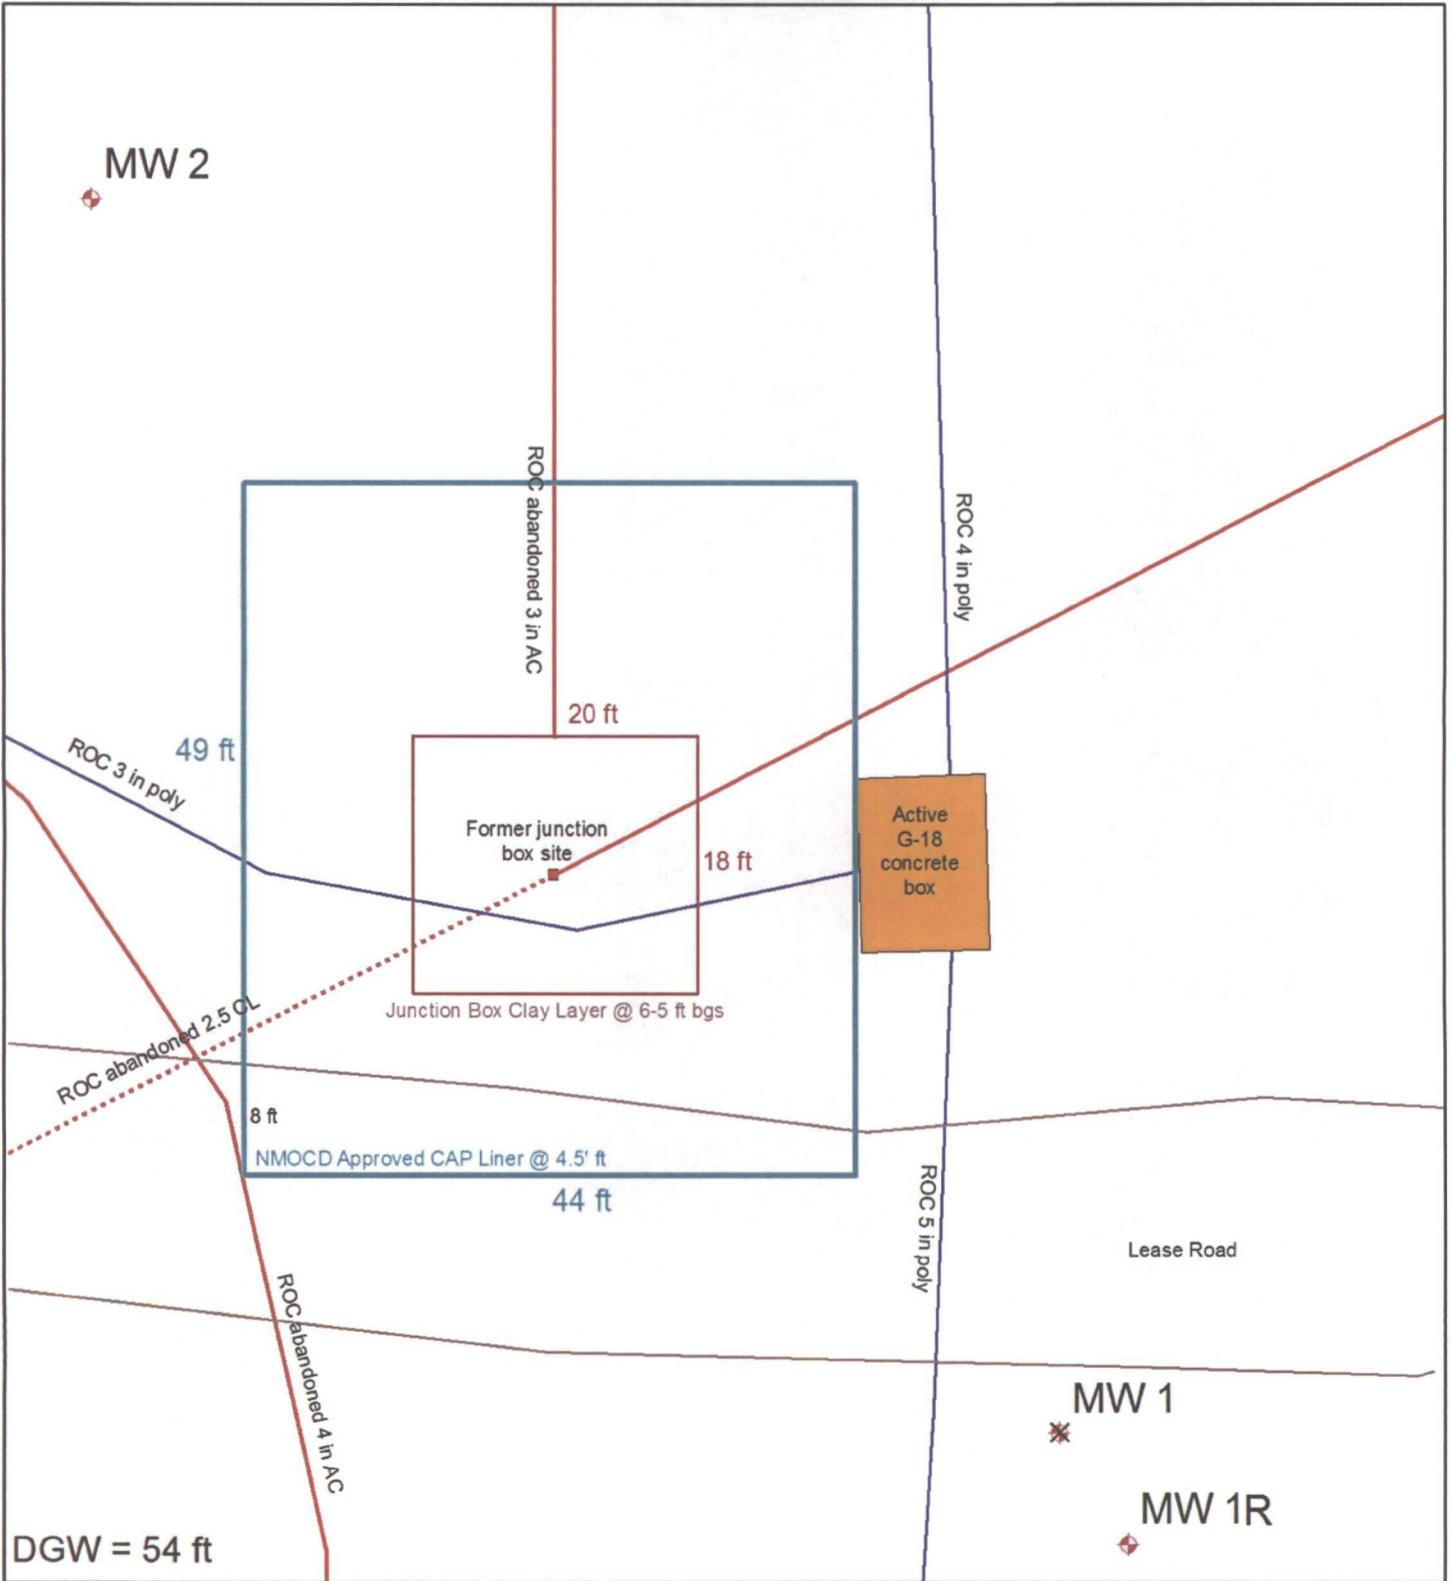
Figure 2

NMOCD Approved Liner

On November 23rd, 2011, RECS personnel were on site to begin excavating for the liner installation. The site was excavated to 44 ft x 49 ft x 5 ft deep and the excavated soil was blended on site to use as backfill (Figure 2). A sample of this blended soil was tested in the field for hydrocarbons using a PID meter and returned a result of 4.0 ppm. The sample was then taken to a commercial laboratory for analysis of chlorides and returned a result of 80 mg/kg. Clean soil was imported to the site to pad the liner to protect it from punctures. A sample of the imported soil was PID field tested for hydrocarbons returned a result of 0.6 ppm. The sample was then taken to a commercial laboratory for analysis of chlorides and returned a result of non-detect. The excavation was padded with six inches of the imported sand and then the liner was properly seated into the excavation at approximately 4.5 ft bgs. The liner was padded on top with six inches of imported sand and then backfilled with the blended soil to six inches bgs. The remaining imported soil was used to complete the backfill and to contour the site to the surrounding area. A total of 132 yards of soil was imported to the site to use as padding and as backfill. The remainder of the blended soil, 228 yards, was taken to a NMOCD approved facility for disposal. The site was seeded with a blend of native vegetation and a silt net fence was placed around the area to maintain seed integrity. Documentation of these activities can be found in Appendix A.

ROC has completed the vadose zone remediation approved by NMOCD in the CAP. The NMOCD approved 20-mil reinforced liner will inhibit the further migration of chlorides through the vadose zone to groundwater. The chloride plume beneath the site is limited, as evidenced by the below WQCC standards chloride concentrations in MW-1R, and, in combination with the installation of the liner, will decrease. Therefore, ROC requests 'remediation termination' status of the regulatory file.

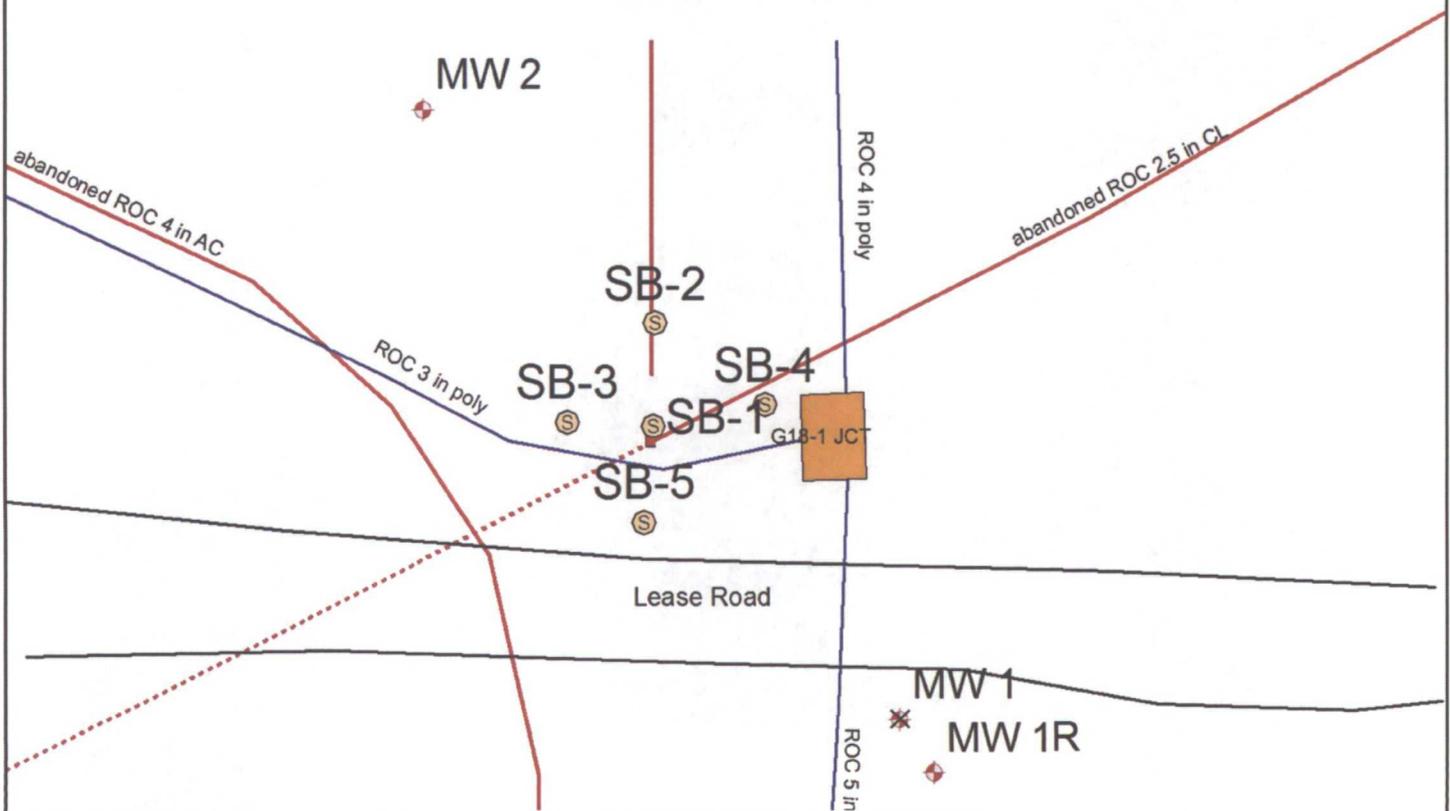
Figure 3

MW-1R Installation and Monitor Well Sampling

MW 3
DGW = 54 ft

On October 26th, 2011, MW-1 was plugged and abandoned with a 1-3% bentonite/concrete slurry and capped with three feet of concrete. MW-1 was then replaced with a 4 inch well (MW-1R) which was installed 9 ft southeast of the former MW-1 (Figure 3). The monitor well was not sampled as it was installed (Appendix B).

The monitor wells have been sampled quarterly since their installation (Figure 3). During the most recent sampling event on February 14th, 2012, MW-1R had a chloride reading of

192 mg/kg, MW-2 had a chloride reading of 24 mg/kg and MW-3 had a chloride reading of 85 mg/kg (Appendix C).

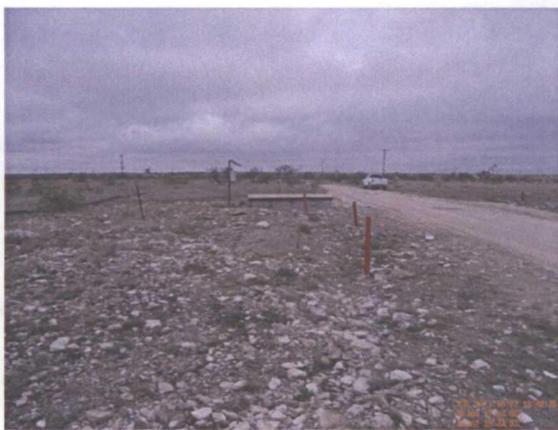
Site prior to excavation, facing east 10.27.11

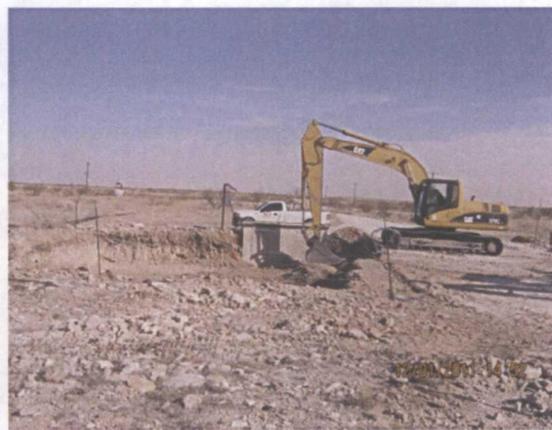
Excavating site, facing east 12.1.11

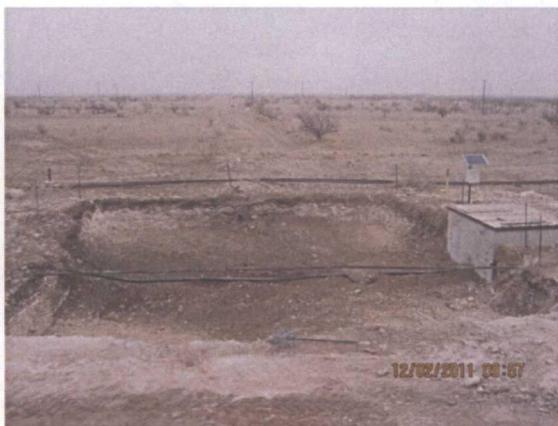
Site excavated to 49x44x5-ft deep, facing north 12.2.11

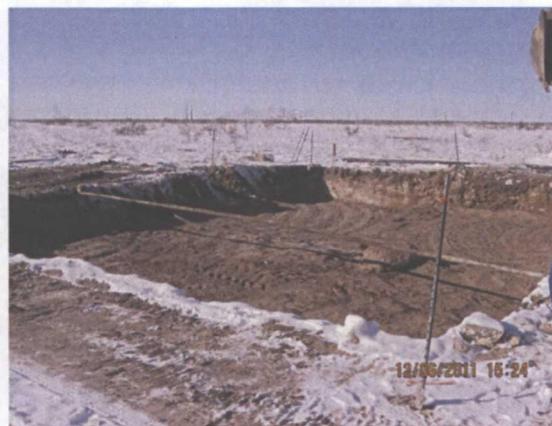
Installed bottom 6" sand pad, facing northwest 12.6.11

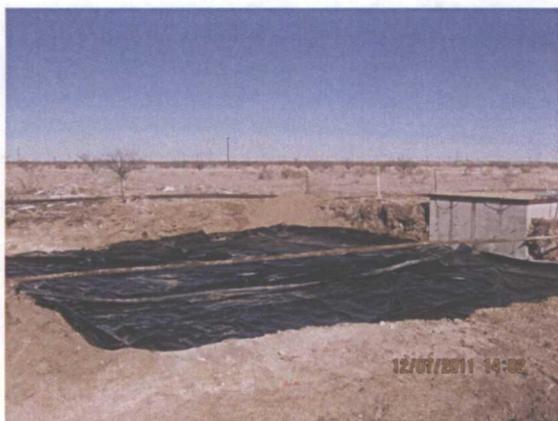
20-mil reinforced plastic liner installed at 4.5 ft BGS, facing northeast 12.7.11

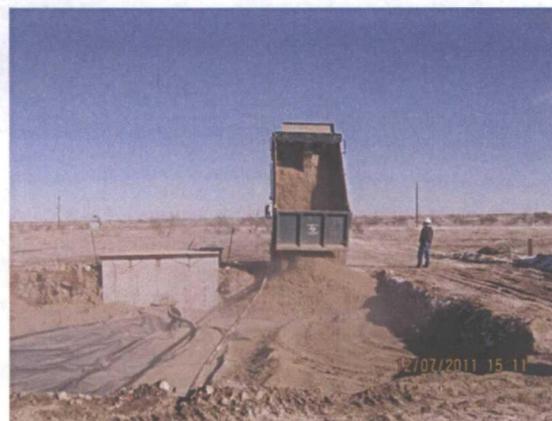
Installing 6" sand pad above liner with imported blow sand, facing east 12.7.11

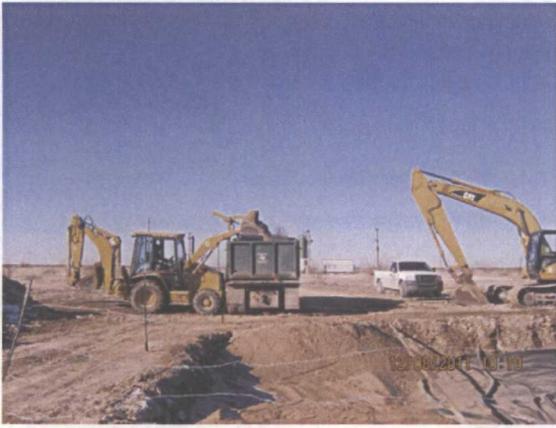
Exporting soil, facing west 12.8.11

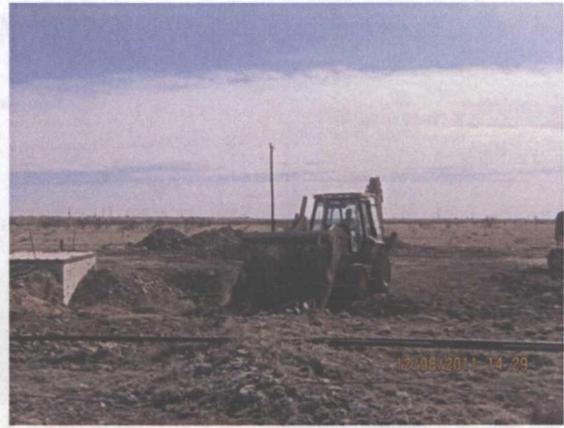
Backfilling with blended backfill, facing south 12.8.11

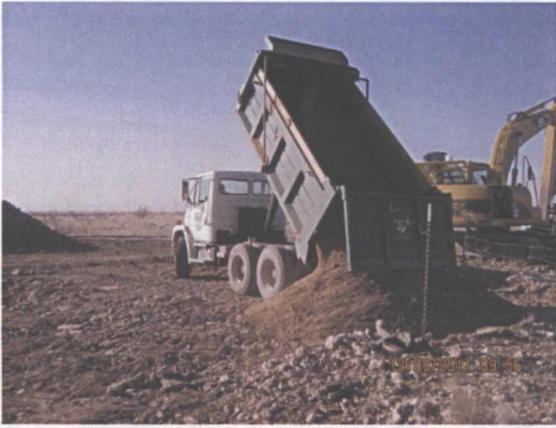
Importing blow sand, facing south 12.9.11

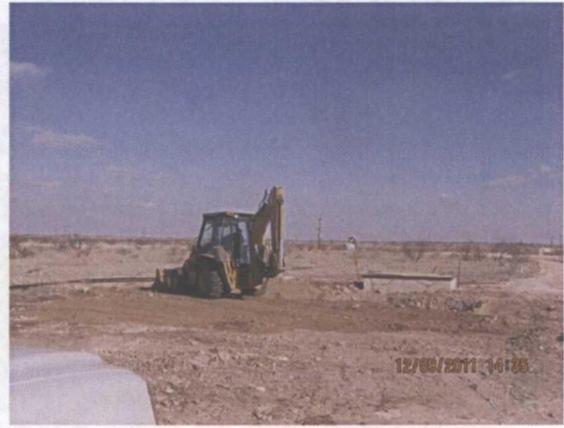
Backfilling top 6" with blow sand, facing east 12.9.11

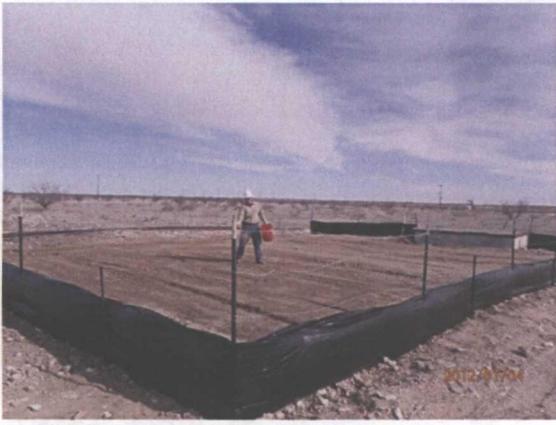
Seeding site, facing northeast 1.4.12

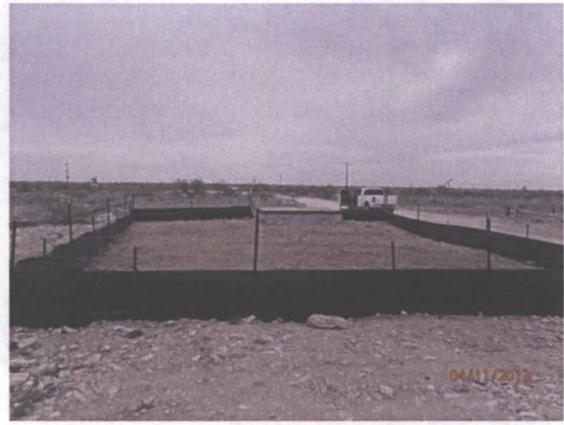
Site completed, facing east 4.11.12

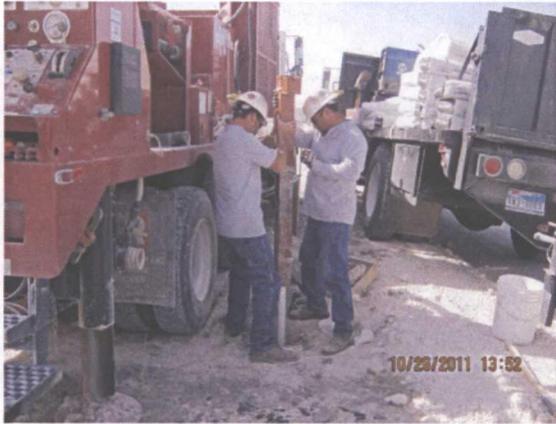
Pulling MW-1, facing west 10/26/11

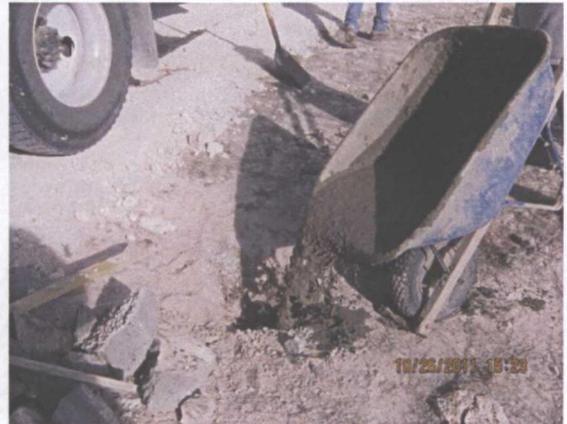
Plugging MW-1 with a 1 – 3%
concrete/bentonite slurry 10/26/11

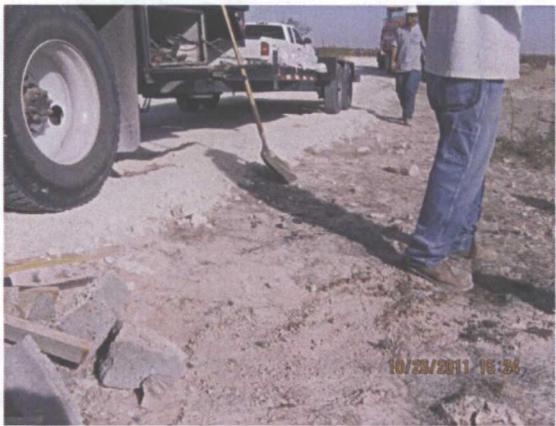
MW-1 plugged, facing east 10/26/11

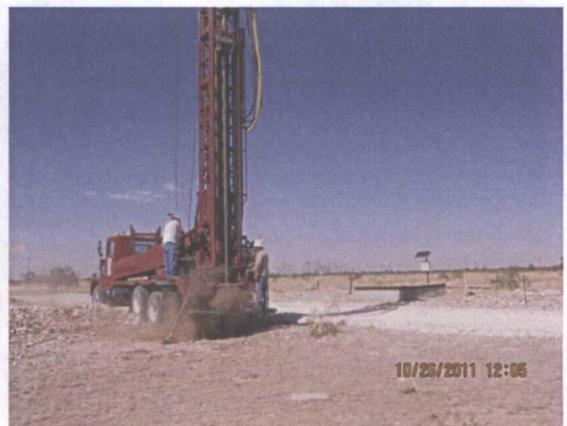
Drilling MW-1R, facing northwest 10/26/11

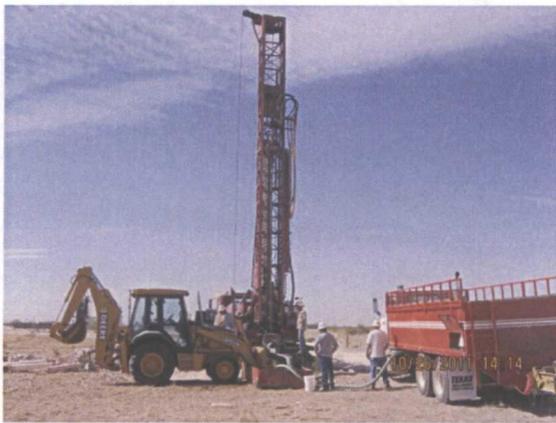
Mudding in MW-1R, facing west 10/26/11

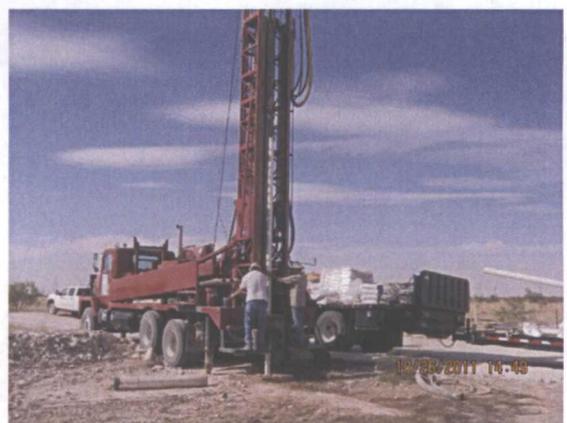
Installing casing in MW-1R, facing west
10/26/11

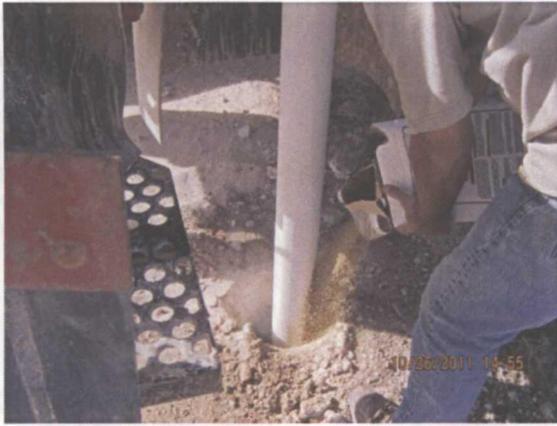
Adding the sand pack 10/26/11

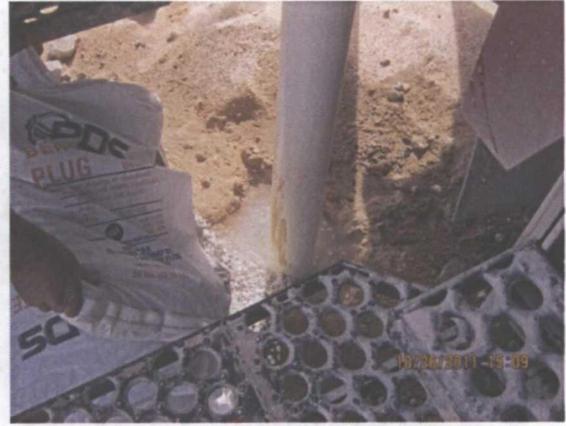
Placing the bentonite seal 10/26/11

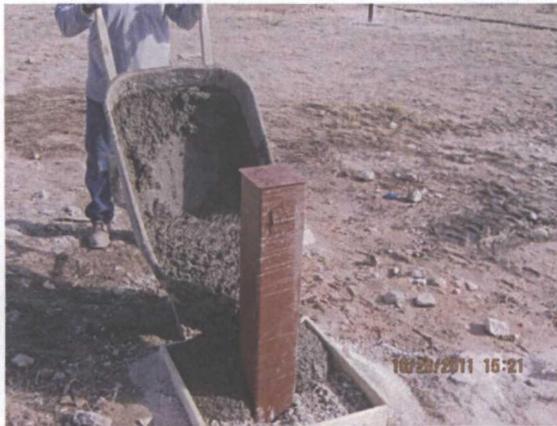
Concreting the well in, facing east 10/26/11

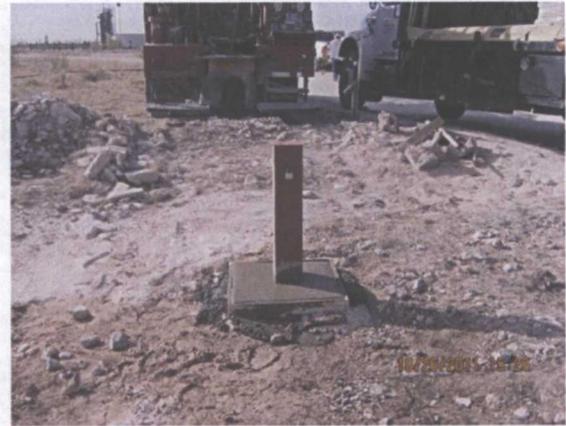
Completed MW-1R, facing west 10/26/11
