# WORKPLANS

**RE: CAP Report for Vadose Zone Remediation and Proposed Groundwater  
Remedy  
Rice Operating Company – EME SWD System  
EME D-2 boot (1R427-14): UL/D sec. 2 T20S R36E  
(formerly the EME M-35-2 boot)**

**Figure 2 – NMOCD Approved Liner**

**Appendix A – Vadose Zone Activities Documentation**

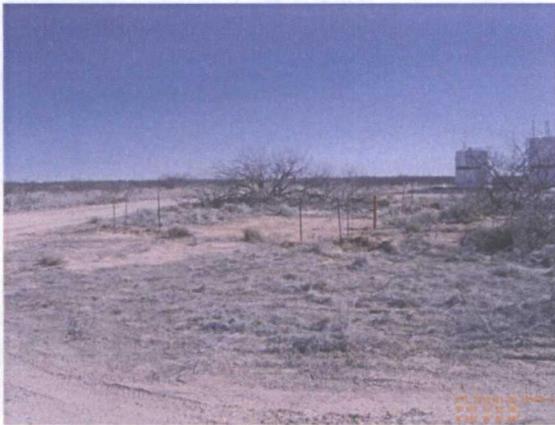
Site prior to excavation, facing east 1/20/12

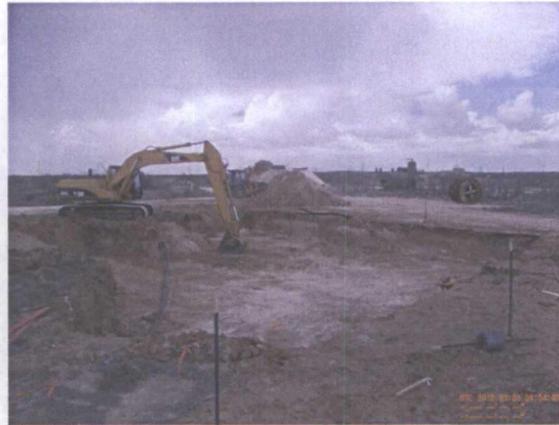
Excavating site, facing west-northwest 3/20/12

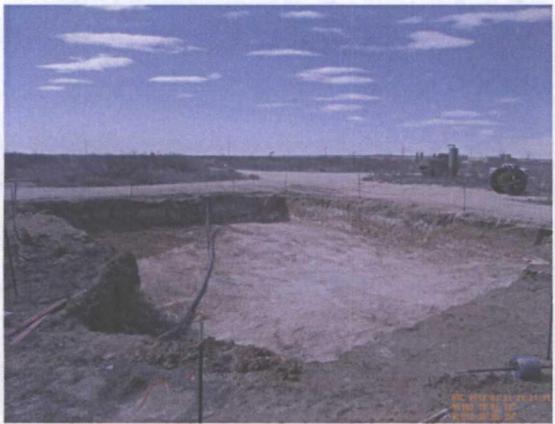
Excavation complete, facing west-northwest  
3/21/12

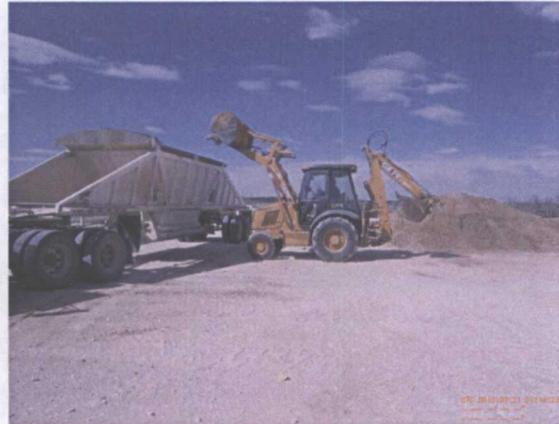
Exporting soil, facing north-northwest 3/21/12

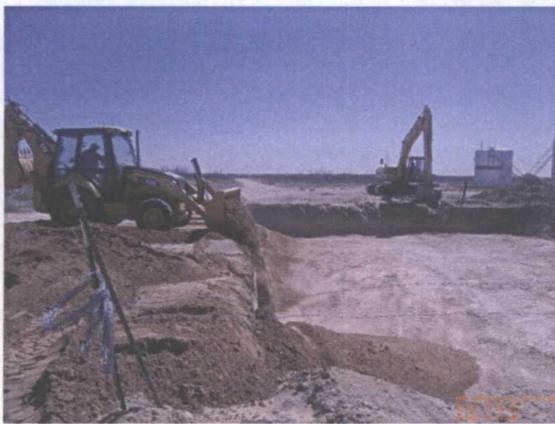
Importing blow sand, facing east 3/22/2012

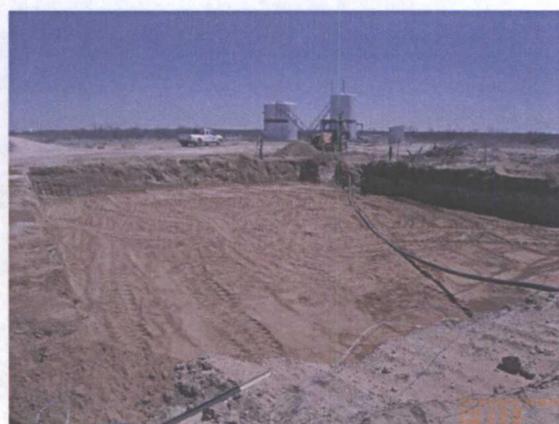
Installed bottom 6'' blow sand pad, facing  
southeast 3/21/12

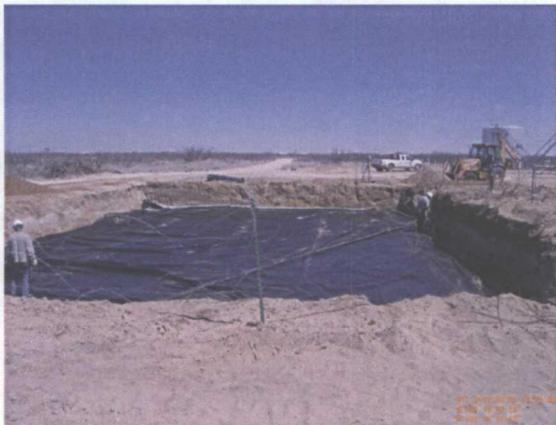
Installing 62 x 51 ft 20-mil reinforced liner,  
facing east 3/22/12

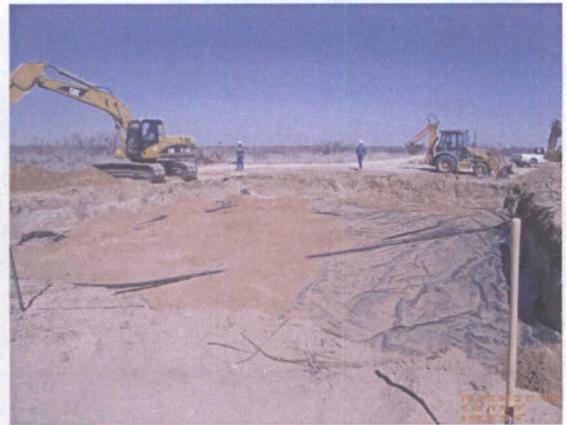
Installing top 6" blow sand pad above liner,  
facing northeast 3/22/12

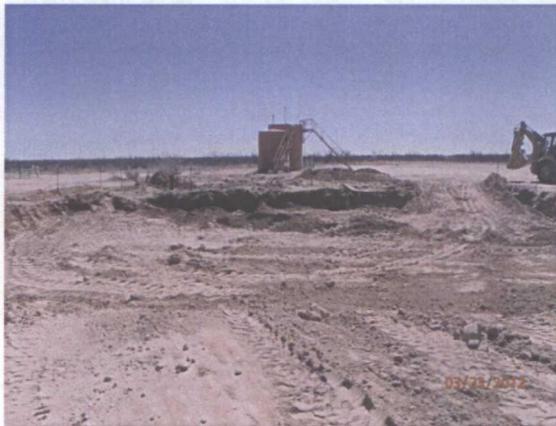
Backfilling with imported caliche up to 4' BGS,  
facing south 3/23/12

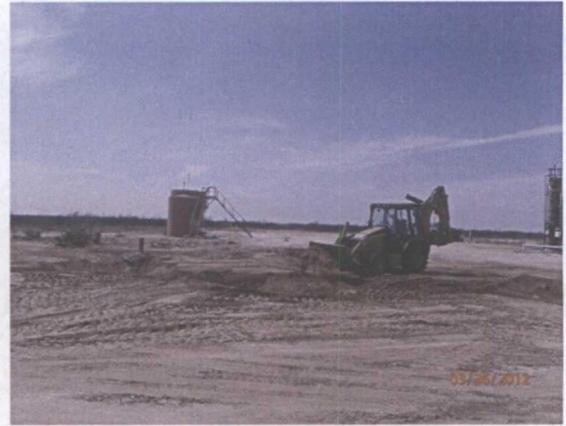
Backfilling with imported top soil to ground  
surface, facing south 3/26/12

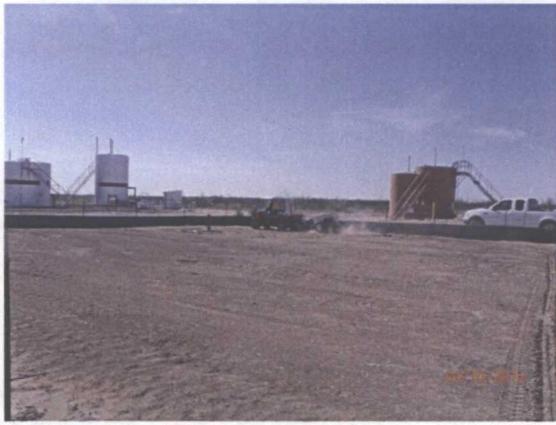
Seeding site, facing southeast 4/10/2012

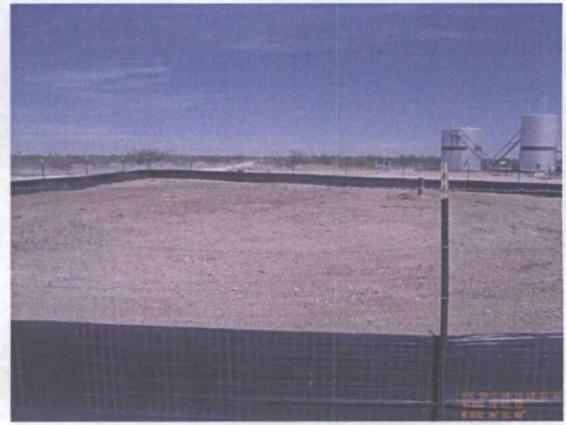
Site completed, facing east 4/13/12
