1R - 426-28

WORKPLANS

**RE: ICP Report and Corrective Action Plan (CAP)
Rice Operating Company – BD SWD System
BD B-16 (1R426-28): UL/B sec. 16 T22S R37E**

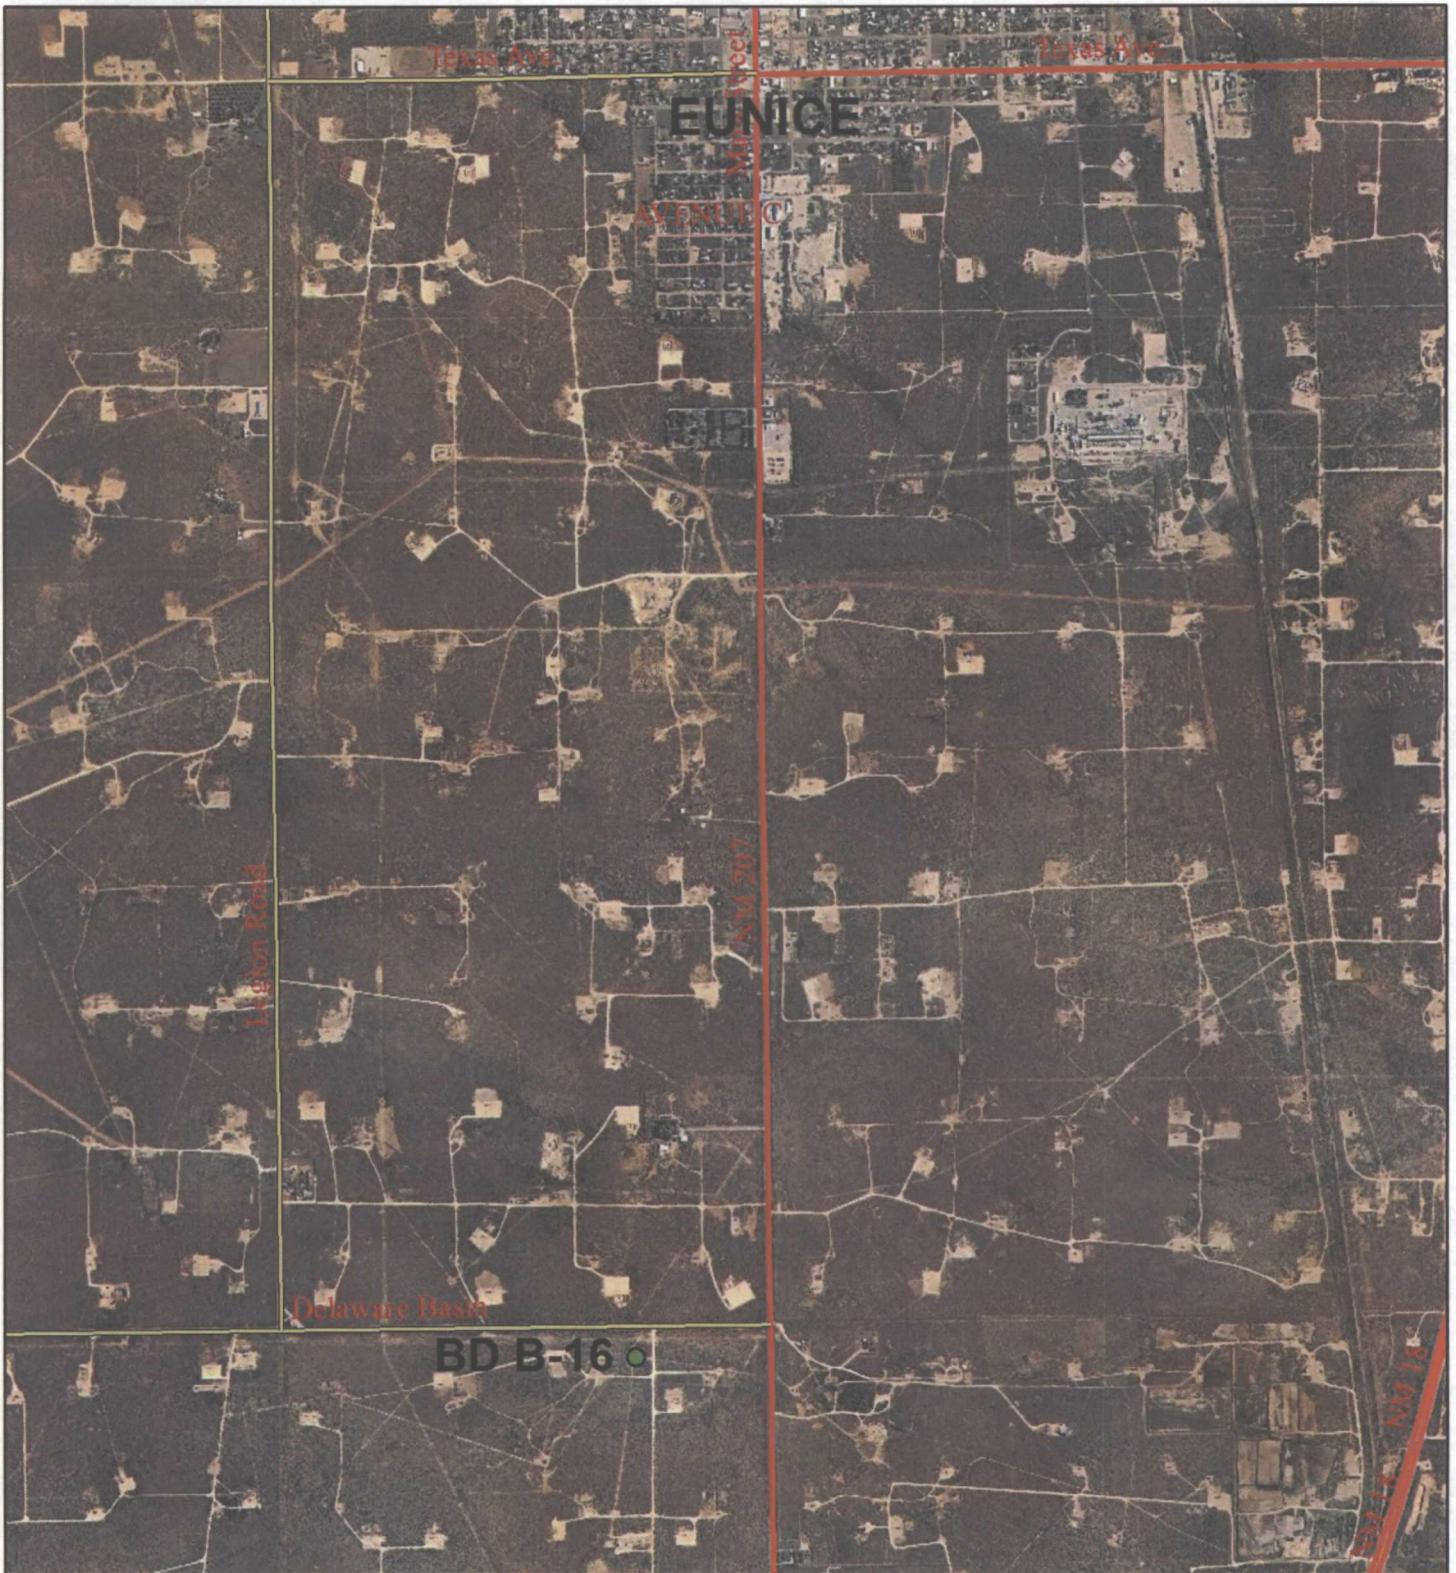
Figure 1

The site is located approximately 2.5 miles south of Eunice, New Mexico at UL/B, Sec. 16, T22S, R37E as shown on the Site Location Map (Figure 1). Groundwater at this site is located approximately 78 +/- feet below ground surface (bgs).

Site Location

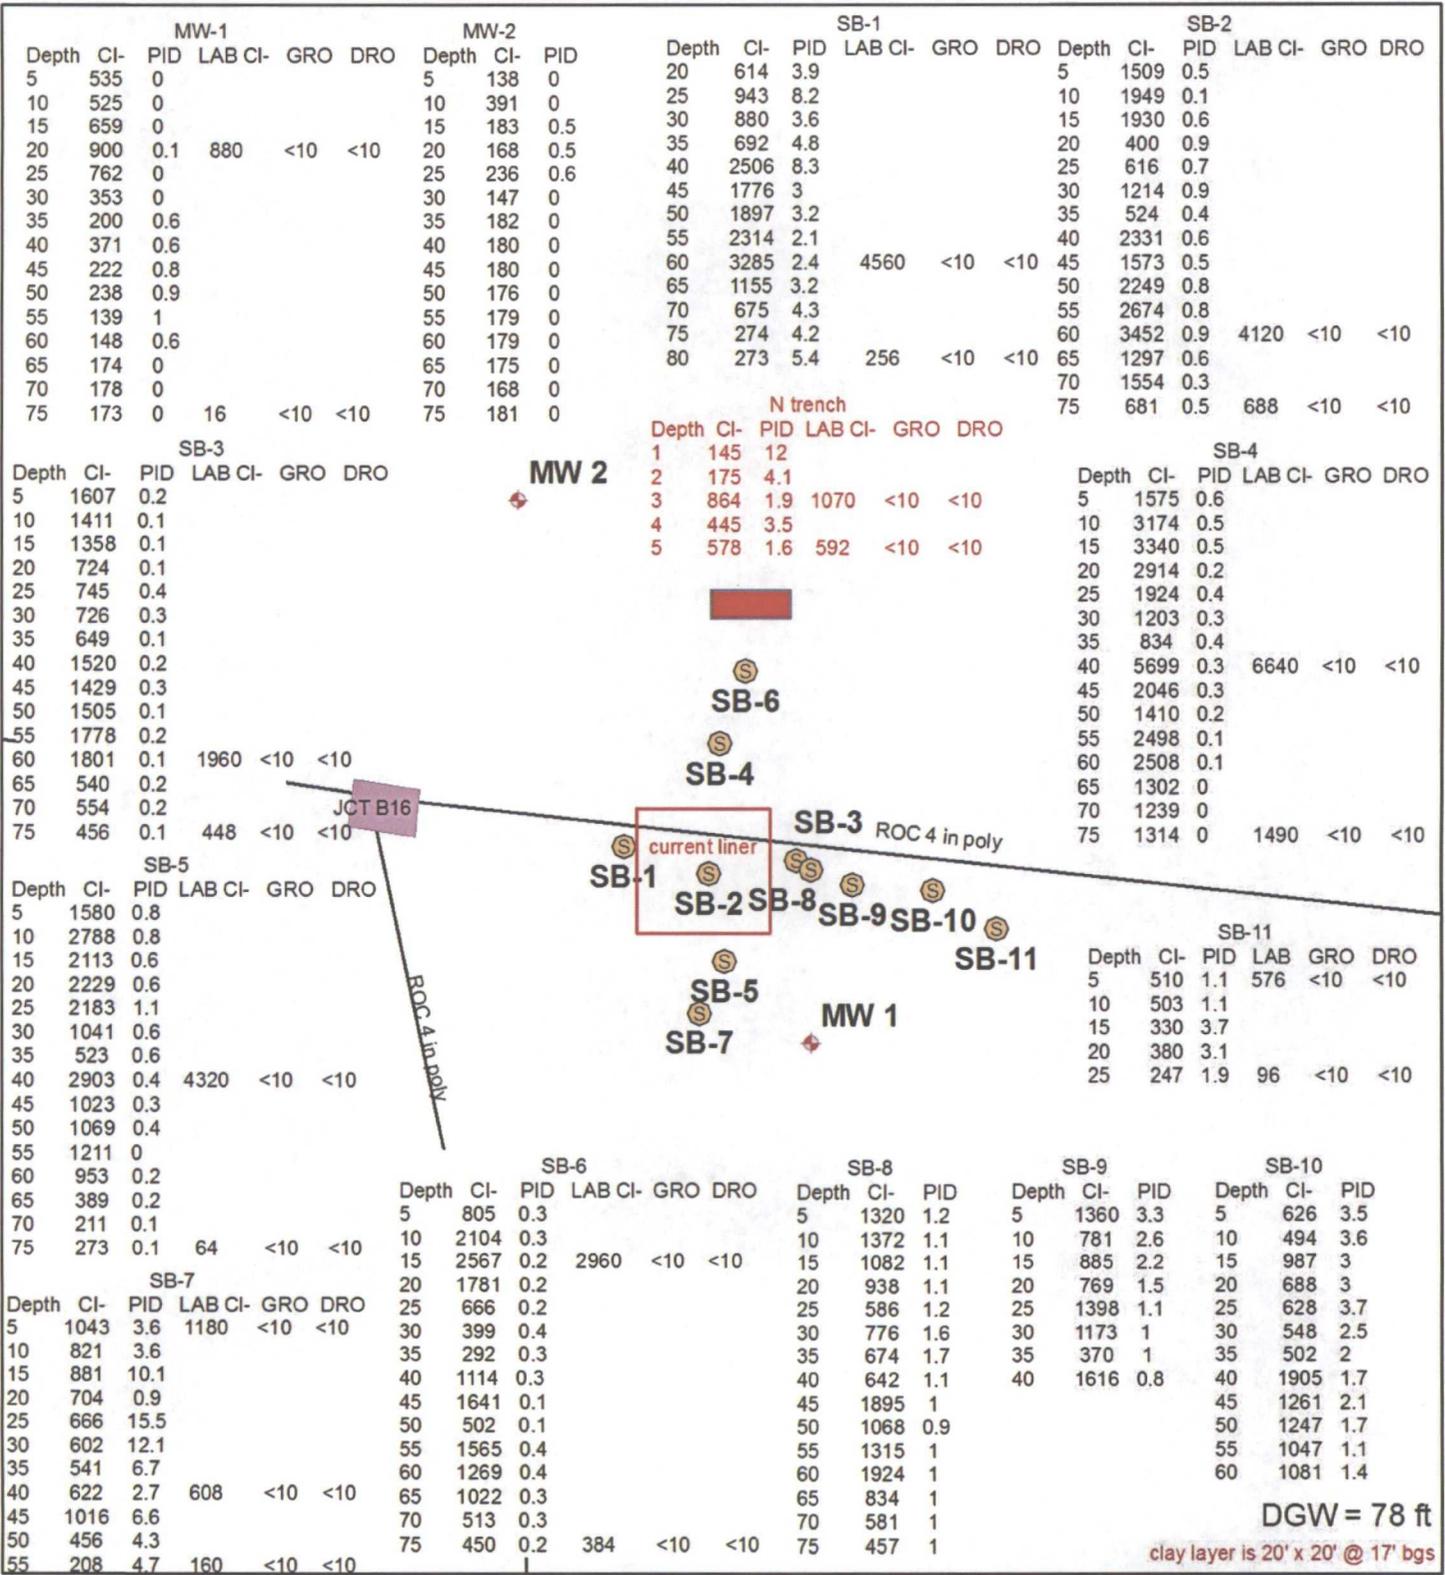
Figure 2

As per the ICP, six soil bores were advanced through the former junction box site on July 28th, 2010 (Figure 2). ROC personnel field tested the soil for chlorides and screened in the field with a photo-ionization detector (PID) for hydrocarbons. Representative samples from the bore were taken to a commercial laboratory for confirmation of chloride and hydrocarbon field numbers (Appendix A). Laboratory chloride readings showed that in each soil bore, the chloride values decreased with depth with the peak chloride readings between 40 and 60 ft bgs in all soil bores. SB-1 decreased from 4,560 mg/kg at 60 ft to 256 mg/kg at 80 ft bgs, SB-2 decreased from 4,120 mg/kg at 60 ft to 688 mg/kg at 75 ft bgs, SB-3 decreased from 1,960 mg/kg at 60 ft to 448 mg/kg at 75 ft bgs, SB-4 decreased from 6,640 mg/kg at 40 ft to 1,490 mg/kg at 75 ft bgs, SB-5 decreased from 4,320 mg/kg at 40 ft to 64 mg/kg at 75 ft bgs and SB-6 decreased from 2,960 mg/kg at 15 ft to 384 mg/kg at 75 ft bgs. All samples had GRO and DRO readings of non-detect.

On October 26th, 2010, two monitor wells were installed at the site to a depth of 90 ft (Figure 2). MW-1, the near-source monitor well, and MW-2, the up gradient monitor well, were field tested for chlorides and screened in the field with a photo-ionization detector (PID) for hydrocarbons. Two samples from MW-1 were taken to a commercial laboratory for confirmation of field numbers and returned laboratory chloride readings of 880 mg/kg at 20 ft bgs and 16 mg/kg at 75 ft bgs. Both samples had GRO and DRO readings of non-detect (Appendix B).

Soil Bore and Monitor Well Data

DGW = 78 ft
clay layer is 20' x 20' @ 17' bgs

On January 28th, 2011, due to time restraints and resource management, a trench was installed 10 ft north of SB-6 (Figure 2). Representative samples from the trench were taken to a commercial laboratory for confirmation of chloride and hydrocarbon field numbers. Laboratory readings showed chloride numbers of 1,070 mg/kg at 3 ft bgs and 592 mg/kg at 5 ft bgs. Laboratory readings for GRO and DRO showed non-detect (Appendix A).

Five additional soil bores were installed at the site on March 22nd and 23rd, 2011 (Figure 2). Representative samples from SB-7 and SB-11 were taken to a commercial laboratory for confirmation of chloride and hydrocarbon field numbers. Laboratory readings in SB-7 showed chloride numbers of 1,180 mg/kg at 5 ft bgs, 608 mg/kg at 40 ft bgs and 160 mg/kg at 55 ft bgs. Laboratory readings in SB-11 showed chloride readings of 576 mg/kg at 5 ft bgs and 96 mg/kg at 25 ft bgs. Laboratory readings for GRO and DRO showed non-detect in both soil bores (Appendix A).

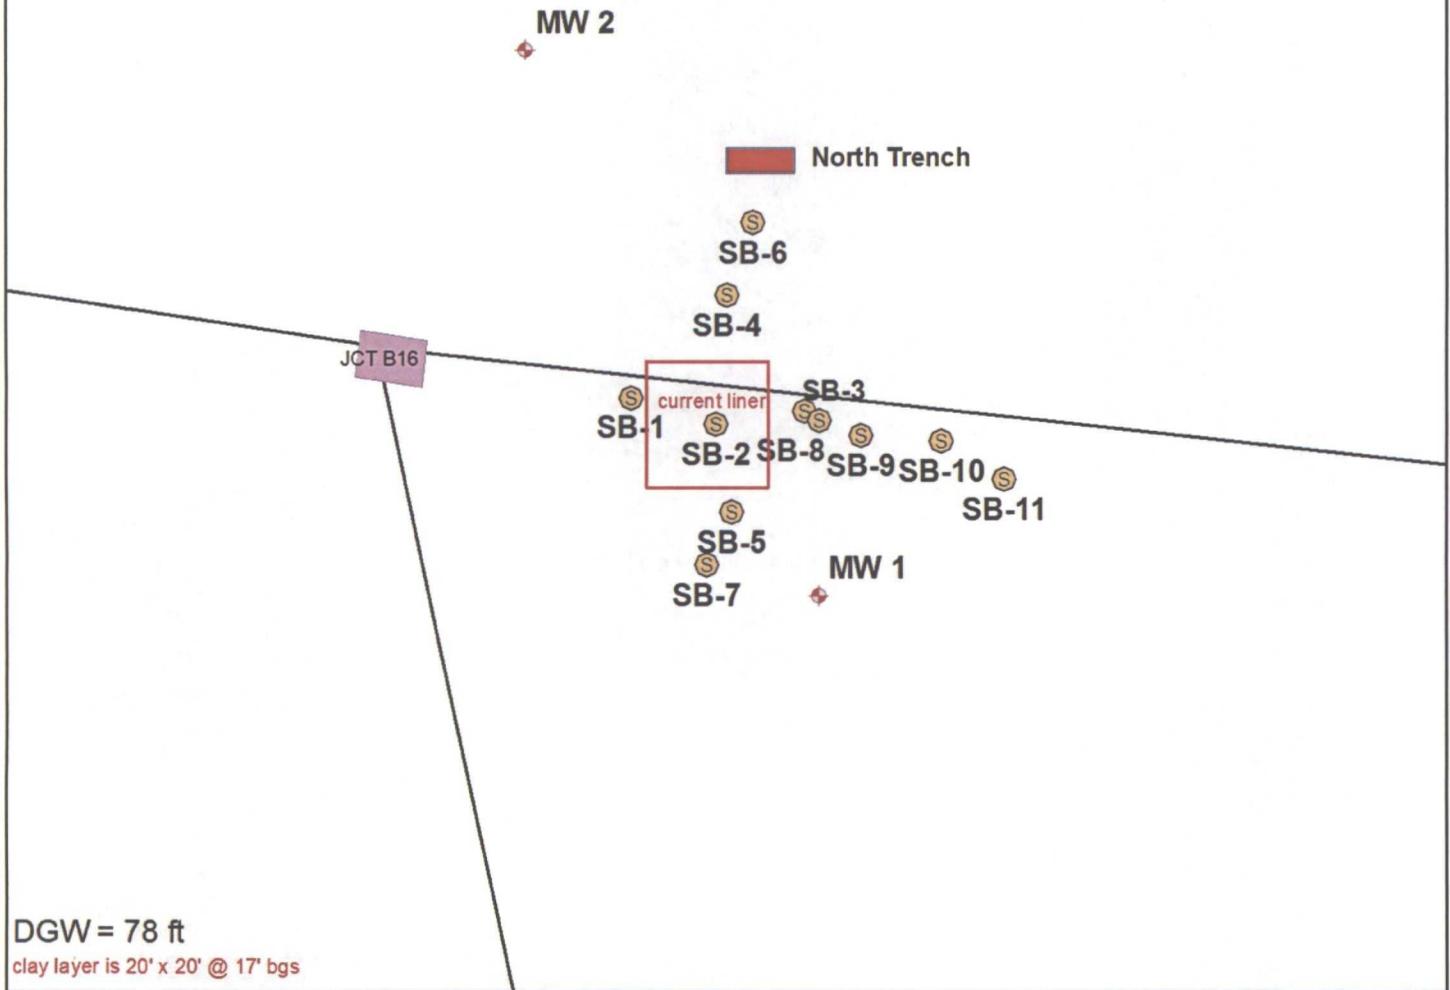
Figure 3

The monitor wells have been sampled quarterly since their installation (Figure 3). The most recent (January 27th, 2012) groundwater samples tested 260 mg/L in the near-source well (MW-1) and 220 mg/L in the up-gradient well (MW-2). Both monitor wells had BTEX levels of non-detect (Appendix C).

Monitor well sampling

- Six quarters of monitoring well sampling shows no impact to groundwater. The two monitor wells evidence laboratory chloride values near or below WQCC standards with the near-source well showing a chloride reading of 260 mg/L and the up gradient monitor well showing a chloride reading of 220 mg/L. Since the site shows no groundwater impact, ROC proposes to plug and abandon both monitor wells with a 1-3% bentonite/concrete slurry with a 3 ft cement cap. A letter from Arc Environmental is included as Appendix D, and gives a description of the aquifer located beneath this site.
