WORKPLANS

**INVESTIGATION & CHARACTERIZATION PLAN (ICP)
EME Jct. C-13 (NMOCD Case #: not yet assigned)
Unit C, SEC. 13, T20S, R36E, Monument, Lea County, New Mexico**

EME Jct. C-13

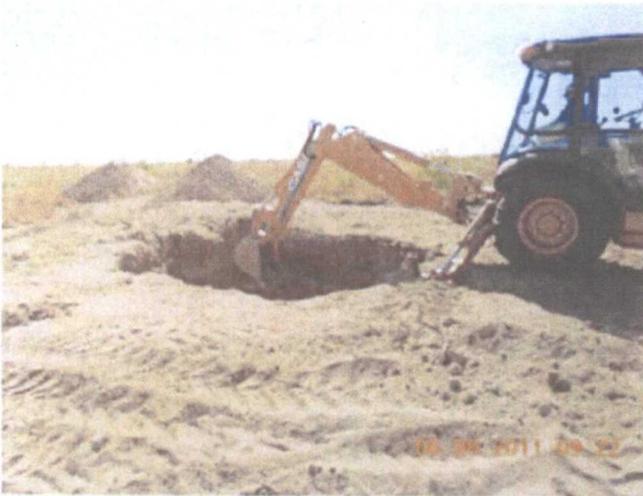
Excavating the former junction box, facing south
8.8.11

A backhoe was used to excavate soils from an excavation measuring 30 feet by 30 feet by 12 feet deep around the former junction box. Soil samples were collected at regular intervals and analyzed in the field for chlorides using field-adapted Standard Method 4500-Cl⁻B and screened in the field using a photoionization detector (PID).

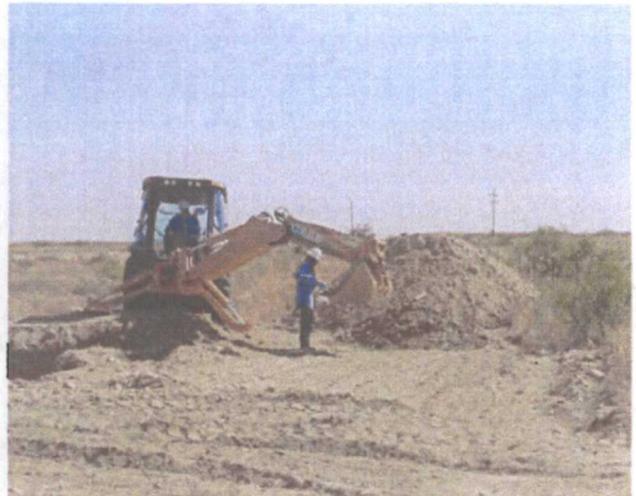
Collecting a soil sample, facing north
8.30.11

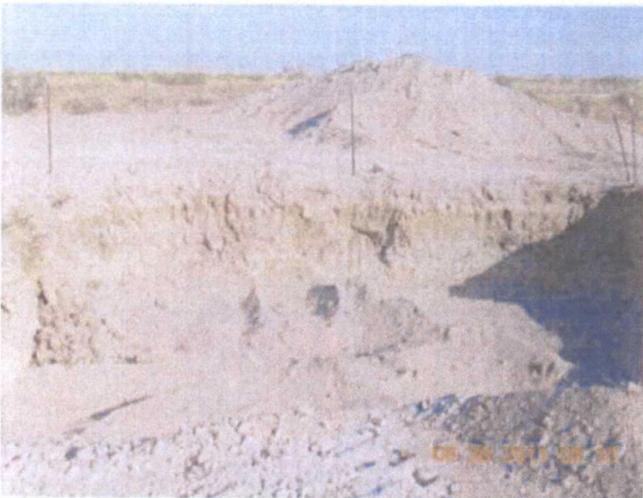
Excavation prior to installation of plastic liner up to
5-ft. BGS, facing west
8.30.11

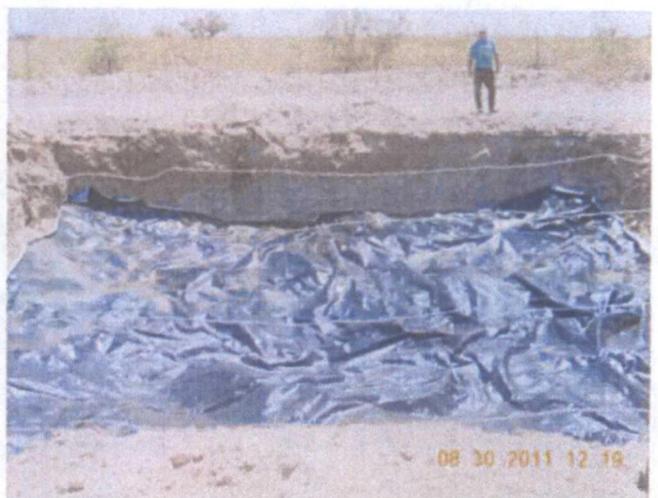
Installing a 30x30-ft., 20-mil reinforced liner at 5-ft.
BGS, facing east
8.30.11

Approximately 204 cubic yards of excavated soil was properly disposed of at a NMOCD approved facility. The remaining excavated soils were blended on site with clean imported soil and backfilled into the excavation to a depth of five feet below ground surface. A 20-mil poly liner was installed at five feet below ground surface and the remaining excavation was backfilled with blended soil to ground surface. The area was contoured to the surrounding landscape.

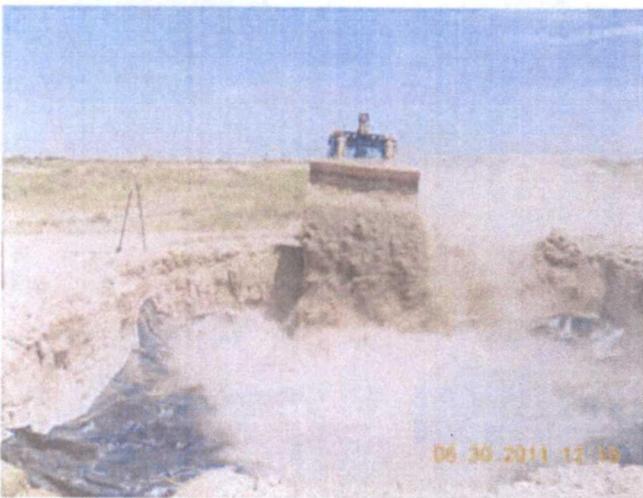
Backfilling site above liner, facing north
8.30.11

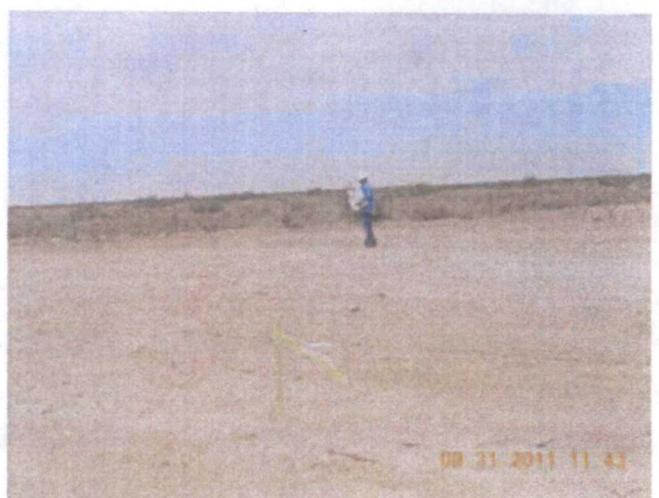
Seeding site, facing west
8.31.11

Custom seed mix <input checked="" type="checkbox"/>	Prescribed mix <input type="checkbox"/>	Seed mix name: Sandy Mix Grass Seed	Seeding date: 8/31/2011
Broadcast <input checked="" type="checkbox"/>			
Method: Hand Broadcast			
Soil conditions during seeding: Dry <input checked="" type="checkbox"/> Damp <input type="checkbox"/> Wet <input type="checkbox"/>			
Photos attached <input checked="" type="checkbox"/>		Observations: 15 lbs of sandy mix	
Number of photos: 11

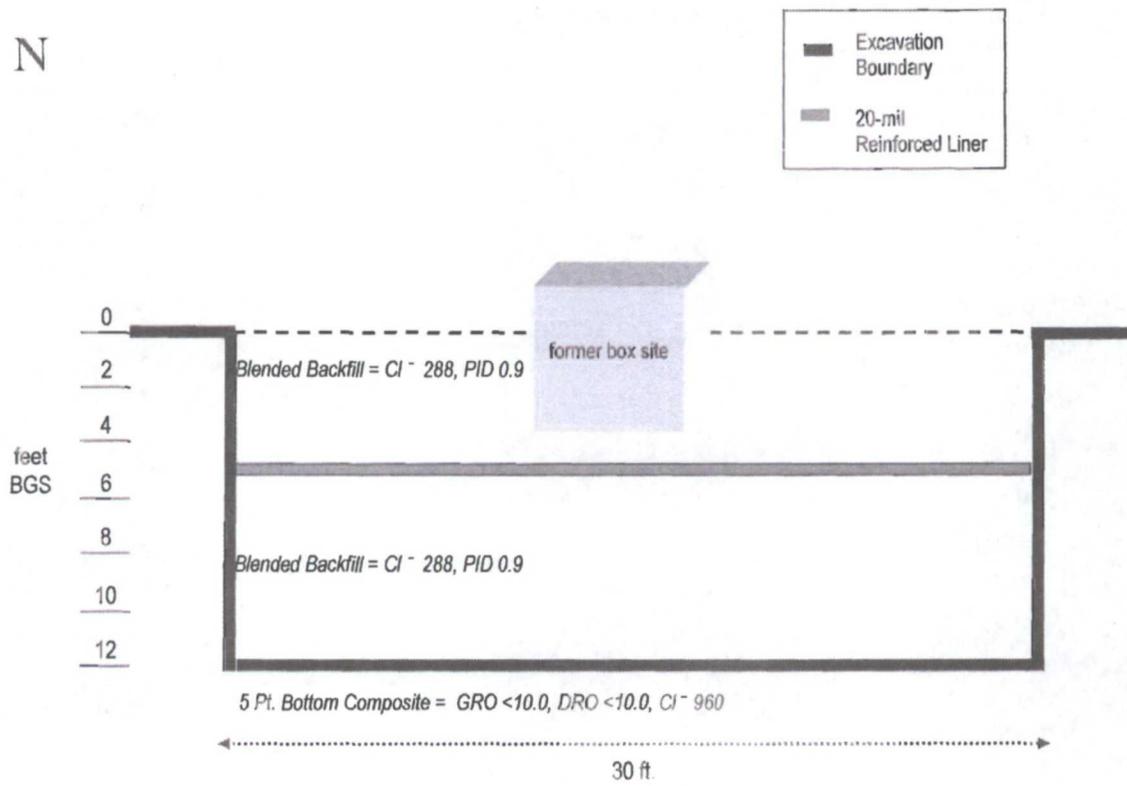
Excavation Cross-Section

EME Jct. C-13
Unit 'C', Sec. 13, T20S, R36E

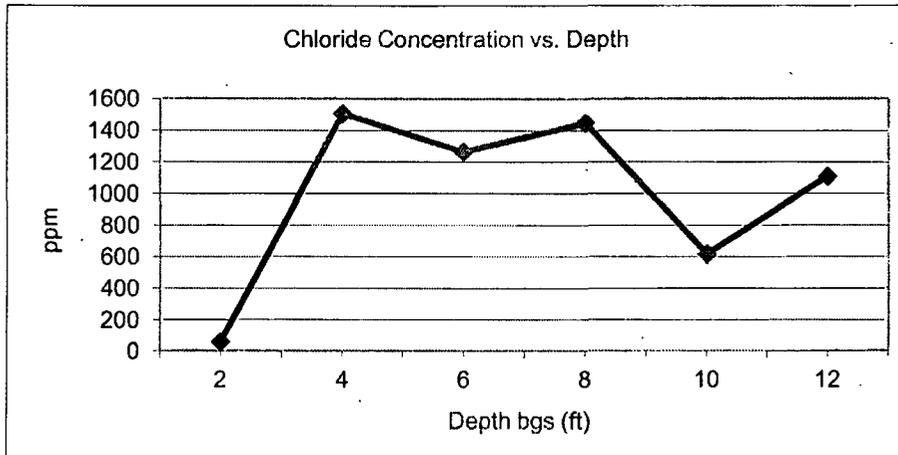
CHLORIDE CONCENTRATION CURVE

Backhoe samples at 10 ft South of the junction (source)

Depth bgs (ft)	[Cl ⁻] ppm
2	58
4	1,505
6	1,265
8	1,447
10	616
12	1,110

Groundwater = 31 ft
