RE: Termination Request
Vacuum Jct. O-33 (1R425-58): UL/O, Sec. 33, T17S, R35E
RICE Operating Company – Vacuum SWD System

**RICE OPERATING COMPANY
JUNCTION BOX FINAL REPORT**

Vacuum Jct. O-33

Unit O, Section 33, T17S, R35E

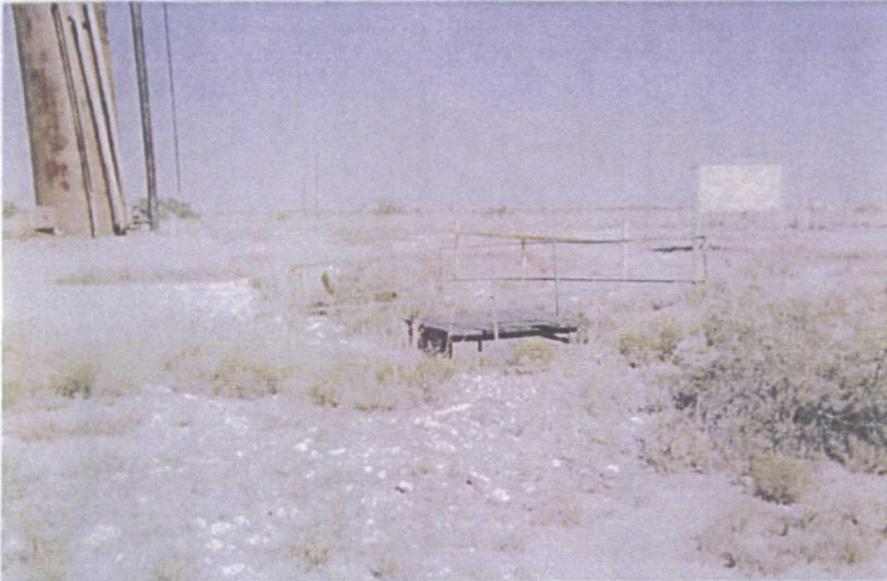
11/4/2005

undisturbed junction box, facing north

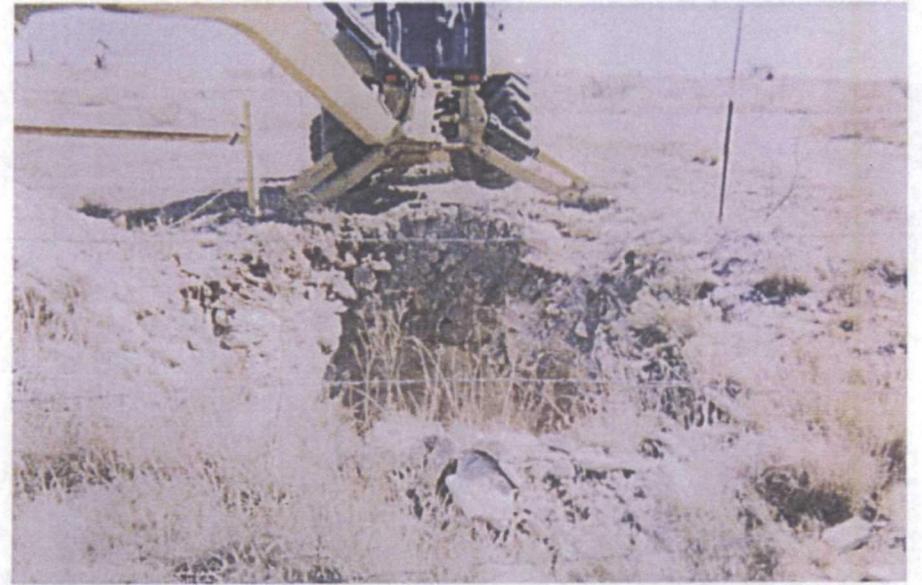
delineation trench at former junction site, facing east 2/13/2008

General Description of Remedial Action: This junction was eliminated during the Vacuum SWD system abandonment. After the former box was removed, an investigation was conducted using a backhoe to collect soil samples at regular intervals producing a 5x3x9-ft-deep excavation. Field data suggest the site is low in organic vapors and chloride concentrations are similar to that of the background. The deepest sample, 9 ft BGS, was

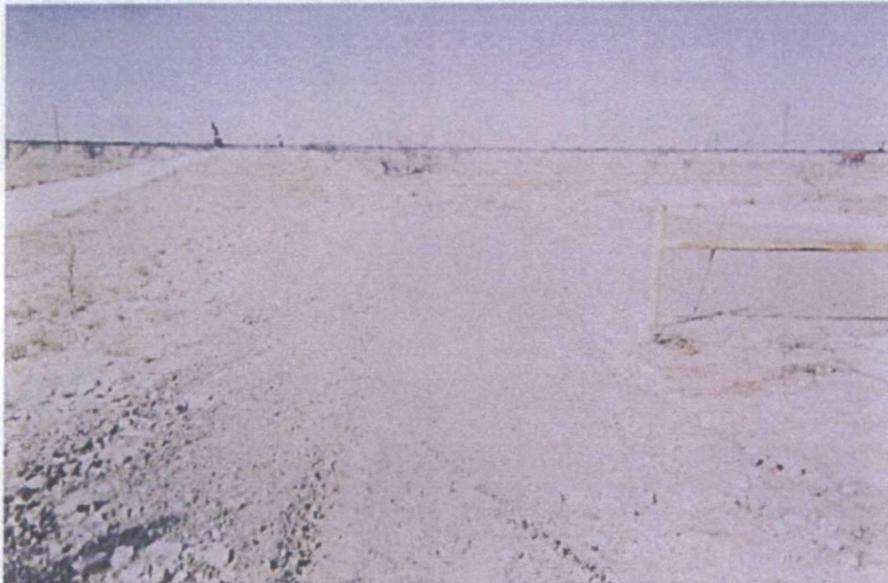
2/28/2008

backfilled with clean, imported soil, facing west

sent to a commercial laboratory for analysis of chloride and TPH, which confirmed low concentrations. The excavated soil was returned to the excavation and clean, imported soil was used as a top cap and to contour the site to the surrounding area. On 2/28/2008, the site was seeded with a blend of native vegetation and is expected to return to a productive capacity at a normal rate.

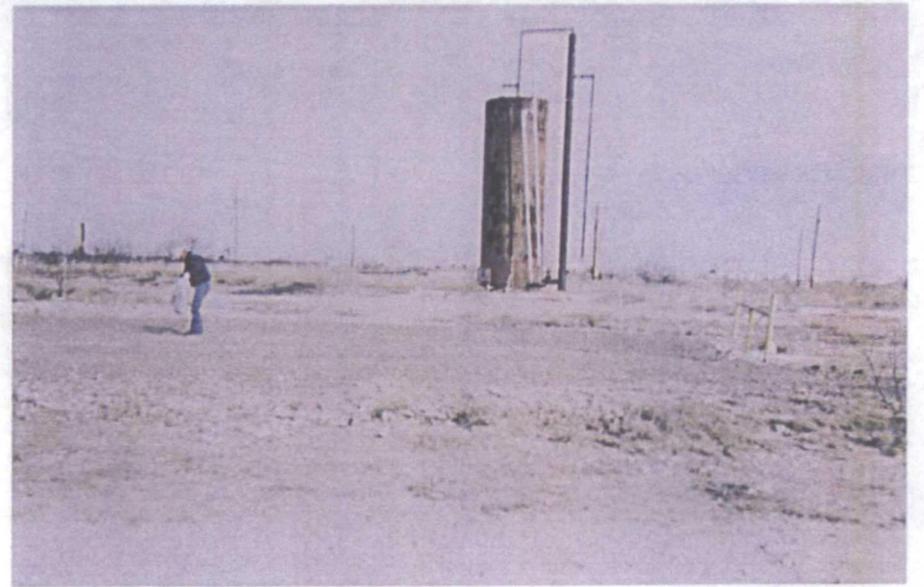
2/28/2008

seeding backfilled site, facing north
