1R - 427-04

**RE: Corrective Action Plan Report and Termination Request
Rice Operating Company – EME SWD System
EME L-34 (1R427-04): UL/L sec. 34 T20S R36E**

REVEGETATION FORM

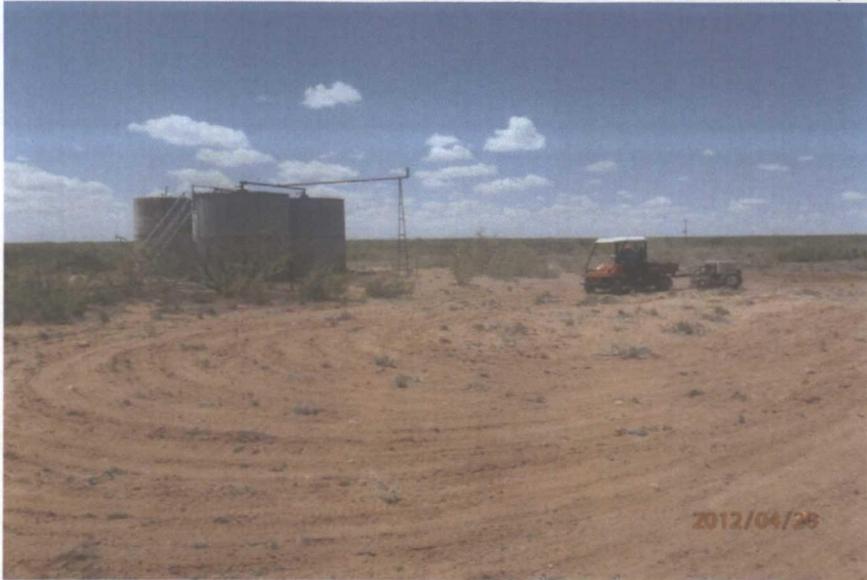
Seeding and tilling site, facing southwest

On April 20th, 2012, REC personnel were on site to seed the location. The site was seeded with a blend of native vegetation and the site was then watered to promote vegetative growth. A silt net fence was placed along the northeast end of the site to help maintain seed integrity. Documentation for these activities can be found in Appendix A. The site has an existing 20 ft x 20 ft poly liner installed at 4 ft bgs, which will impede migration of residual chlorides and hydrocarbons.

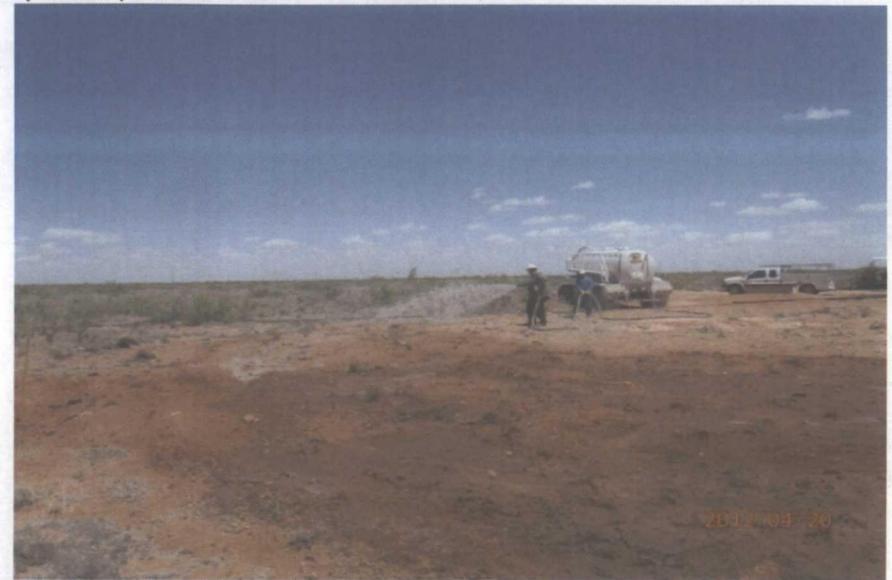
Watering seeded site, facing northeast

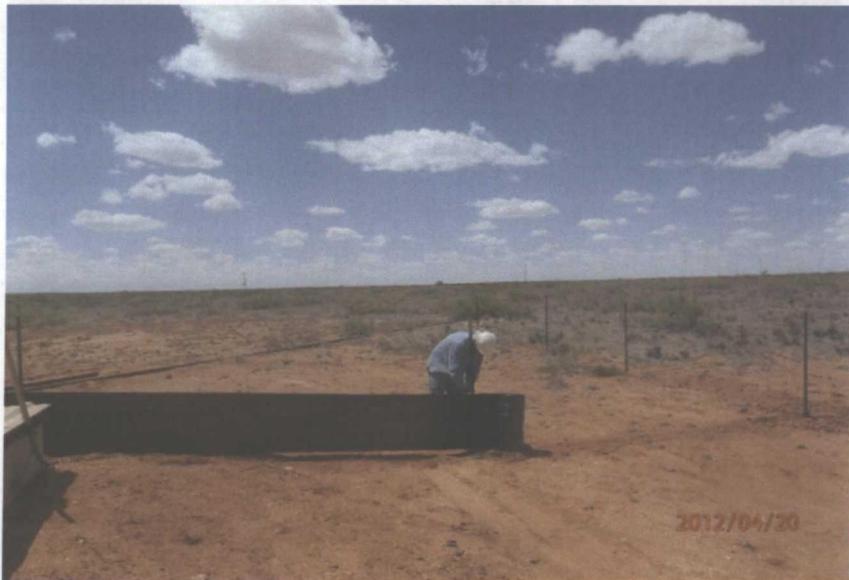
Installing silt net fence, facing west

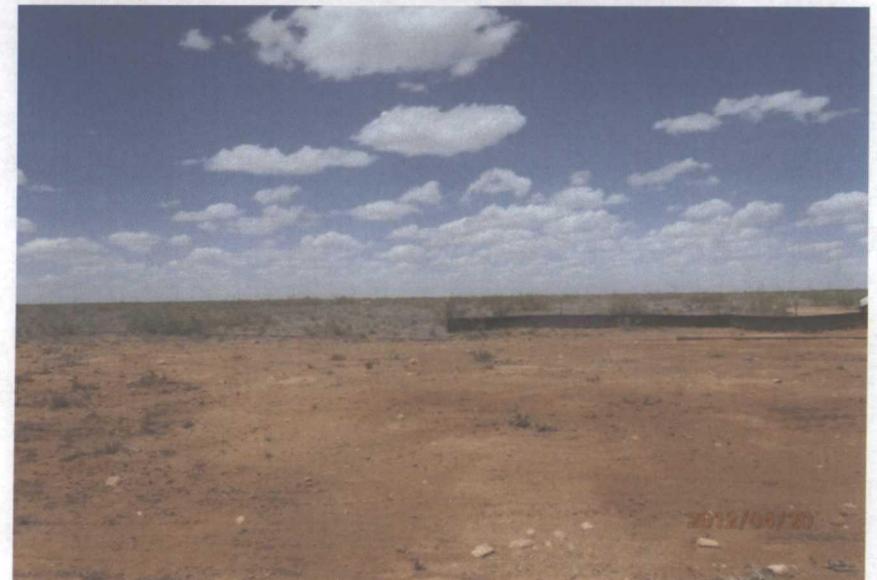
Site complete, facing north

ROC has completed the corrective actions as approved by NMOCD in the CAP by seeding the site. Therefore, ROC requests 'remediation termination' status of the regulatory file.
