# WORKPLANS

**RE: Corrective Action Plan (CAP)  
Rice Operating Company – EME SWD System  
BD M-26-1 (1R426-04): UL/M sec. 26 T21S R37E**

# Soil Bore and MW Installation and Proposed Liner

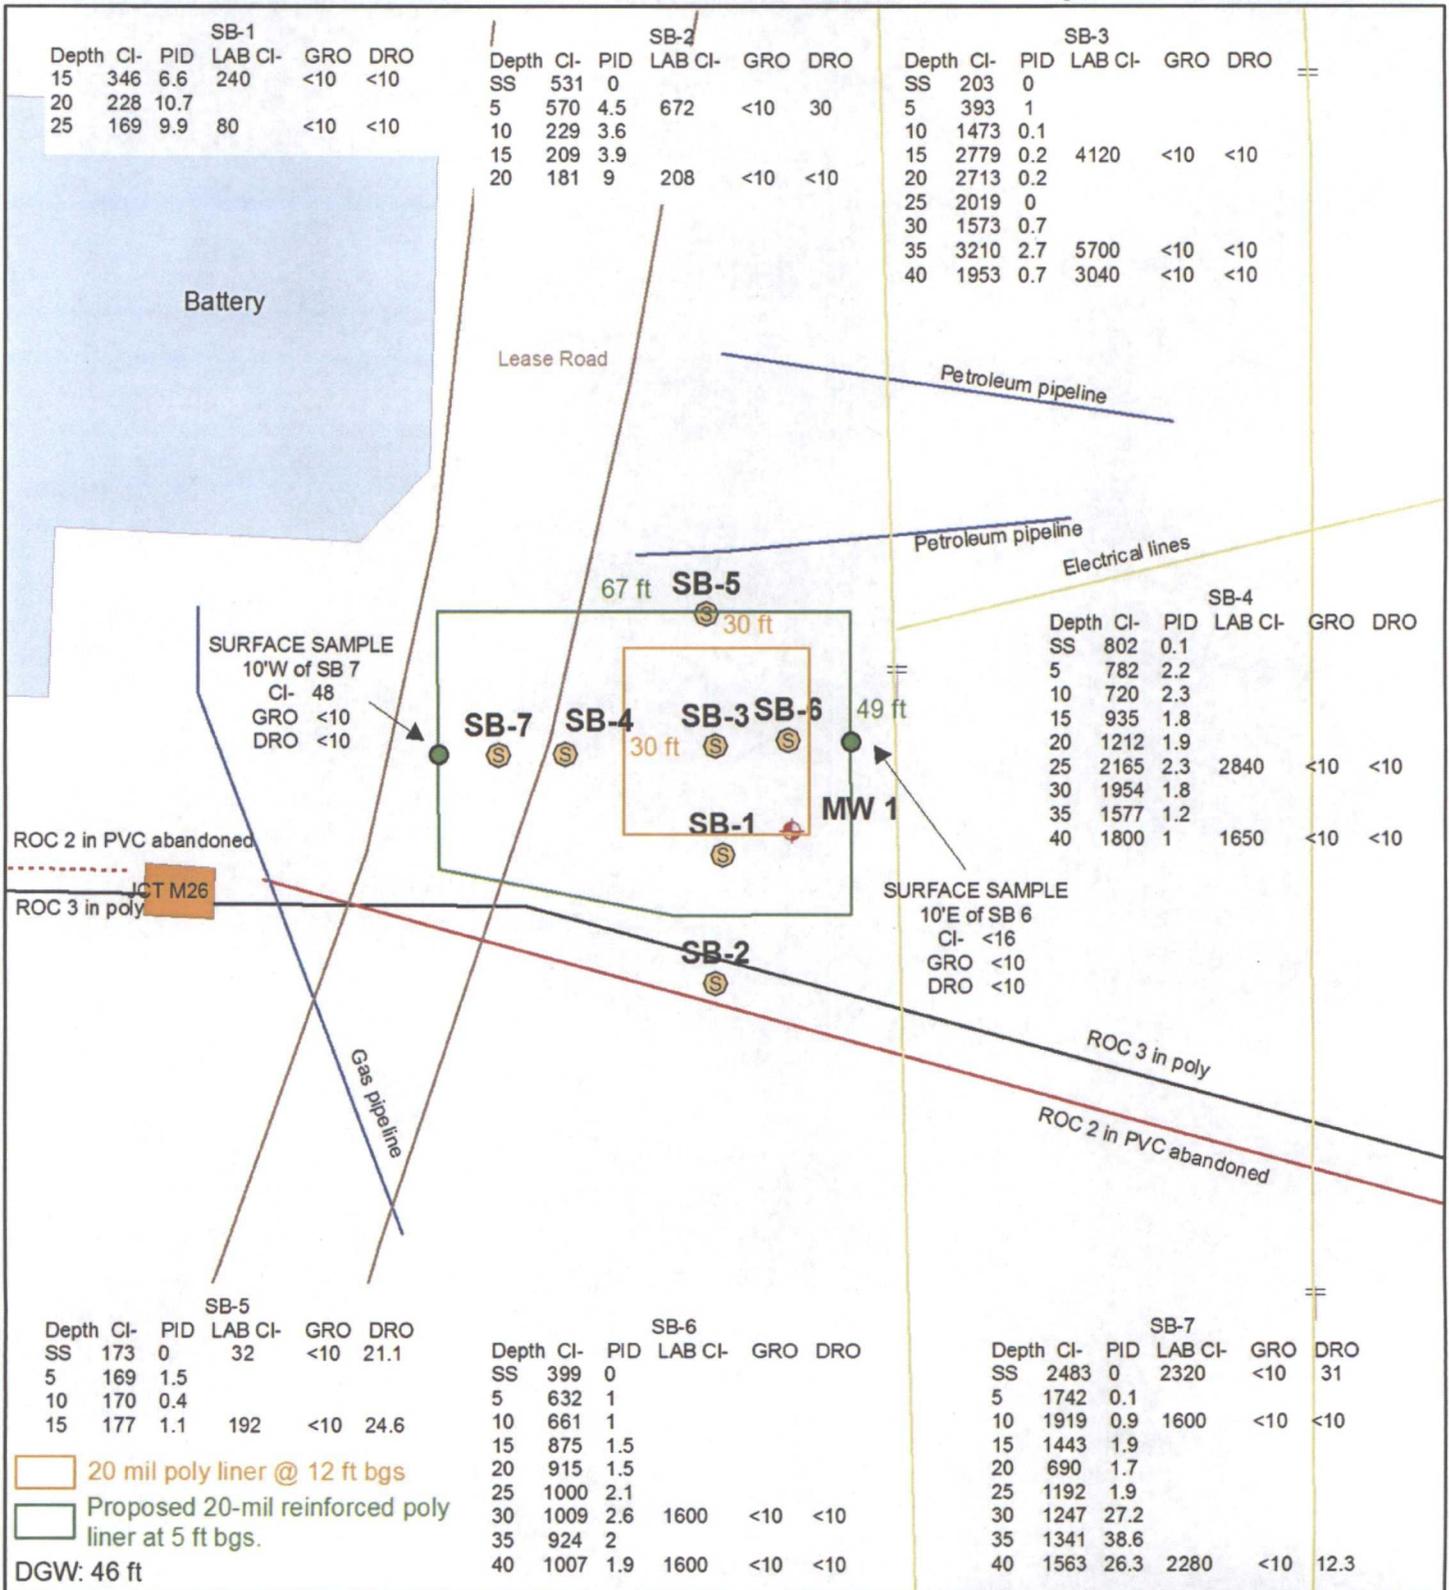
**Figure 2**

ROC proposes to excavate the site to the dimensions of 49 ft x 67 ft with the southwest corner angled to remain a safe distance from nearby pipelines and properly seat a 20-mil reinforced poly liner at approximately 5 ft bgs (Figure 2). The liner will provide a barrier that will inhibit the downward migration of chlorides to groundwater. The liner will cover the existing 20-mil poly liner measuring 30 ft x 30 ft installed at 12 ft bgs. The soils placed above the liner will have a laboratory chloride reading no greater than 500 mg/kg and a field PID reading below 100 ppm. Excavated soil will be evaluated for use as backfill and any soils requiring disposal will be properly disposed of at a NMOCD approved facility. Upon completion of backfilling, the site will be seeded with a native

Two surface samples were taken 10 feet outside SB-6 and SB-7 (Figure 2) on May 4<sup>th</sup>, 2012. The surface sample 10 feet east of SB-6 returned laboratory results of non-detect for chlorides, GRO and DRO. The surface sample 10 ft west of SB-7 showed a chloride laboratory reading of 48 mg/kg and GRO and DRO readings of non-detect (Appendix A).

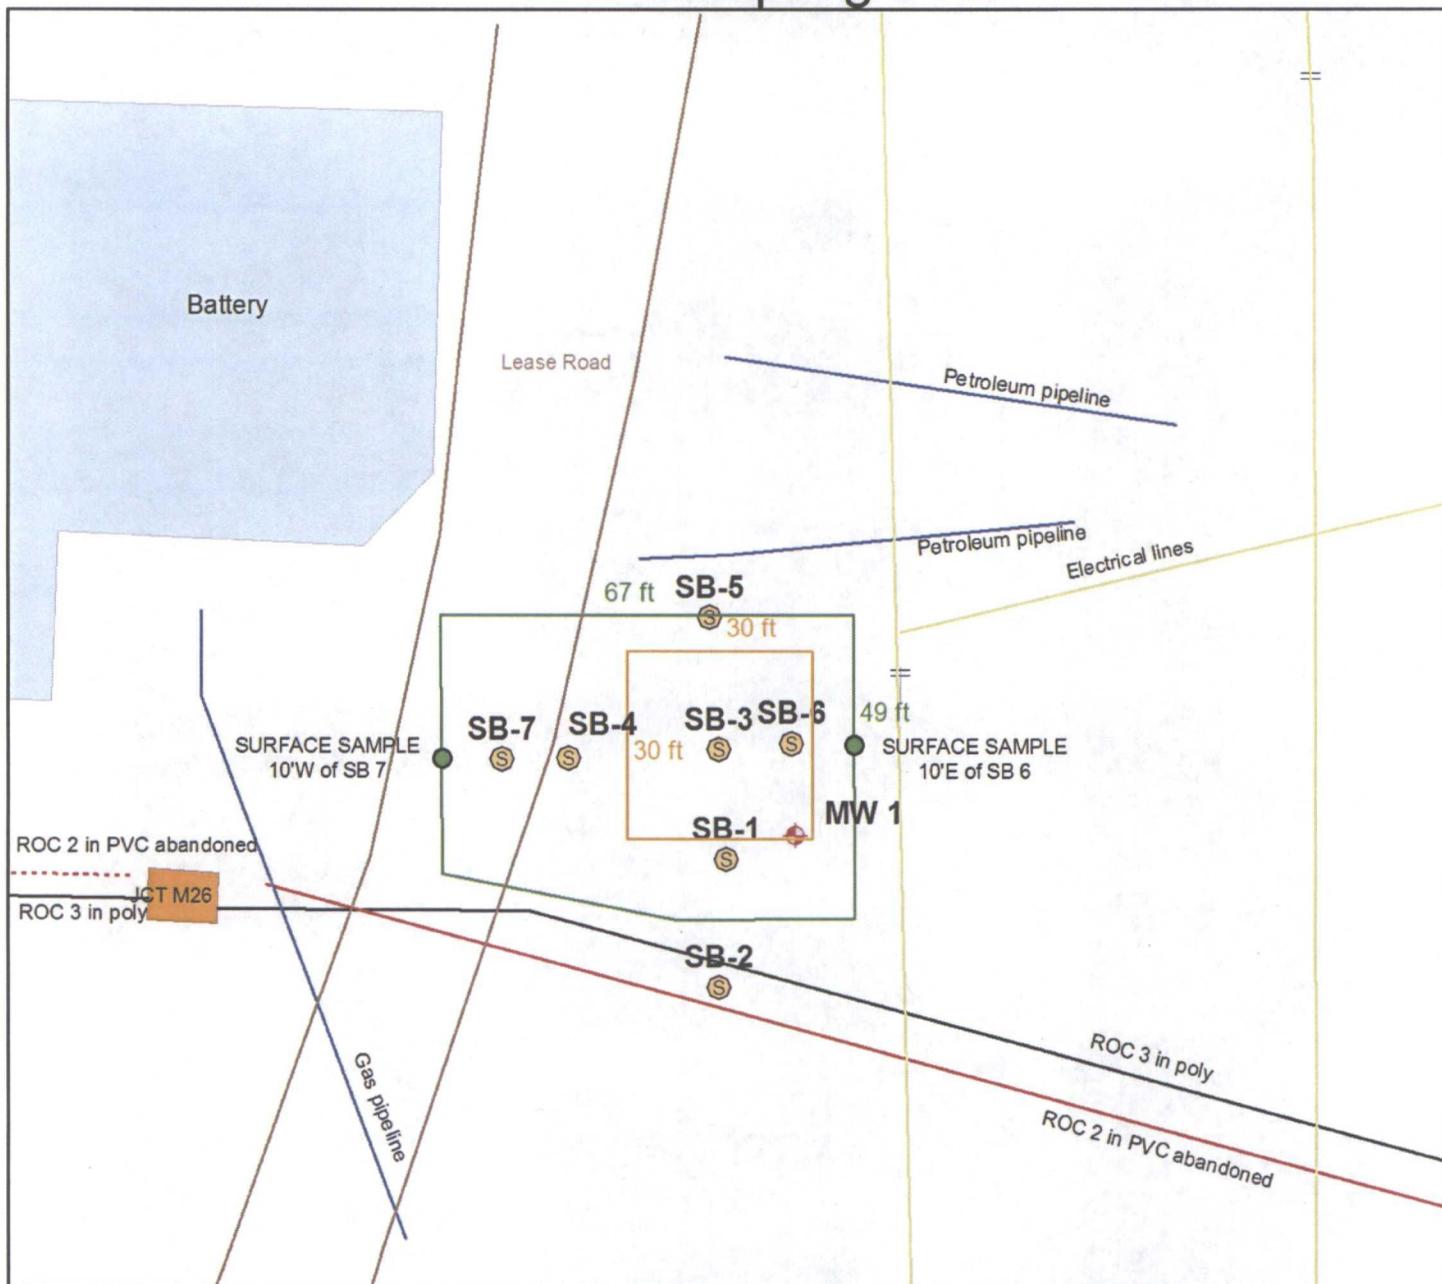
**Figure 3**

# MW Sampling Data

MW	Depth to Water	Total Depth	Sample Date	Cl	TDS	Benzene	Toluene	Ethyl Benzene	Total Xylenes	Sulfate
MW-1	46.57	77.29	11/7/2011	236	1200	<0.001	<0.001	<0.001	<0.003	242
	46.59	77.29	1/24/2012	212	1210	<0.001	<0.001	<0.001	<0.003	371

20 mil poly liner @ 12 ft bgs  
 Proposed 20-mil reinforced poly liner at 5 ft bgs.  
 DGW: 46 ft

The monitor well has been sampled quarterly since its installation. During the most recent sampling event on January 24<sup>th</sup>, 2012, the laboratory chloride reading was 212 mg/L (Appendix B). Given that the near-source monitor well has shown chloride values below WQCC standards since its installation (Figure 3), it is evident that chlorides in the vadose zone have not impacted groundwater beneath the site. Therefore, ROC proposes to plug and abandon the near-source monitor well with a 1-3% bentonite/concrete slurry and a three foot concrete cap.

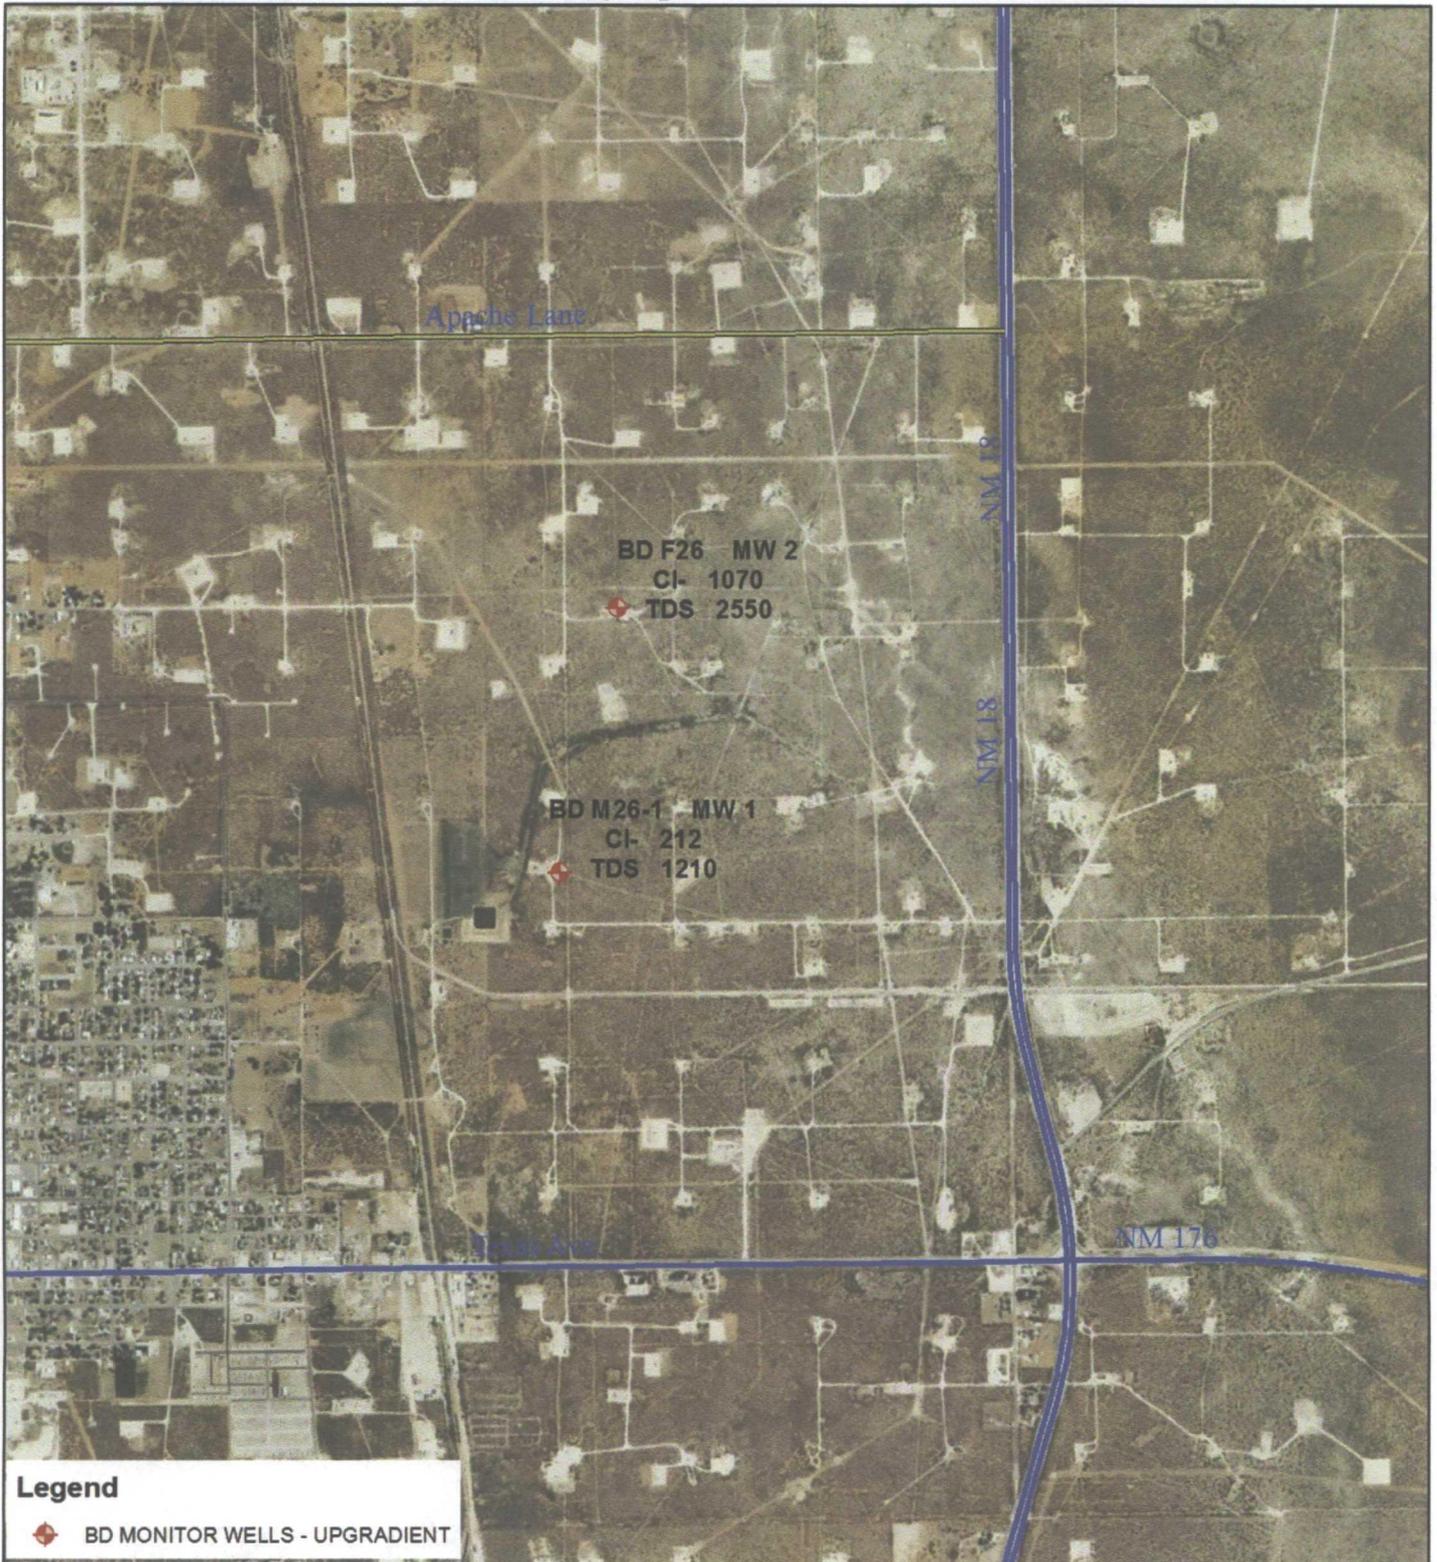
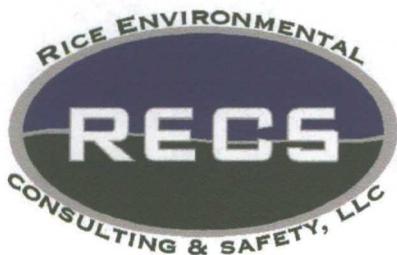
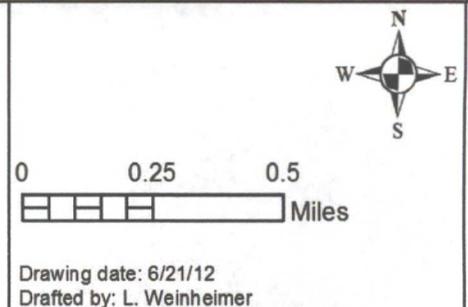
Hack asked me to send you the attached map showing the ROC's BD M-26-1 (1R426-04) in relation to the up-gradient site BD F-26. I put the chloride and TDS values from the most recent groundwater sampling event for the F-26 up-gradient well.

# Additional Up-gradient Information
