ANNUAL REPORT - 2011

SOUTHERN UNION GAS SERVICES SOUTHERN UNION LANDFARM

Lea County, New Mexico

**SE ¼ of the NW ¼ of Section 36, Township 23 South, Range 36 East
Permit #NM-02-0019**

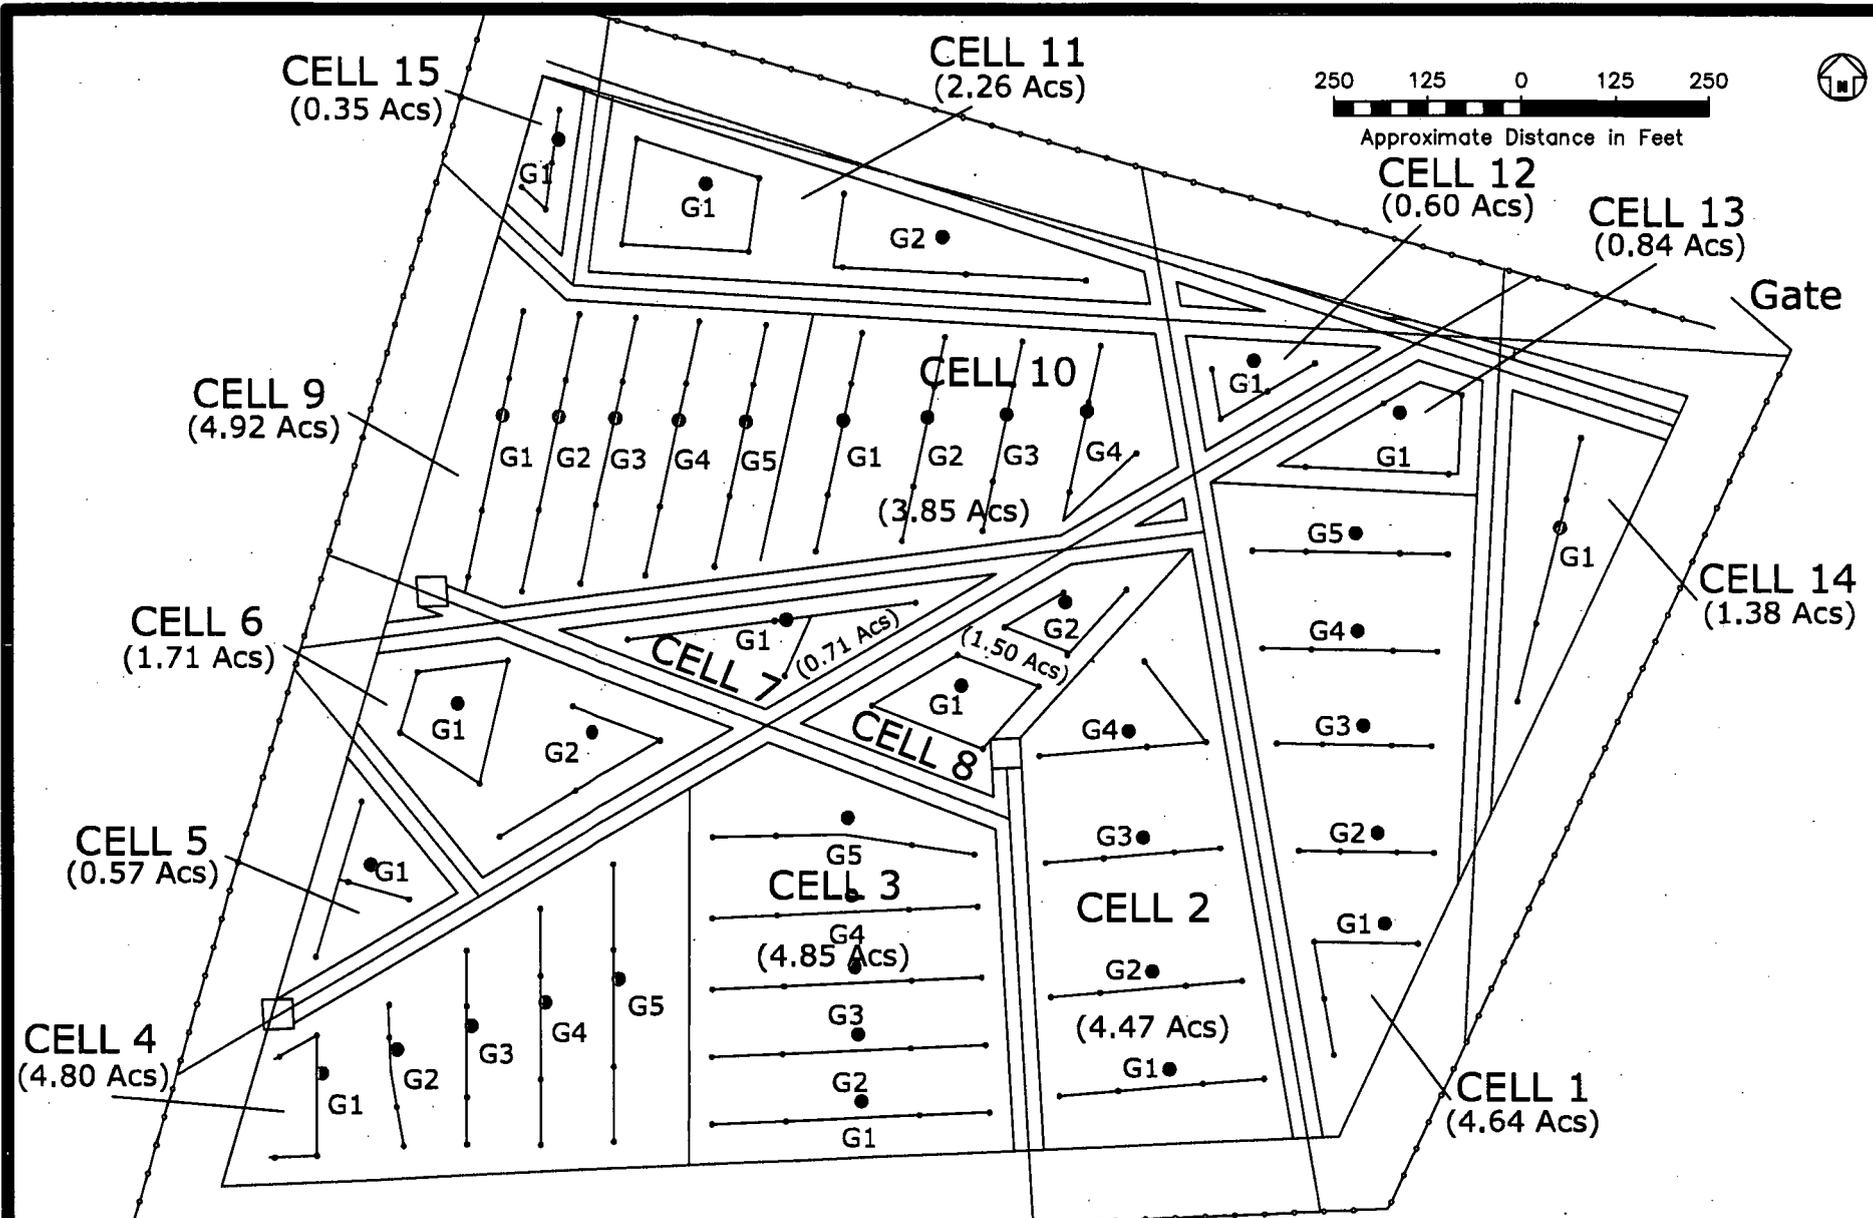
Figure 1
 Sample Location Map
 June 2011
 Southern Union Gas Services
 Landfarm
 Lea County, New Mexico
 NMOCD Permit # NM02-0019

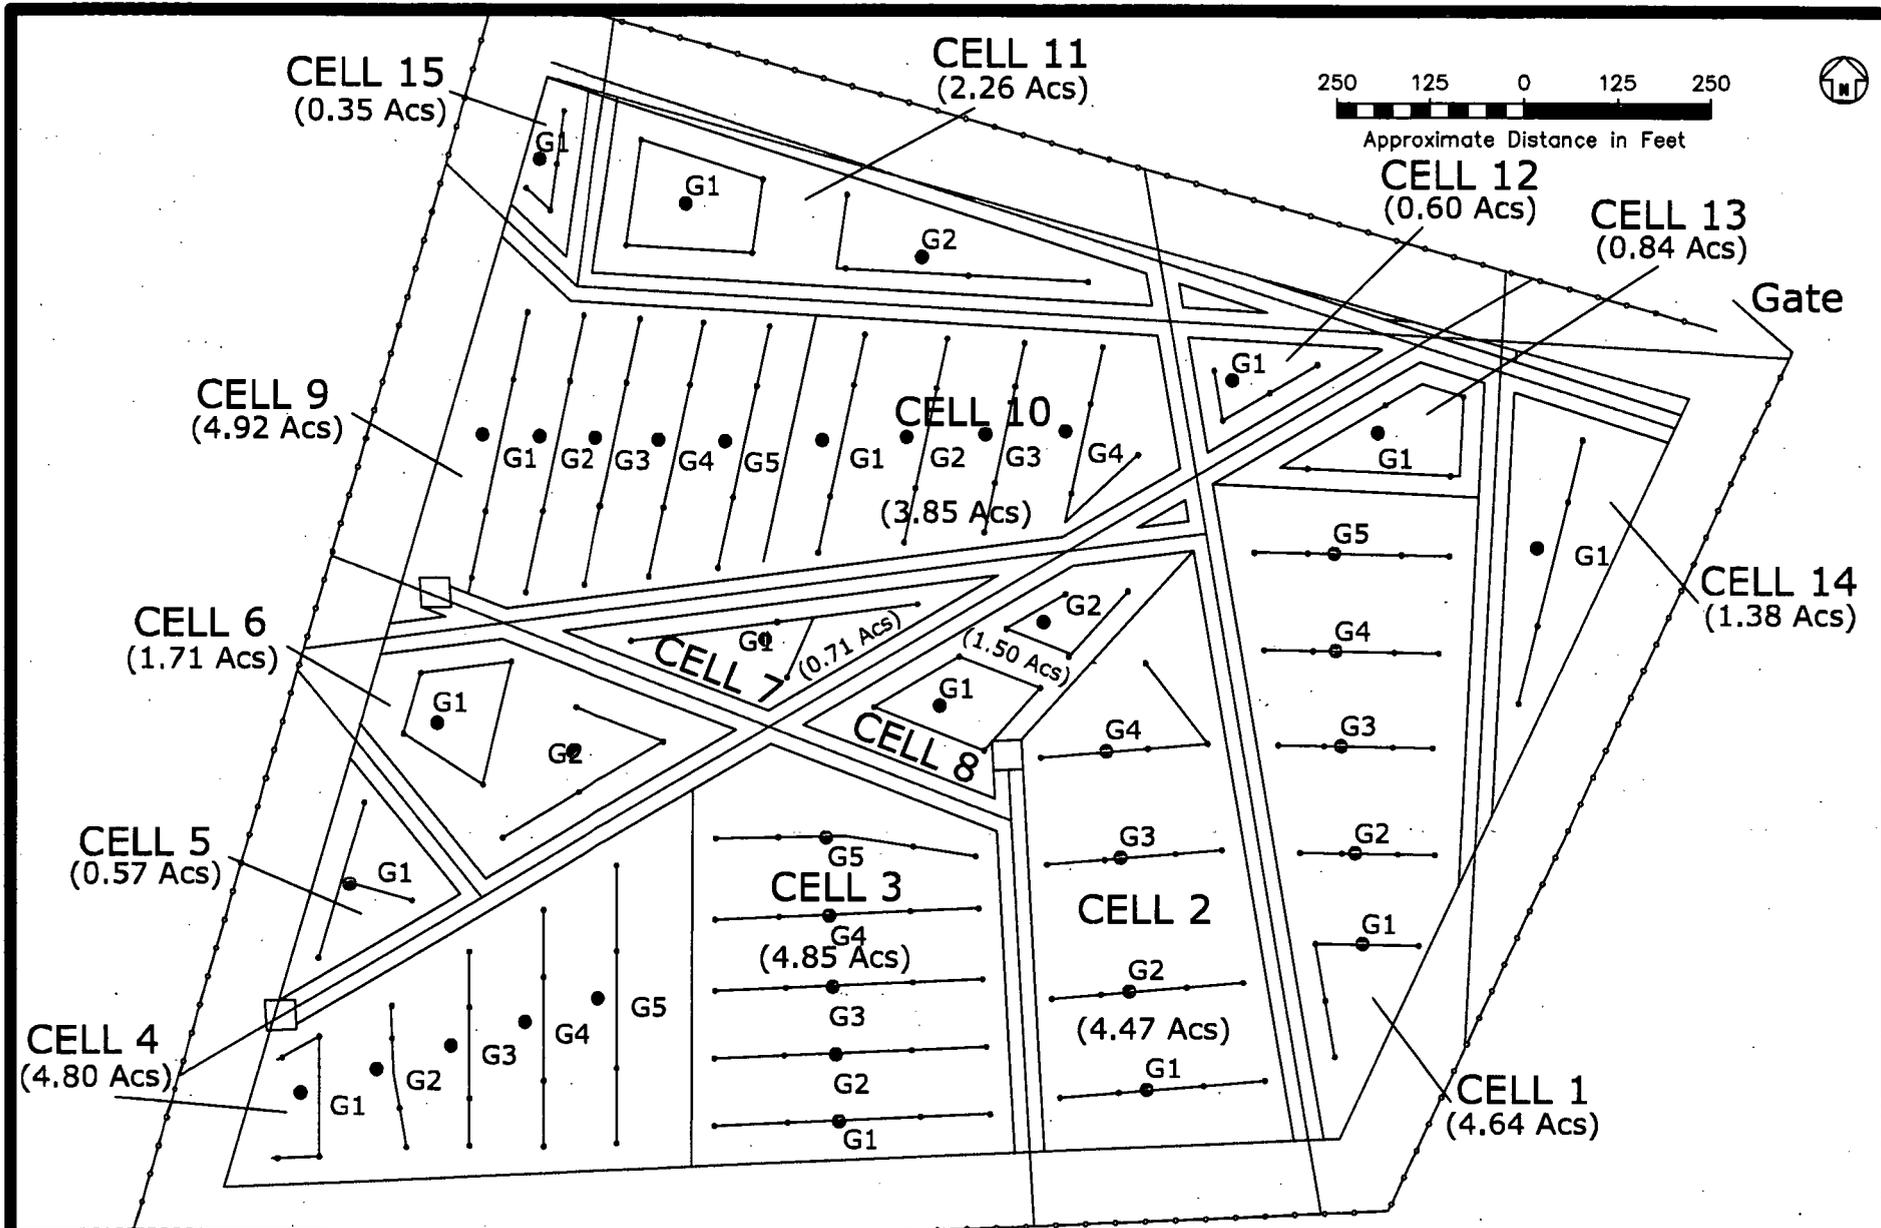
Figure 2
 Sample Location Map
 November 2011
 Southern Union Gas Services
 Landfarm
 Lea County, New Mexico
 NMOC Permit # NM02-0019
