Re: Closure Approval: C-Extension #1 - #130001
Site Reference UL-F, Sec-30 T-20S R-37E
Initial Notification Date: April 5, 2004
Closure Request Dated: October 12, 2004

**SITE INVESTIGATION,
REMEDICATION AND FINAL C-141
CLOSURE DOCUMENTATION**

C-EXTENSION RELEASE SITE

DEFS REF: 130001

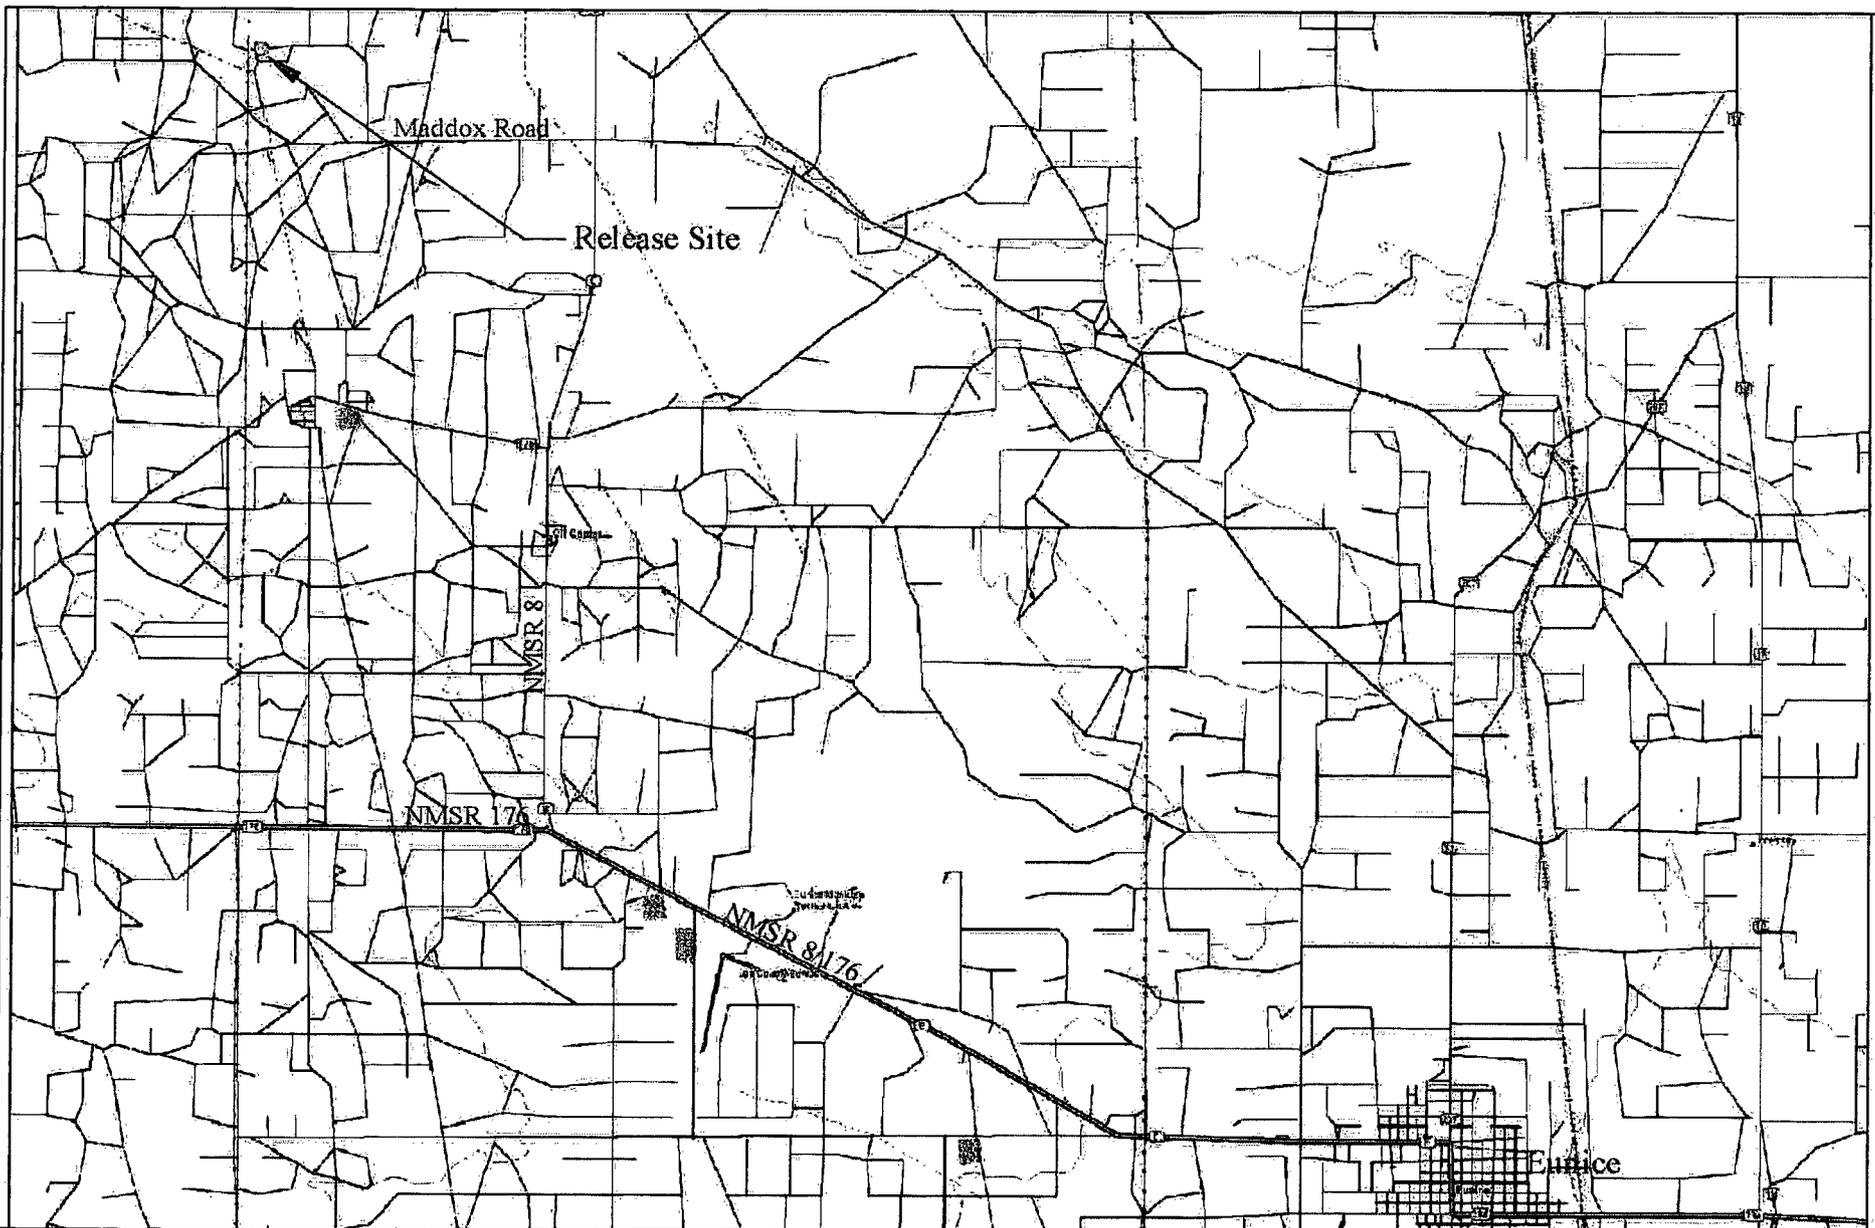
Figure 1
Area Map
 Duke Energy Field Services
 C-Extension #1 04-05-04

Lea County, New Mexico
 SE 1/4 of the NW 1/4, Sec. 30, T20S, R37E
 N 32° 32' 43.7" W 103° 17' 38.7"
 Elevation: 3,535 feet amsl

This release site is located in Unit Letter F, (SE¹/₄ of the NW¹/₄), Section 30, T20, R37E, N32° 32' 43.70" and W103° 17' 38.69". The site is approximately 6-miles southwest of Monument, New Mexico. The property is owned by the State of New Mexico (*reference Figures 1 through 3*).

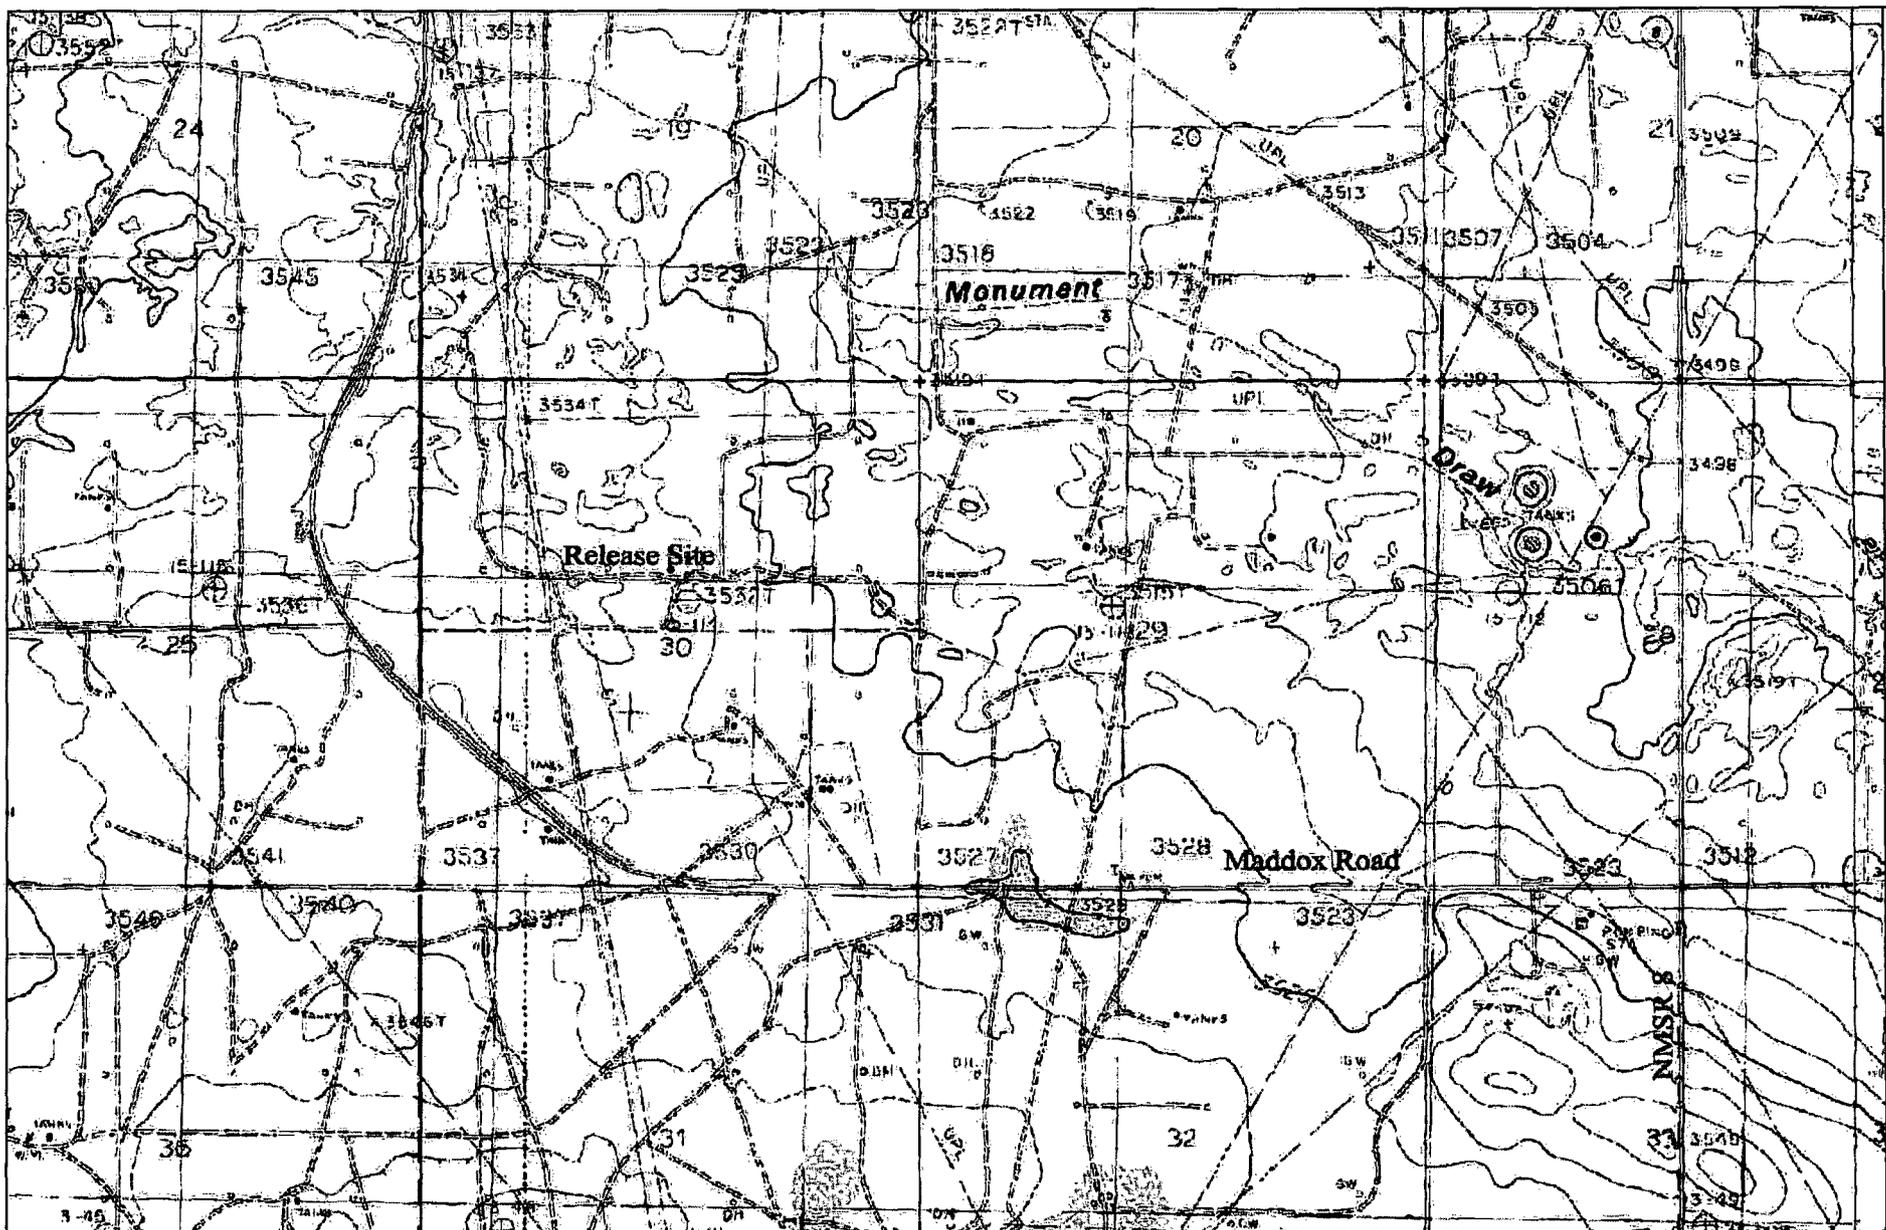
Figure 2
Site Location Map
 Duke Energy Field Services
 C-Extension #1 04-05-04

Lea County, New Mexico
 SE 1/4 of the NW 1/4, Sec. 30, T20S, R37E
 N 32° 32' 43.7" W 103° 17' 38.7"
 Elevation: 3,535 feet amsl

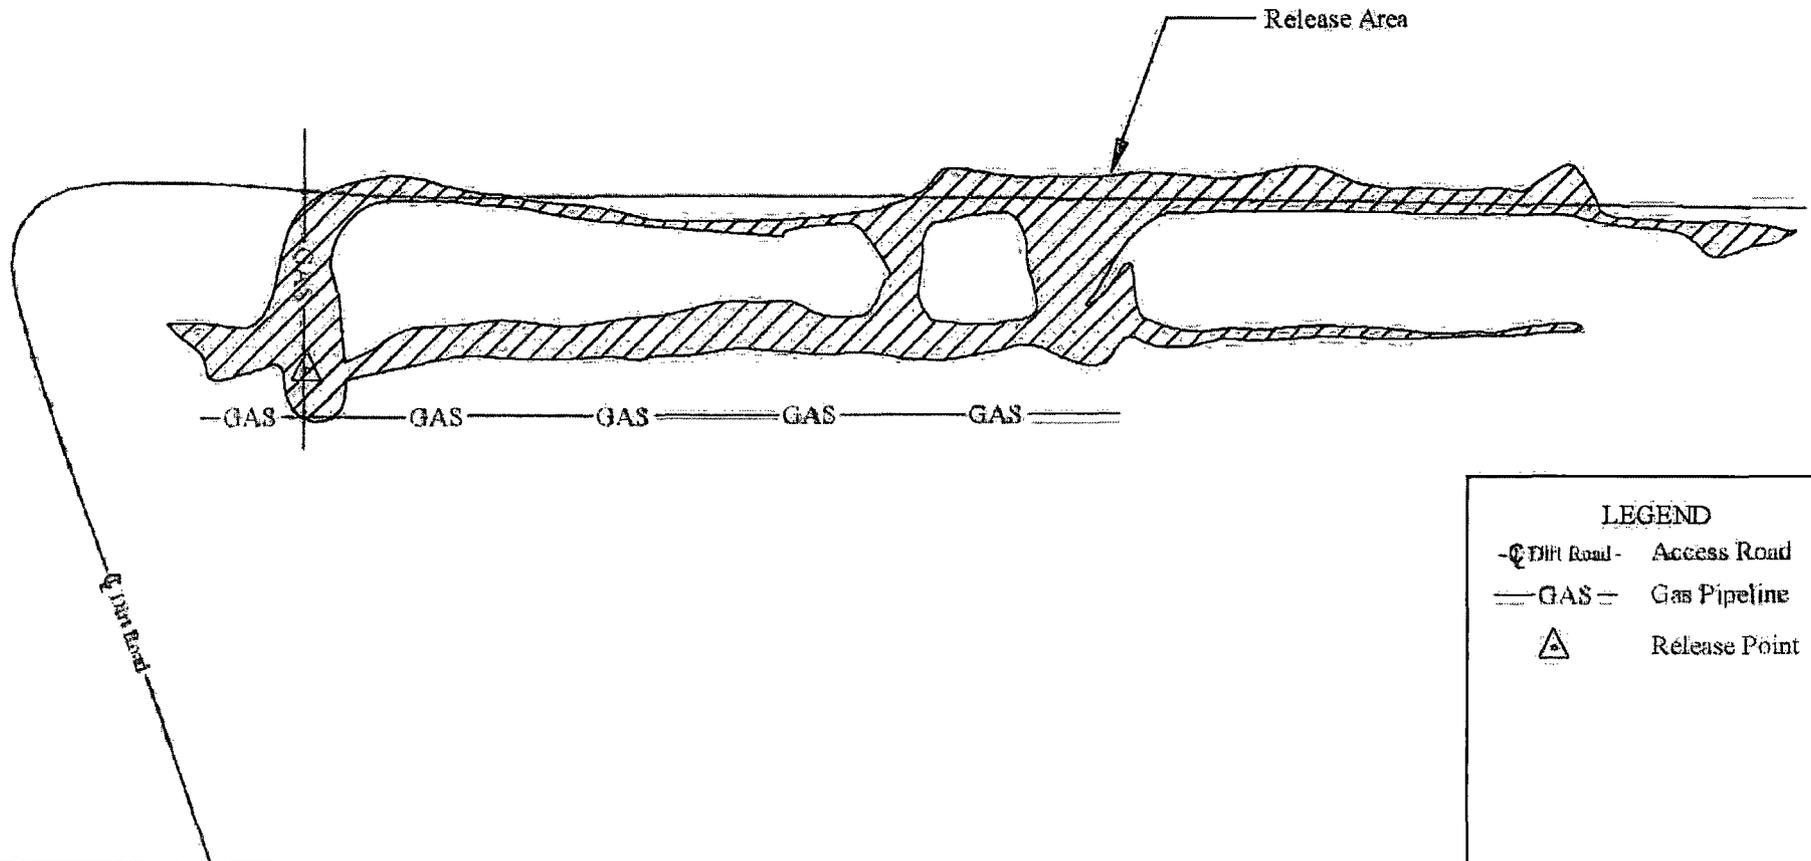
Figure 3
Site Map
 Duke Energy Field Services
 C-Extension #1 04-05-04

Lea County, New Mexico
 SE 1/4 of the NW 1/4, Sec. 30, T20S, R37E
 N 32° 32' 43.7" W 103° 17' 38.7"
 Elevation: 3,535 feet amsl

This report addresses the site investigation and remediation of the Duke Energy Field Services (DEFS) "C-Extension" 16-inch natural gas gathering line remediation site. On April 5, 2004, Environmental Plus, Inc. (EPI) was notified by DEFS regarding a recently discovered natural gas and associated natural gas liquid (NGL) release along the C-Extension. This site is located approximately 6 miles southwest of Monument, Lea County, New Mexico (*reference Figure 1*). The initial C-141 Form submitted to the New Mexico Oil Conservation Division (NMOCD) on April 6, 2004, reports the release volume as approximately 180-barrels with 120-barrels recovered. EPI performed GPS surveying, photography and characterization of the site on April 5, 2004. The initial site consisted of an approximate 58,000 square feet (ft²) visibly affected surface area (*reference Figure 3*).

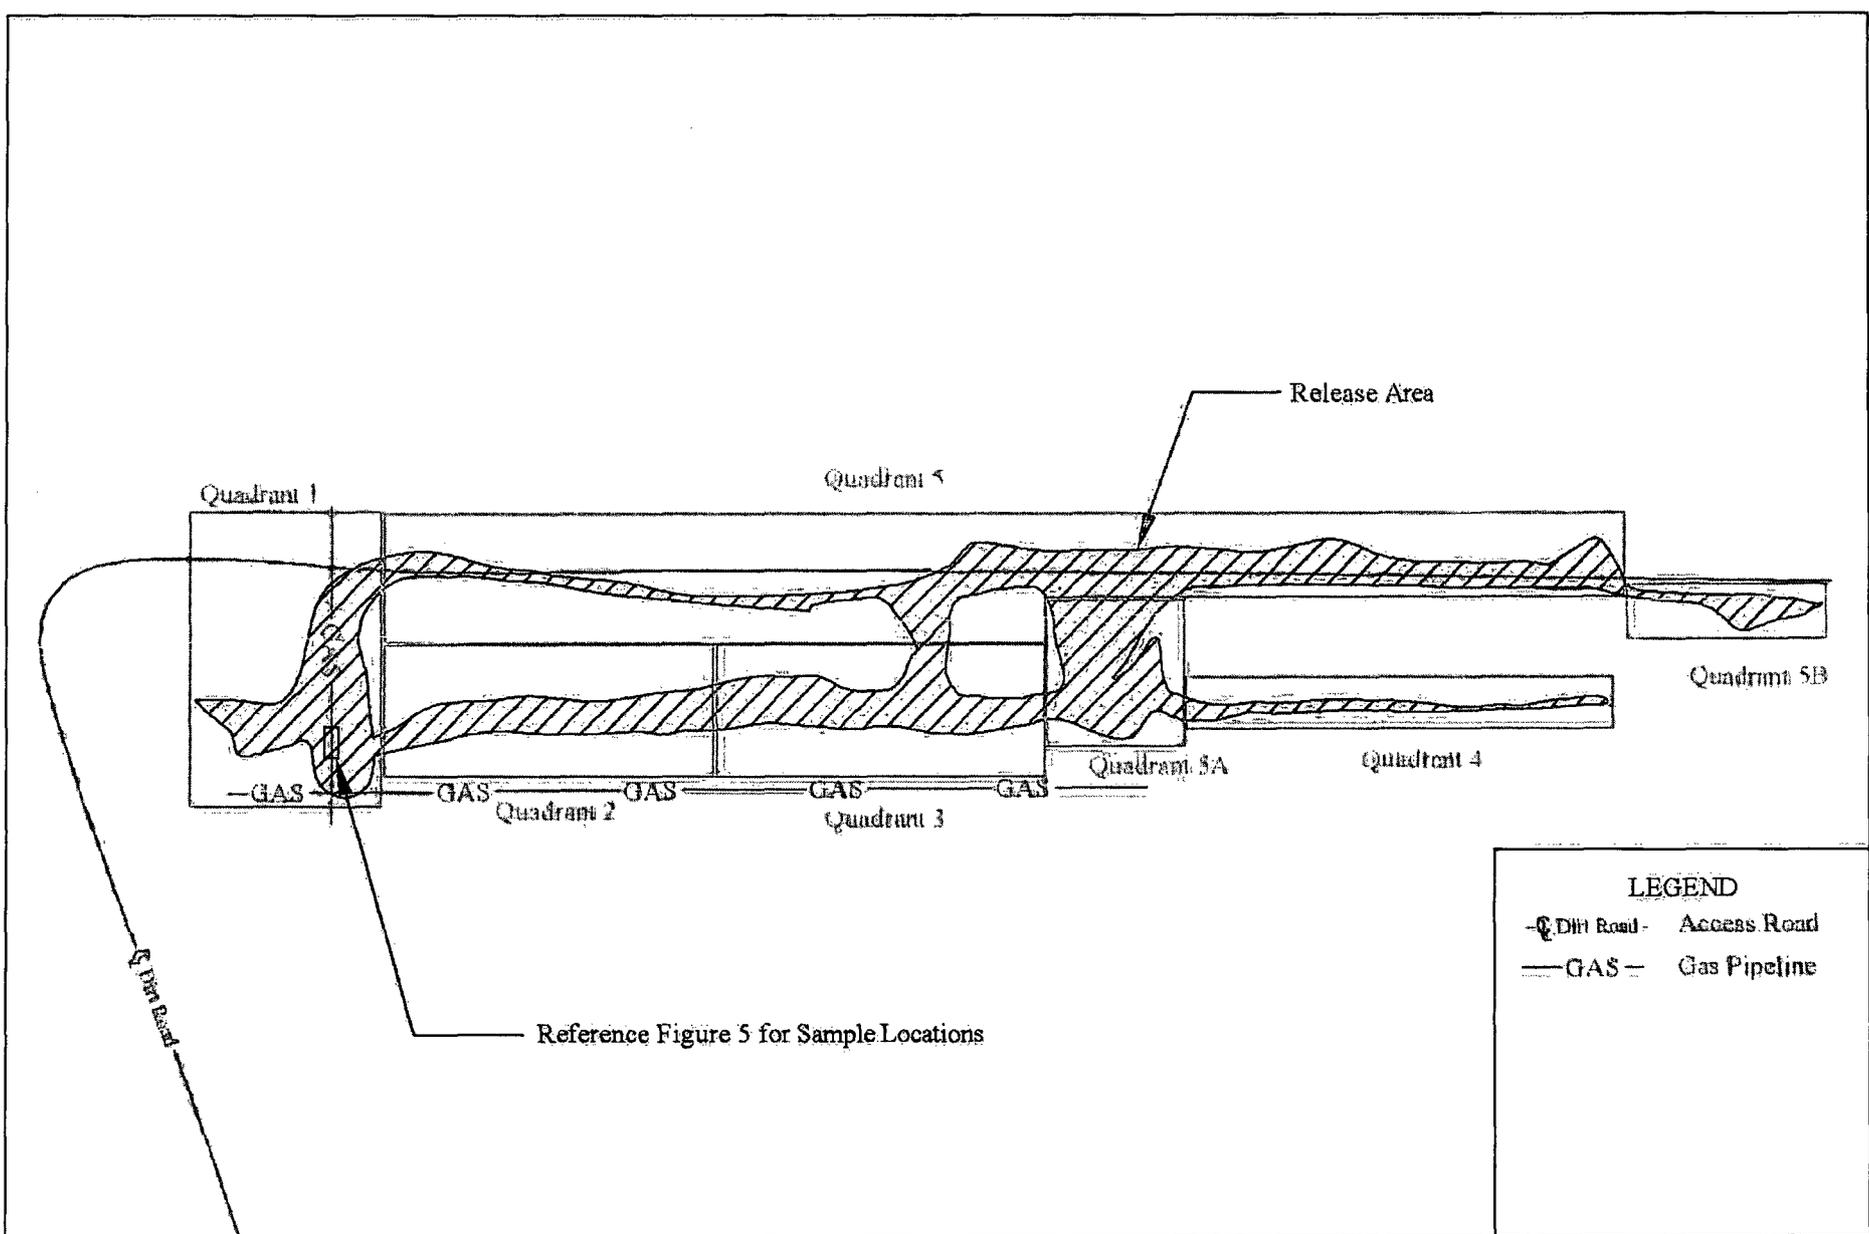
Figure 4
Sample Location Map
 Duke Energy Field Services
 C-Extension #1 04-05-04

Lea County, New Mexico
 SE 1/4 of the NW 1/4, Sec. 30, T20S, R37E
 N 32° 32' 43.7" W 103° 17' 38.7"
 Elevation: 3,535 feet amsl

Excavation of the flow paths continued until field analyses of soil samples indicated organic vapor concentrations were below 50 ppm. The flow paths were divided into five separate quadrants (reference Figure 4), with excavation depths varying from 1 to 3 feet below ground surface in each of the quadrants. Grab samples were collected from each quadrant and analyzed in the field for the presence of organic vapors utilizing an UltraRae® photoionization detector (PID) equipped with a 10.6 electron volt (eV) lamp. Once field analyses indicated organic vapor concentrations were below 50 ppm, samples were collected and submitted to an independent laboratory for quantification of GRO, DRO, BTEX and chloride. Analytical results for these samples reported contaminant concentrations below the NMOCD remedial thresholds for all analytes (reference Table 1).

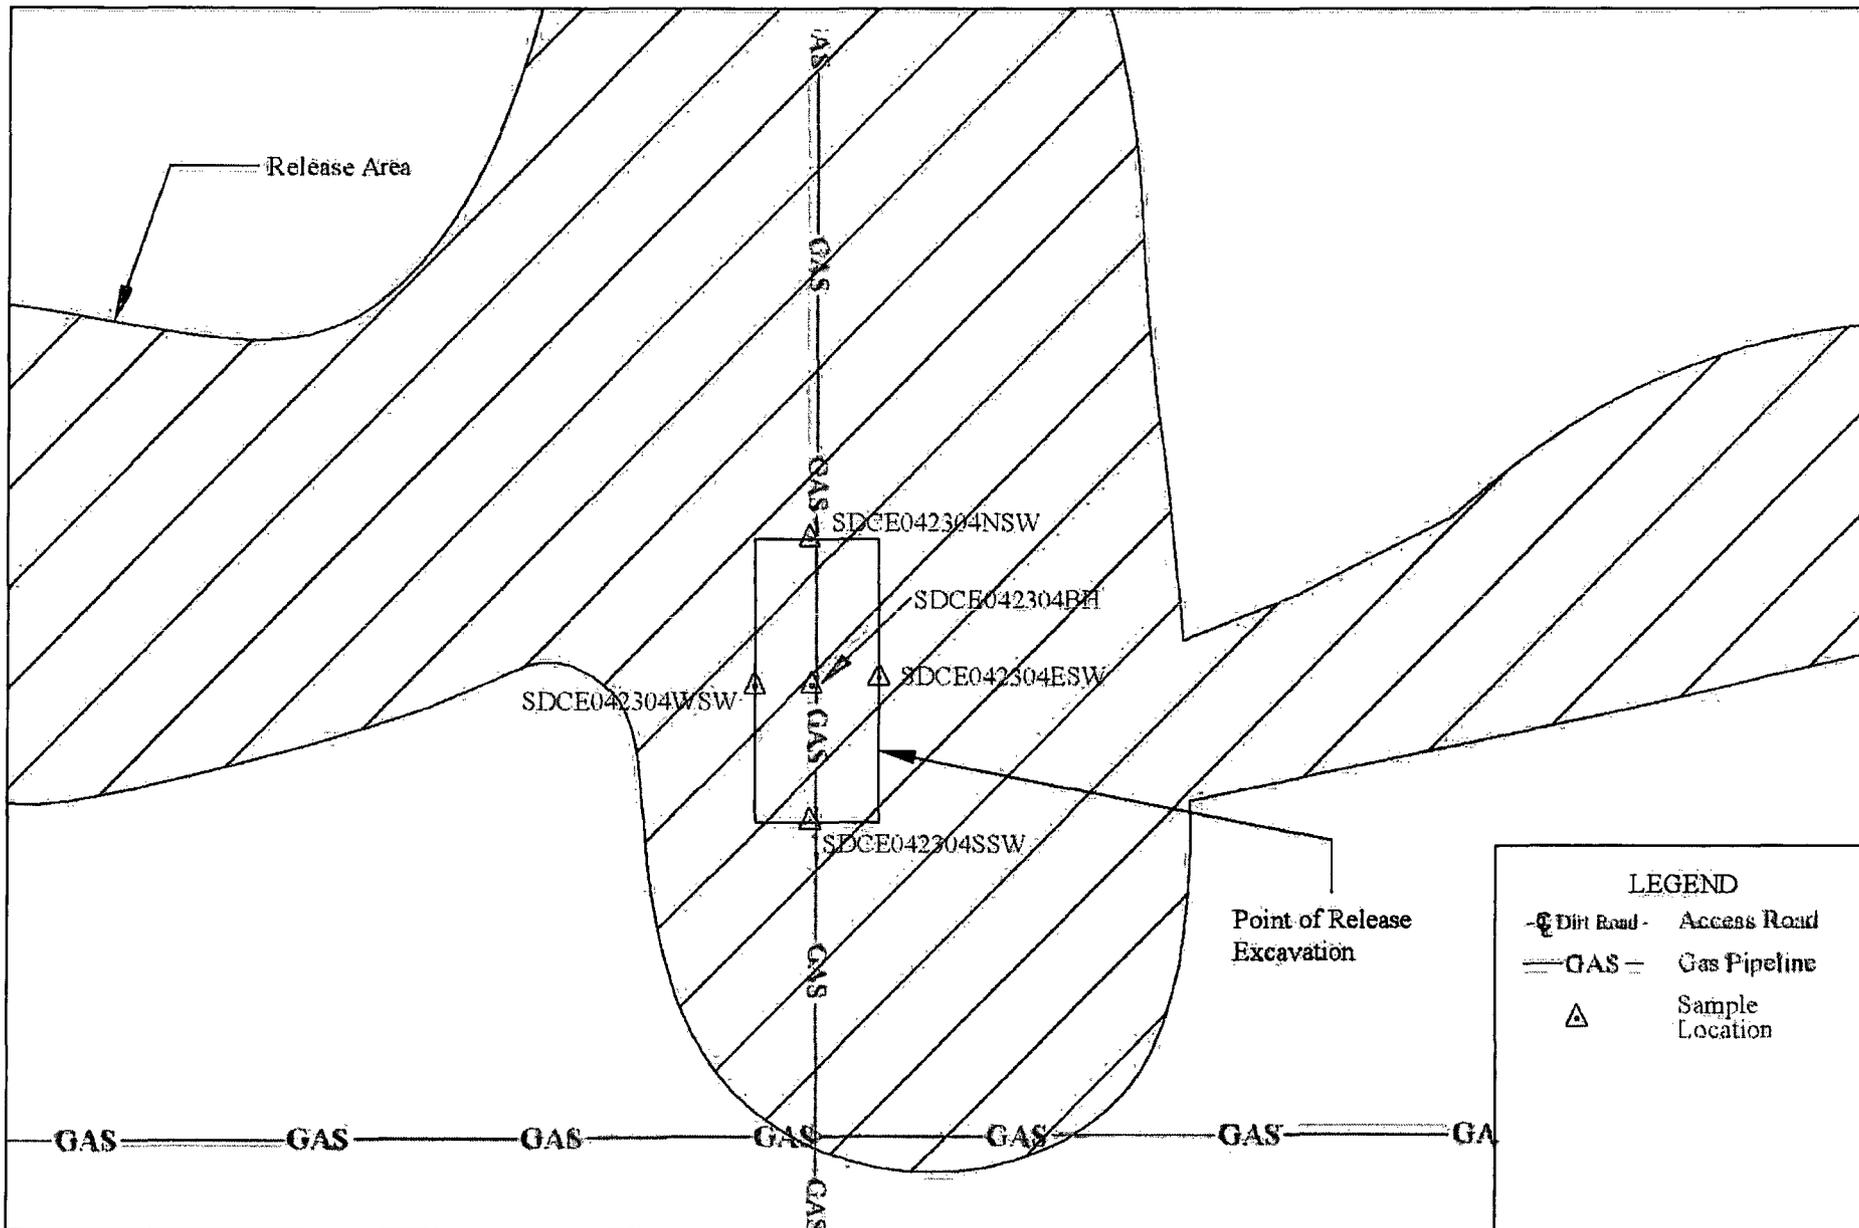
Figure 5
 POR Sample Location Map
 Duke Energy Field Services
 C-Extension #1 04-05-04

Lea County, New Mexico
 SE 1/4 of the NW 1/4, Sec. 30, T20S, R37E
 N 32° 32' 43.7" W 103° 17' 38.7"
 Elevation: 3,535 feet amsl

Approximately 33 cubic yards of soil (22 feet long X 10 feet wide X 4 feet deep) were removed from the excavation at the point of release (reference Figure 5). Grab samples were collected from each sidewall and the bottom of the excavation and analyzed in the field for the presence of organic vapors utilizing an UltraRae® PID equipped with a 10.6 eV lamp. Once field analyses indicated organic vapor concentrations were below 50 ppm, samples were collected and submitted to an

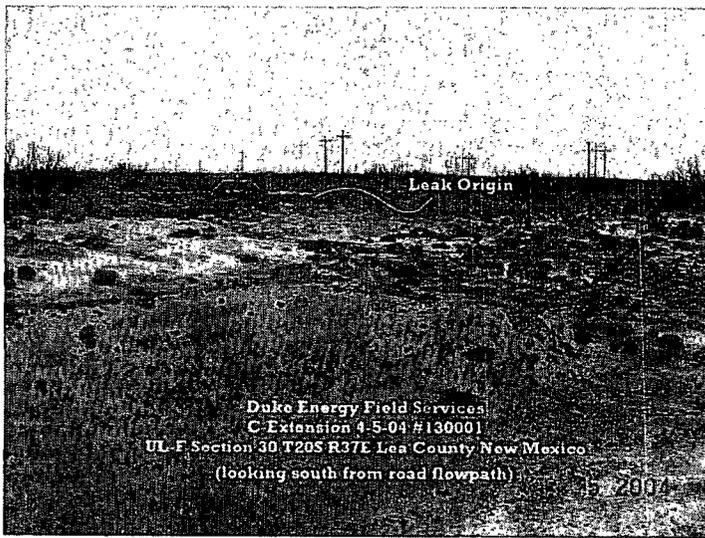
Photo #1: West pooling area, looking south. The release point is near the piping seen in the background.

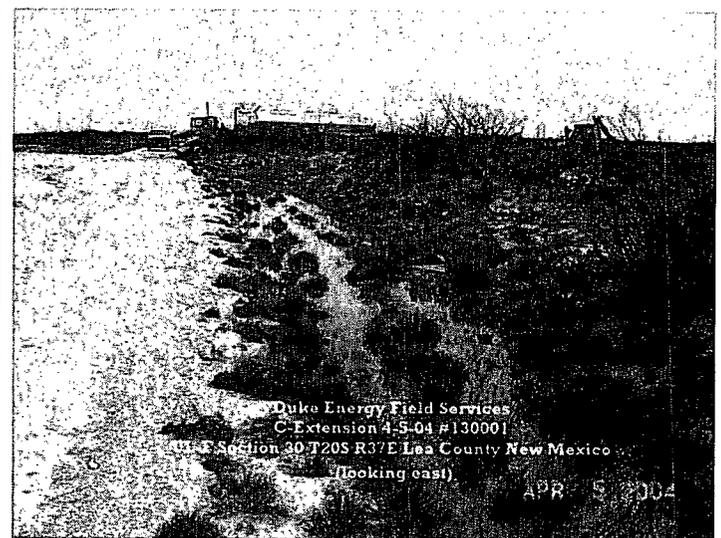
Photo #2: North flow path along access road, looking east from the west pooling area.

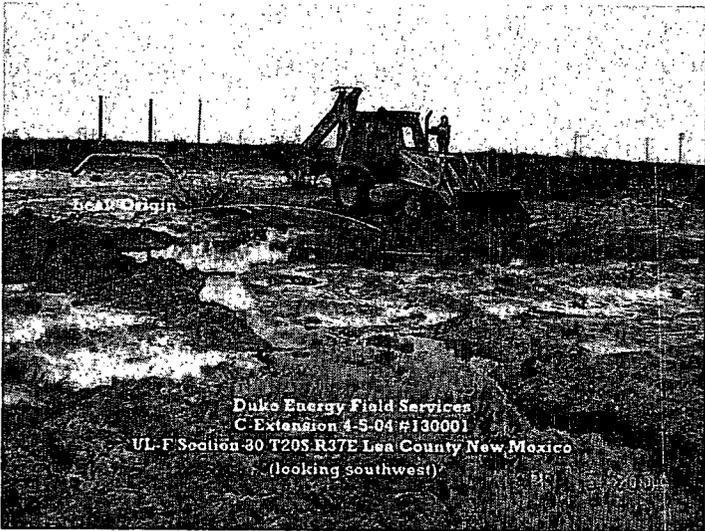
Photo #3: Central pooling area, looking south.

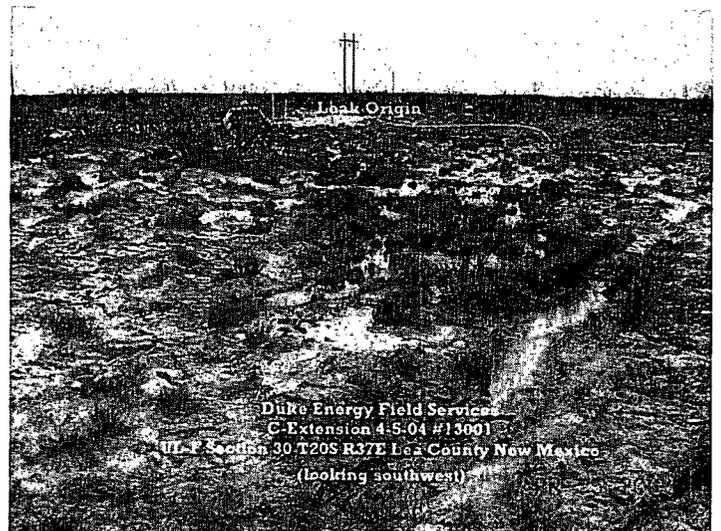
Photo #4: South flow path looking west towards the point of release.

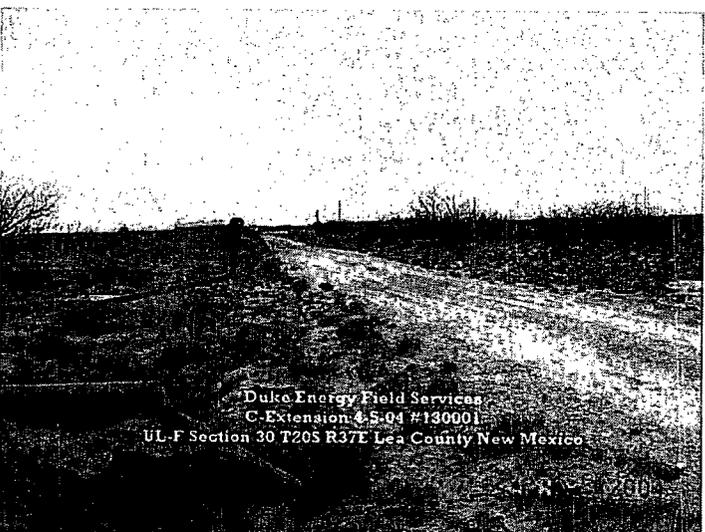
Photo #5: End of north flow path, looking westerly.

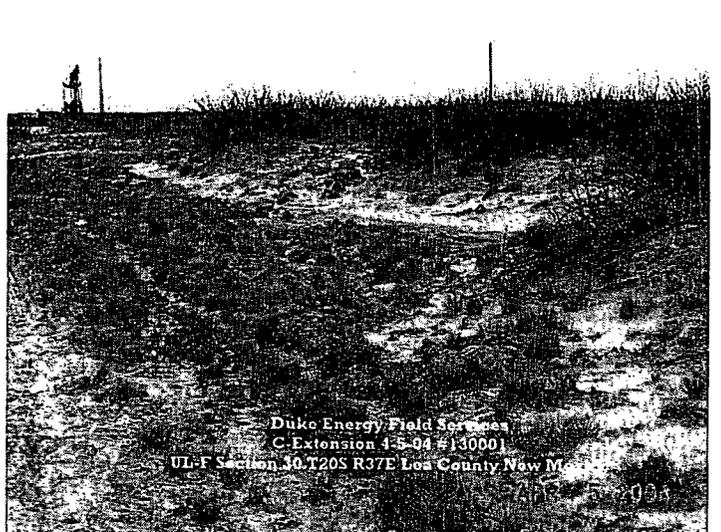
Photo #6: North flow path on north side of service road, looking westerly.

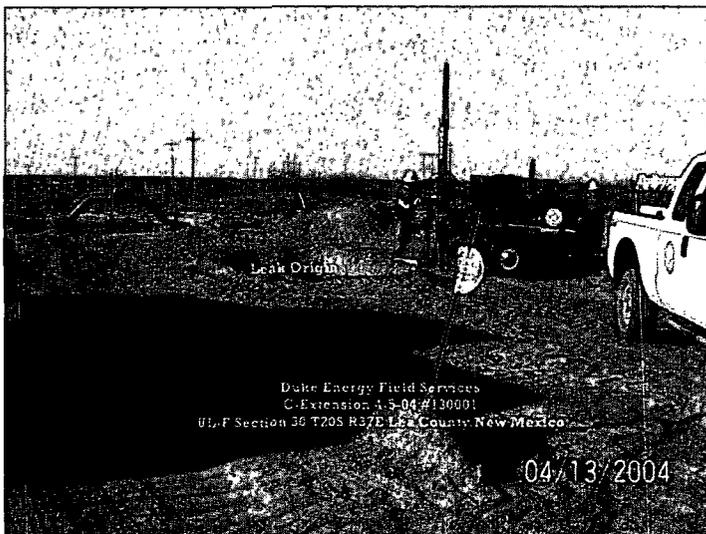
Photo #7: Advancing BH-2, looking southerly.

The vertical extent of hydrocarbon contamination at the site was determined by advancing two soil borings along side the point of release. Field analyses of soil samples collected during the advancement of the soil borings indicated contamination was restricted to the near surface (i.e., <5 feet bgs). Submission of samples to an independent laboratory confirmed the field analyses (reference Table 1).

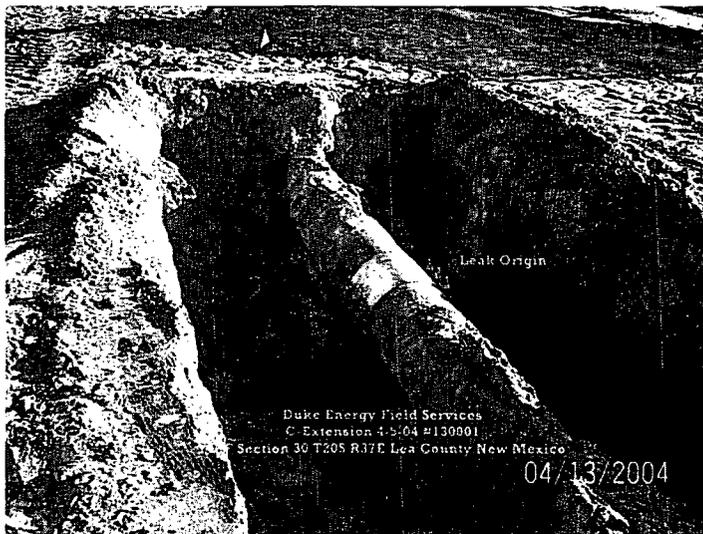
Photo #8: Excavation of the source area, looking southerly.

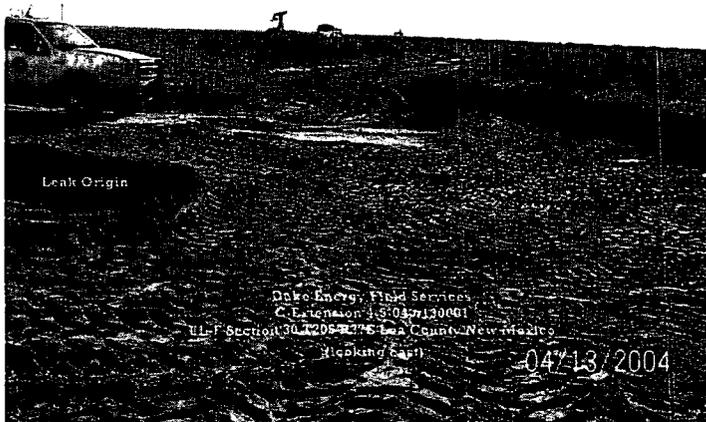
Photo #9: Excavation of source area and south flow path, looking easterly.

Remediation of the site commenced on April 6, 2004 and continued through May 7, 2004. Remedial activities at the site consisted of excavation and disposal of 2,618 yd³ of NGL contaminated soil from the site. The contaminated soil was disposed of at the South Monument Land Farm. After field analyses of soil samples collected from the excavation indicated successful removal of impacted soil, samples were submitted to an independent laboratory to verify remedial goals had been attained. The only analyte that was reported above NMOCD remedial thresholds was chloride in the samples collected from the sidewalls and bottom of the excavation at the point of release. Subsequent conversations with Mr. Larry Johnson of the Hobbs, New Mexico office of the NMOCD resulted in verbal approval of leaving the chloride impacted soil in place and the excavation was backfilled with soil from the surrounding area (i.e., sand dunes). The backfilling and contouring of the site were completed on May 7, 2004.
