From: Hansen, Edward J., EMNRD
Sent: Thursday, July 19, 2012 9:11 AM
To: Hack Conder (hconder@riceswd.com)
Cc: Leking, Geoffrey R, EMNRD; Laura Pena (lpena@riceswd.com); Scott Curtis (scurtis@riceswd.com)
Subject: Remediation Plan (1R425-92) Termination - ROC Vacuum B-5-2 EOL Site

RE: Termination Request
Vacuum B-5-2 EOL (1R425-92): UL/B, Sec. 5, T18S, R35E
RICE Operating Company – Vacuum SWD System

**RICE OPERATING COMPANY
JUNCTION BOX FINAL REPORT**

Vacuum B-5-2 EOL

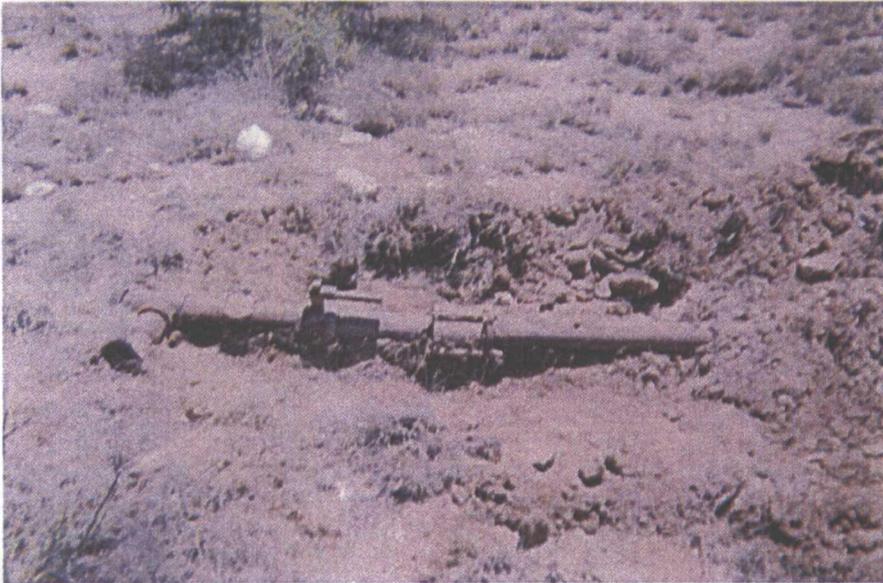
Site prior to delineation

6/21/2010

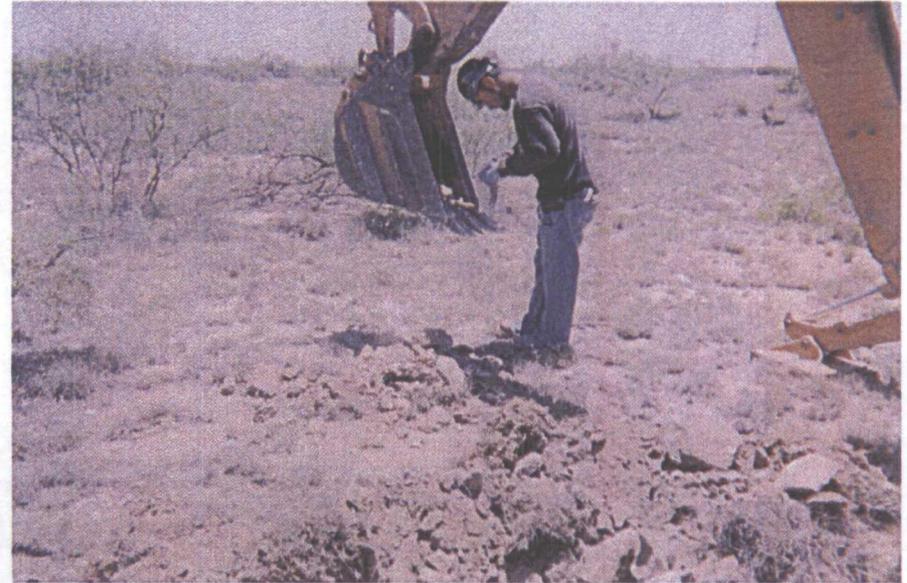
Collecting sample

6/21/2010

General Description of Remedial Action: This junction box was addressed during the Vacuum SWD System abandonment. After the former junction box was removed an investigation was conducted using a backhoe to collect soil sample at regular intervals creating a 3x5x5-ft deep excavation. Each sample was field tested for chlorides and organic vapors which yielded low concentrations similar to that of the background sample.

The deepest sample, 5 ft BGS, was sent to a commercial laboratory for analysis of chloride and TPH which confirmed low concentrations.

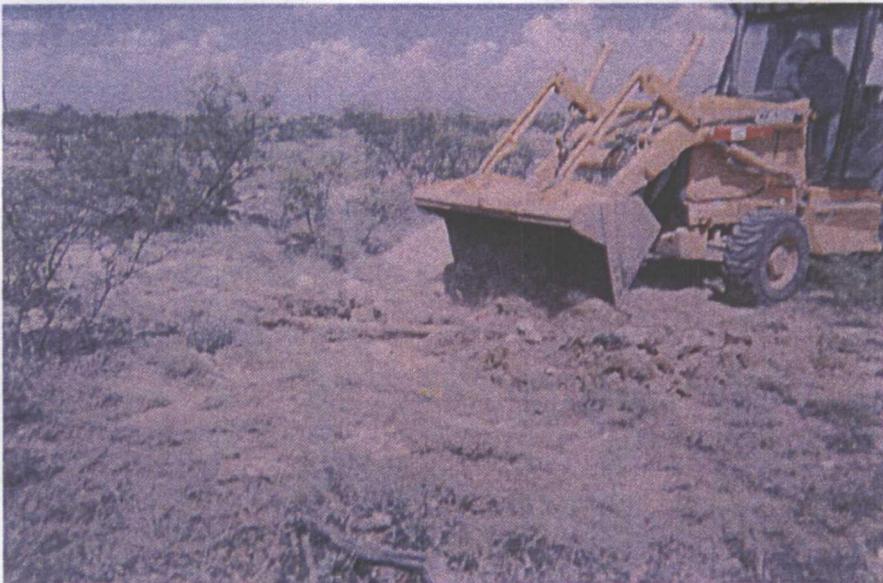
Backfilling excavation

6/21/2010

The excavated soil was returned to the excavation to ground surface and contoured to the surrounding area. On 6/21/2010, the site was seeded with a blend of native vegetation and is expected to return to a productive capacity at a normal rate.

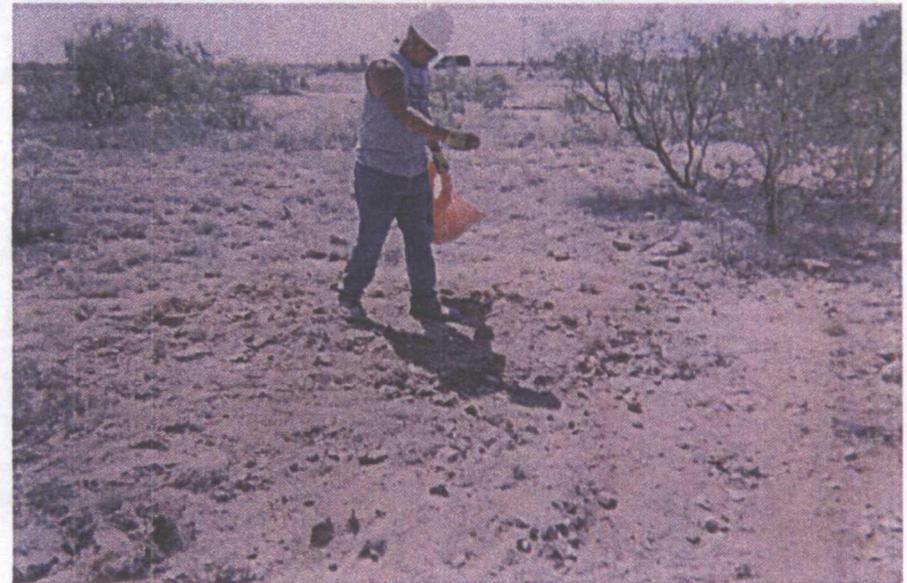
Seeding excavation

6/21/2010
