# WORKPLANS

**INVESTIGATION & CHARACTERIZATION PLAN (ICP)  
EME I-7 EOL  
Unit I, SEC. 7, T19S, R37E, Monument, Lea County, New Mexico  
NMOCD Case #: 1R427-364**

# EME I-7 EOL

Unit I, Section 7, T19S, R37E

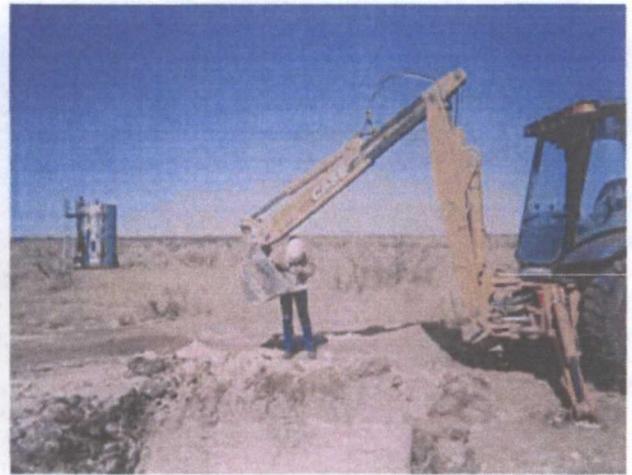
Collecting sample, facing northwest 3.23.11

A five-point wall composite sample was collected from each of the four walls and combined to make a representative four-wall composite sample, and a five-point composite sample was collected from the bottom of the excavation and submitted to Cardinal Laboratories for gasoline range organics (GRO), diesel range organics (DRO) and chloride analysis. DRO was detected at a concentration of 144 milligrams per kilogram (mg/kg) in the four-wall composite sample and 46.8 mg/kg in the five-point bottom composite sample. Chlorides were detected at a concentration of 496 mg/kg in the four-wall composite sample and 48 mg/kg in the five-point composite bottom sample. GRO was not detected in either of the samples.

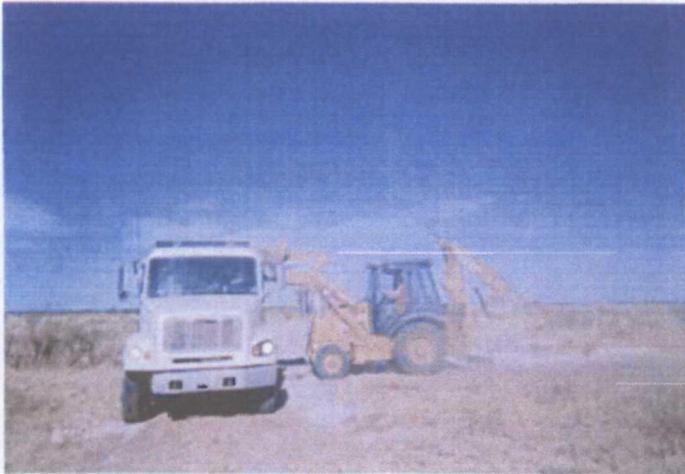
Exporting soil, facing east 4.5.11

Approximately 96 cubic yards of excavated soil was disposed at a NMOCD approved facility. The excavation was backfilled with clean imported soil to ground surface and the area was contoured to the surrounding landscape.

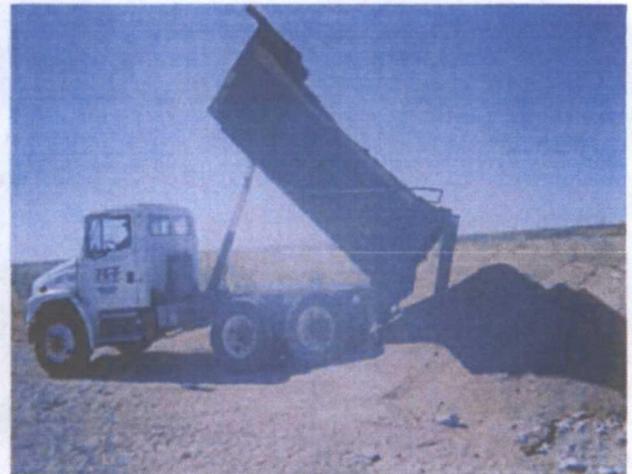
Importing blow sand, facing east 4.8.11

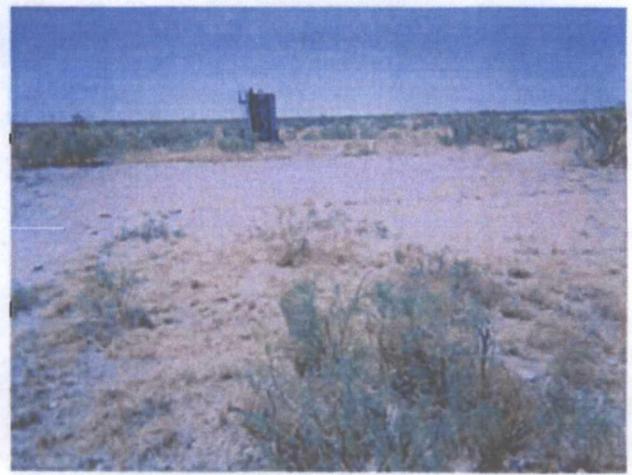
Site completed, facing west 5.12.11
