**From:** Hansen, Edward J., EMNRD  
**Sent:** Wednesday, August 01, 2012 4:42 PM  
**To:** Hack Conder (hconder@riceswd.com)  
**Cc:** Leking, Geoffrey R, EMNRD; Laura Pena (lpena@riceswd.com)  
**Subject:** Remediation Plan (1R425-98) Termination - ROC Vacuum K-26 EOL Site

RE: Termination Request  
Vacuum K-26 EOL (1R425-98): UL/K, Sec. 26, T17S, R35E  
RICE Operating Company – Vacuum SWD System

RICE OPERATING COMPANY  
JUNCTION BOX FINAL REPORT

# Vacuum K-26 EOL

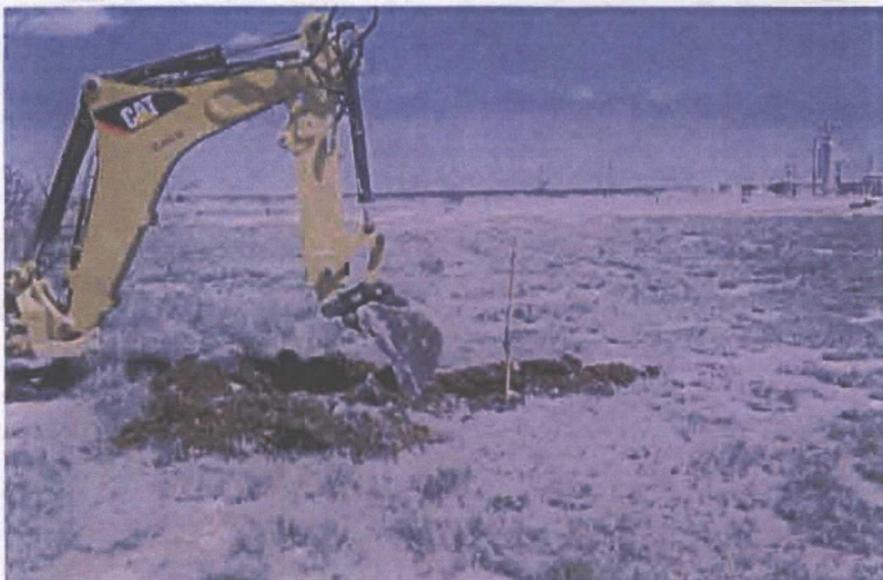
Delineation trench being excavated

4/22/2010

General Description of Remedial Action: This junction box was addressed during the Vacuum SWD System abandonment. After the former junction box was removed an investigation was conducted using a backhoe to collect soil sample at regular intervals creating a 7x3x5-ft deep excavation. Each sample was field tested for chlorides and organic vapors which yielded low concentrations similar to that of the background sample.

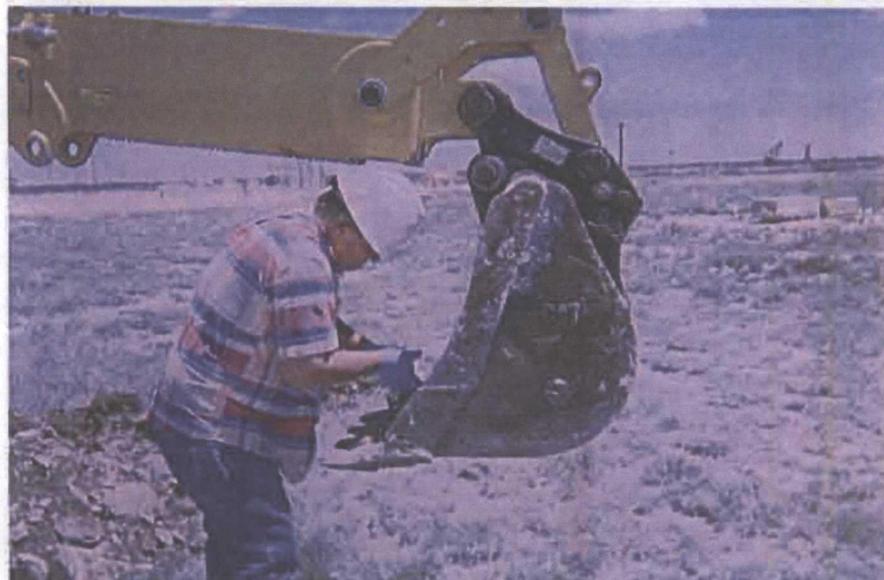
Sample being Collected

4/22/2010

The deepest sample, 5 ft BGS, was sent to a commercial laboratory for analysis of chloride and TPH which confirmed low concentrations

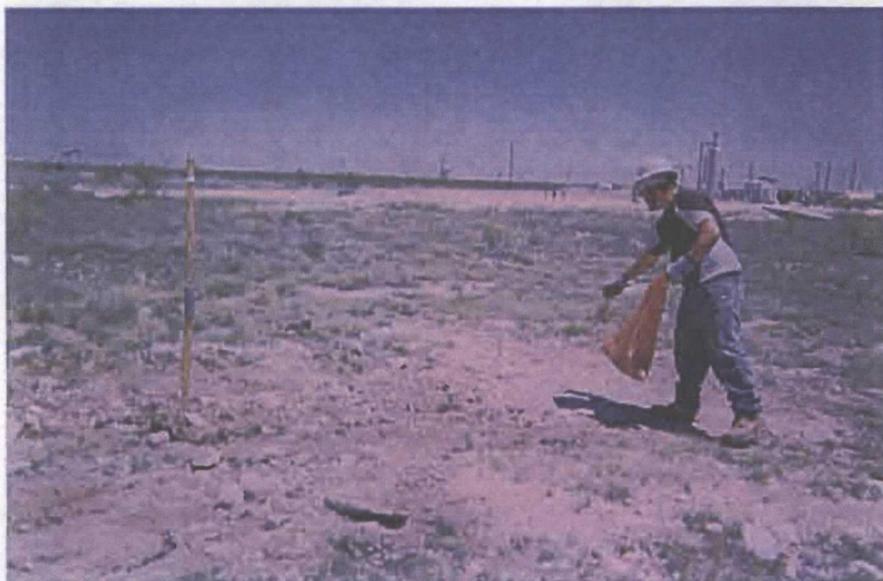
Excavation being seeded

5/11/2010

The excavated soil was returned to the excavation to ground surface and contoured to the surrounding area. On 5/11/2010, the site was seeded with a blend of native vegetation and is expected to return to a productive capacity at a normal rate.

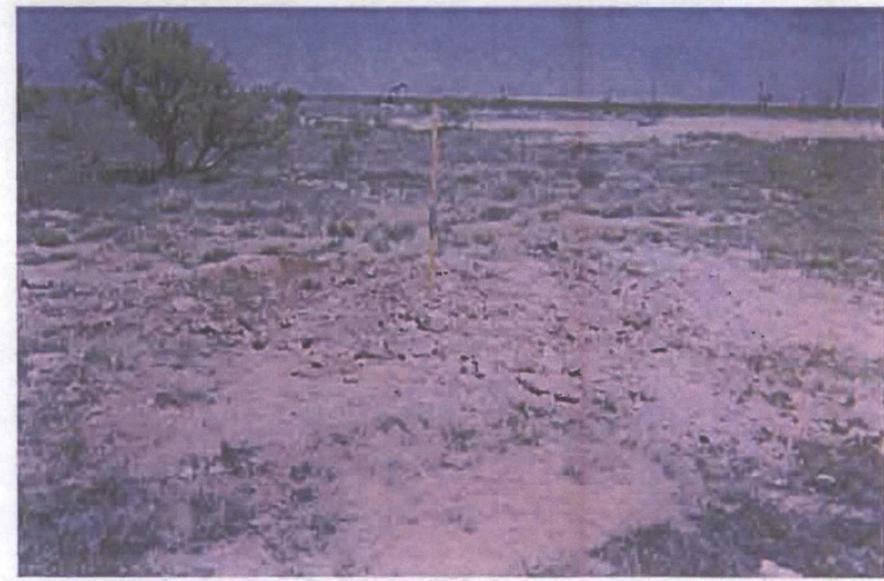
Excavation complete

5/11/2010
