**RE: Corrective Action to Groundwater Report and Termination Request  
Rice Operating Company – EME SWD System  
EME K-6 leak (1RP-2552): UL/K sec. 6 T20S R37E**

**EME K-6 leak  
Unit Letter K, Section 6, T20S, R37E**

EME K-6 leak (1RP-2552)  
Unit Letter K, Section 6, T20S, R37E

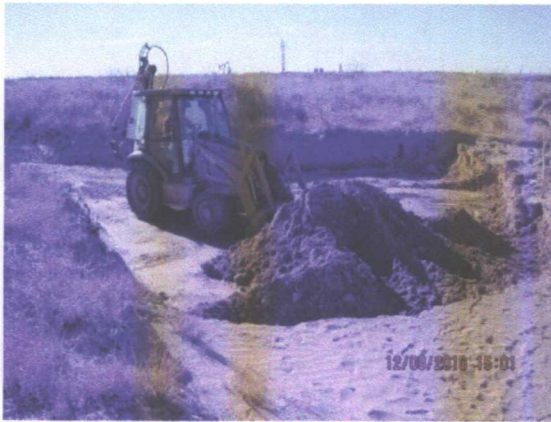
excavating the site

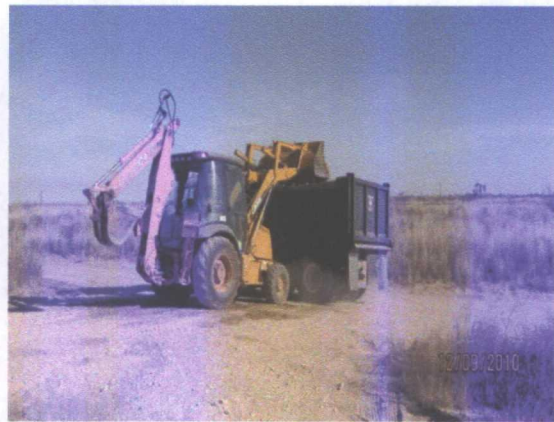
hauling excavated soil to Sundance for disposal

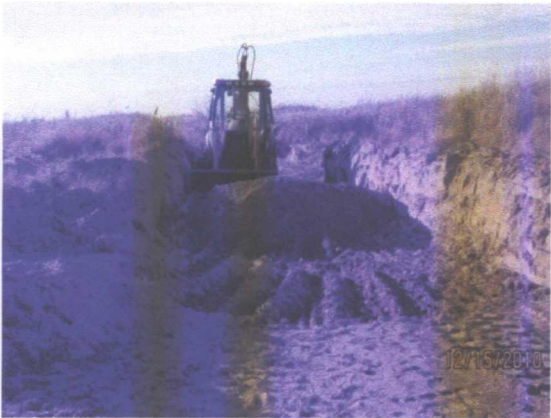
excavating the site

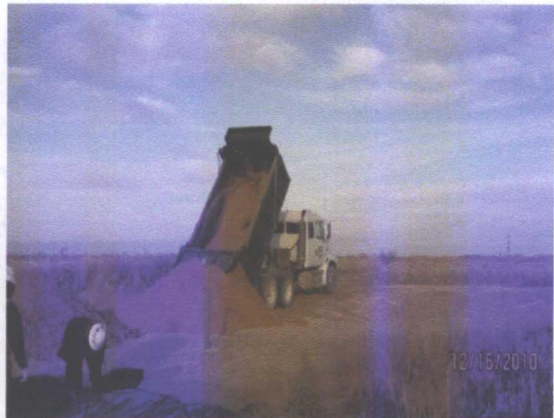
importing blow sand

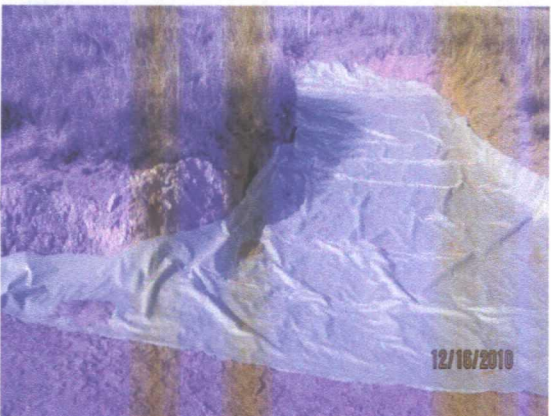
installing the plastic liner

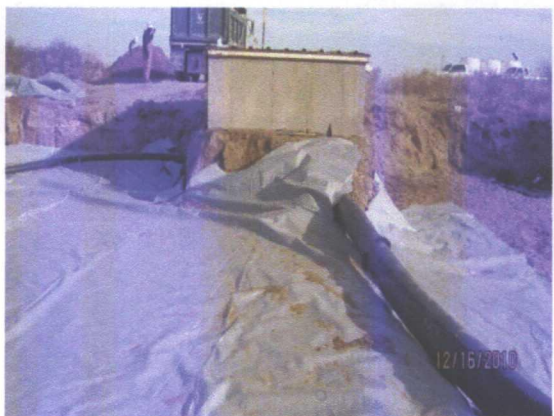
installing the plastic liner

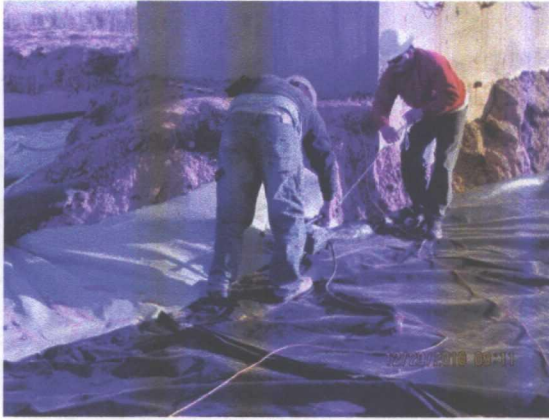
seaming the liners together

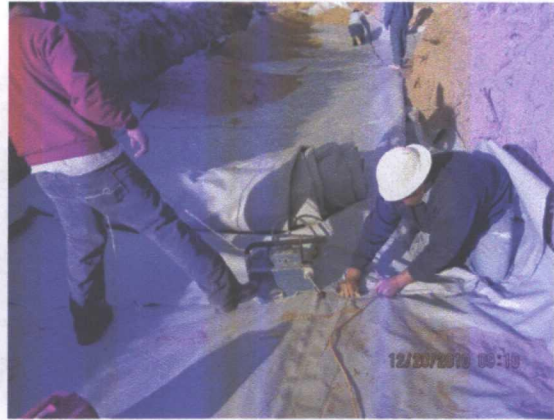
seaming the liners together

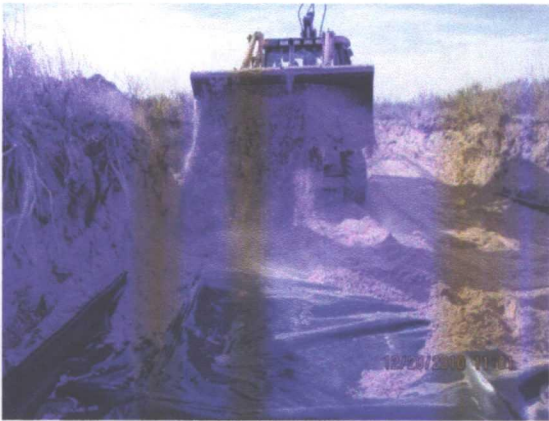
padding the liner with blow sand

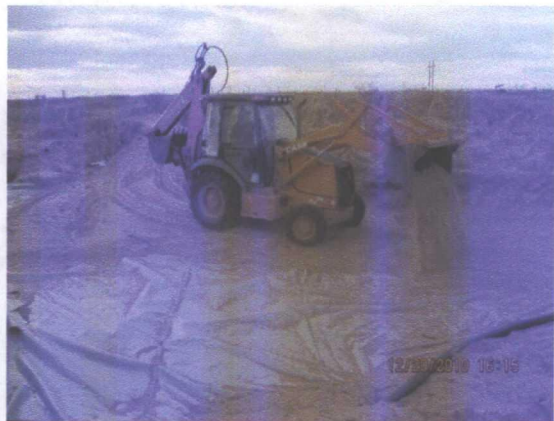
padding the liner with blow sand

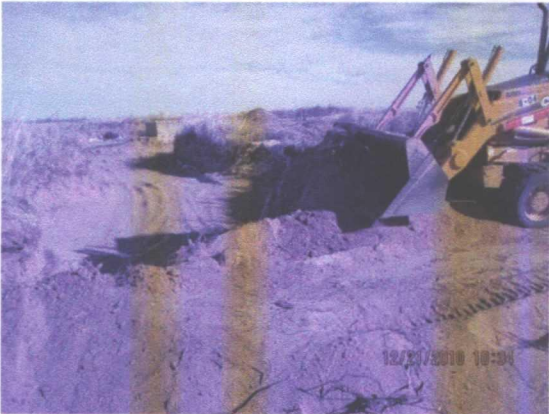
backfill the site with surrounding dunes

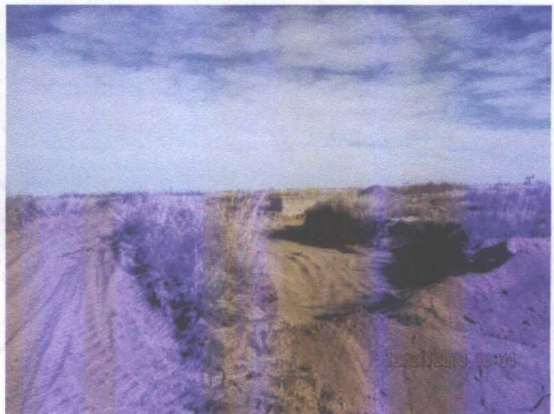
scraping the vegetation from the sand dunes

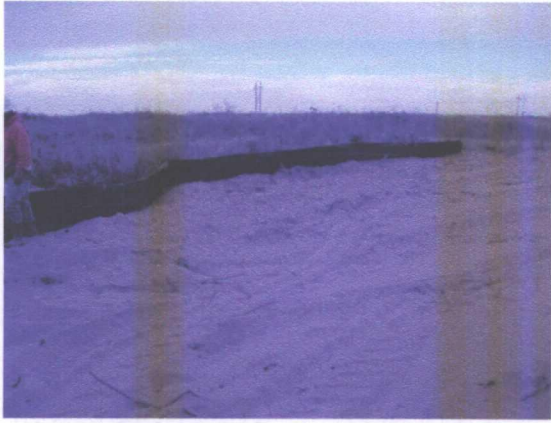
placing the fence with silk netting around site

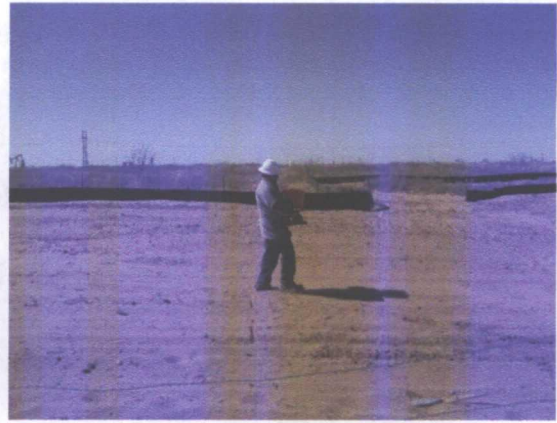
seeding the backfilled site

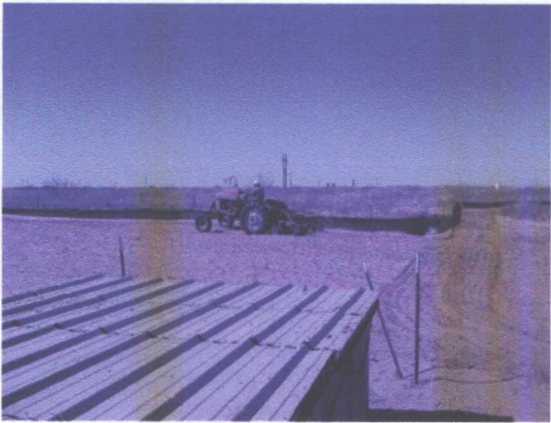
disking the site

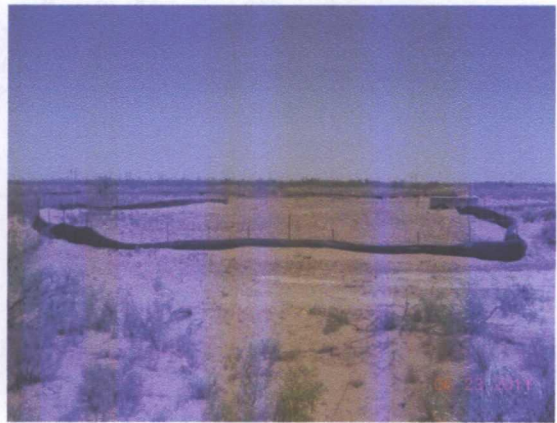
completed site work
