## Loco Federal #1 Central Battery

### Closure Report

2RP-1131

**RE: TERMINATION REQUEST**  
**Apache – Loco Federal #1 Central Battery AD**  
**UL/B sec. 21 T17S R30E**  
**API No. 30-015-30144**  
**2RP-1131**

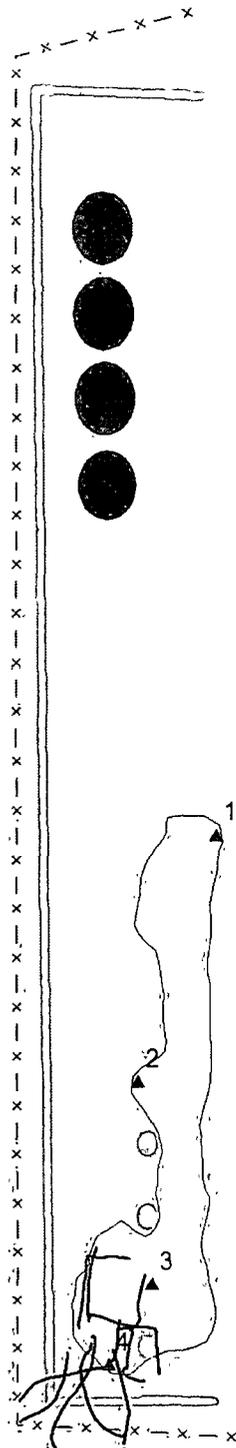
Figure 1

On December 6, 2011, RECS personnel initiated work at the Loco Federal #1 Central Battery (Figure 1). Soil samples were collected from the site at ground surface and at 6 inches below ground surface (bgs), and field tested for chloride. Headspace measurements were also taken in the field using a Photo Ionization Detector (PID). The samples were submitted to a commercial laboratory for chloride and TPH (GRO/DRO) analyses (Appendix C). Chloride ranged from 48 ppm (parts per million or mg/kg) to 6,960 ppm. GRO ranged from 21.4 ppm to 13,500 ppm and DRO ranged from 74.3 ppm to 15,100 ppm.

## INITIAL SAMPLING LAB DATA

Sample Description	Cl-	GRO	DRO
PT 1 SURFACE	112	8,820	14,600
PT 1 @6"	48	21.4	93.5
PT 2 SURFACE	432	13,500	15,100
PT 2 @6"	336	81.3	262
PT 3 SURFACE	4,960	10,900	14,200
PT 3 @6"	928	23.3	124
PT 4 SURFACE	6,960	8,500	10,500
PT 4 @6"	640	23.8	74.3

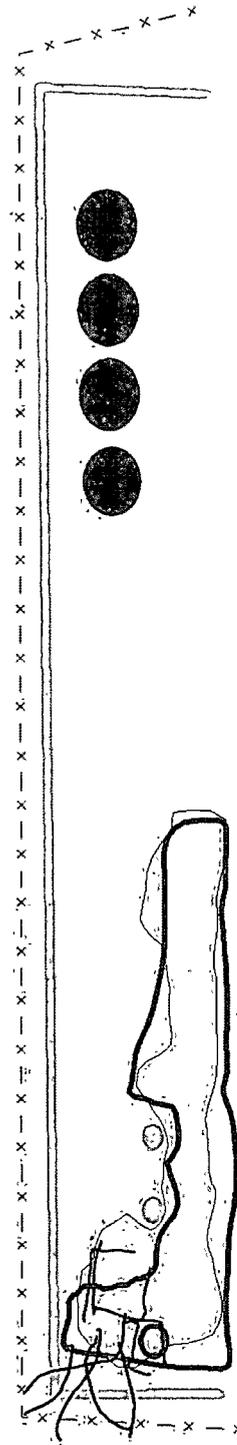
**Figure 2**

The leak area was excavated to 1 ft. bgs (Figure 2). On December 20, 2011, RECS personnel collected and field tested representative grab samples from the excavation walls and a composite sample from the excavation bottom. The samples were submitted to a laboratory for analyses (Appendix C). The walls contained 16.0 ppm chloride and <10.0 ppm TPH with the exception of the E Wall S End sample (368 ppm chloride, 758 ppm TPH). The excavation bottom contained 64.0 ppm chloride and 17.1 ppm TPH.

## FINAL EXCAVATION LAB DATA

Sample Description	Cl-	GRO	DRO
E WALL N END	16	<10.0	<10.0
E WALL S END	368	<50.0	.758
N WALL CENTER	16	<10.0	<10.0
S WALL CENTER	16	<10.0	<10.0
W WALL S END	16	<10.0	<10.0
W WALL N END	192	<10.0	<10.0
5 PT. BOTTOM. COMP @ 1'	64	<10.0	17.1

Scrape.  
112' x 19' x 1'

Impacted soils were removed from the excavation and transported to a NMOCD approved disposal facility. The excavation was backfilled with clean caliche and leveled. See Appendix B for photographs of field activities.

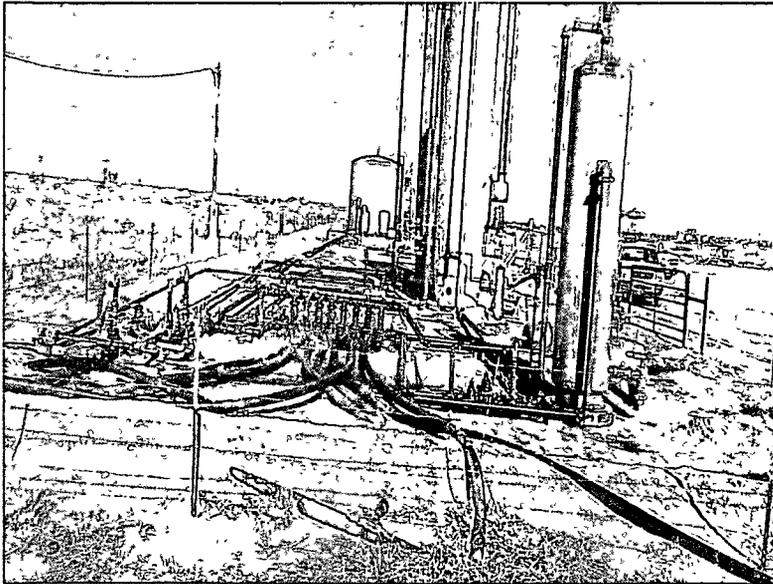
Initial release, facing north

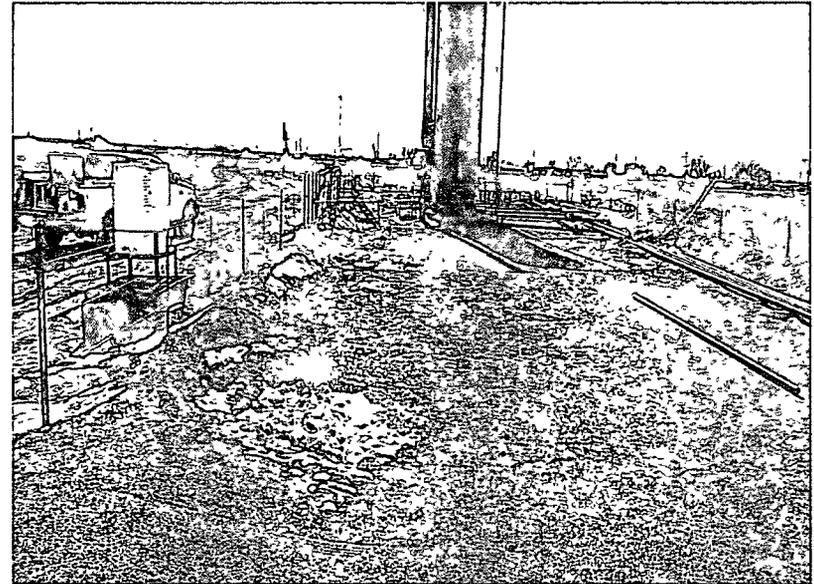
Initial release, facing south

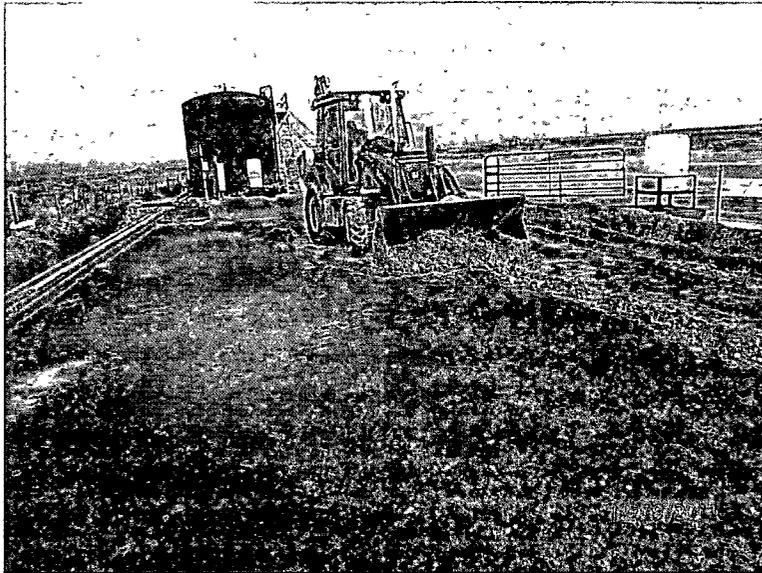
Scraping leak, facing north

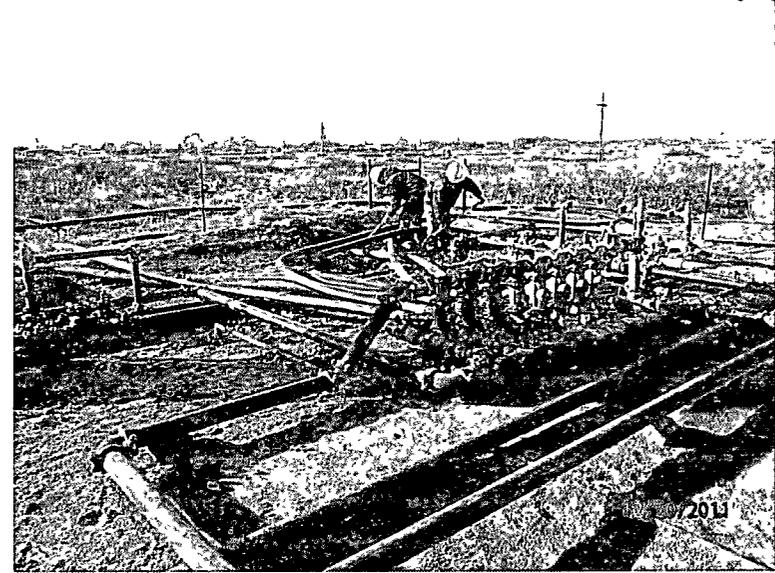
Excavating by hand, facing southwest

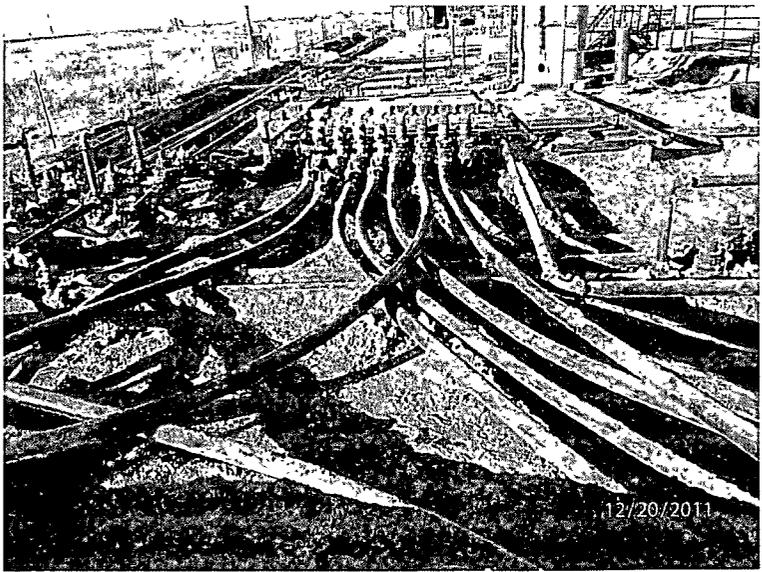
Final excavation, facing north

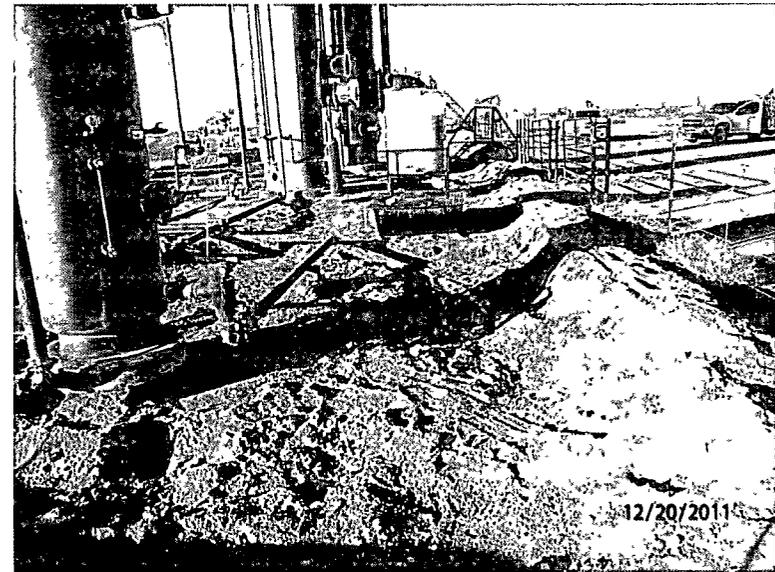
Final excavation, facing north

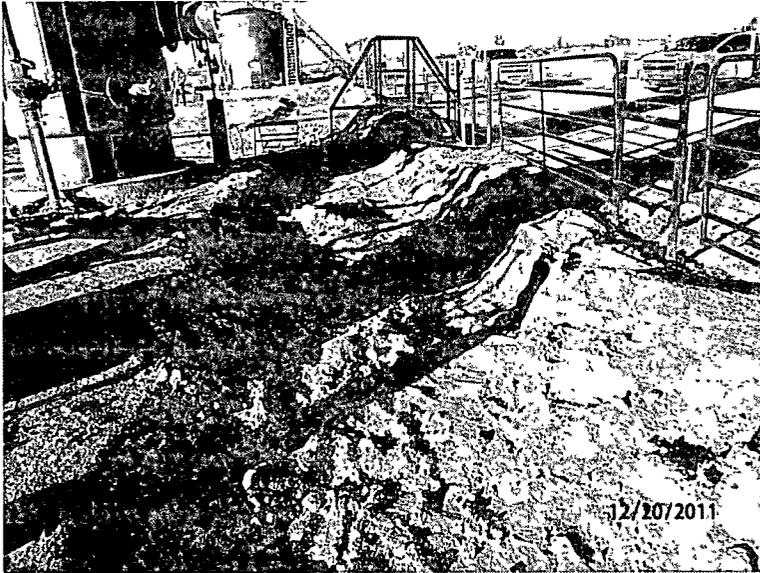
Final excavation, facing north

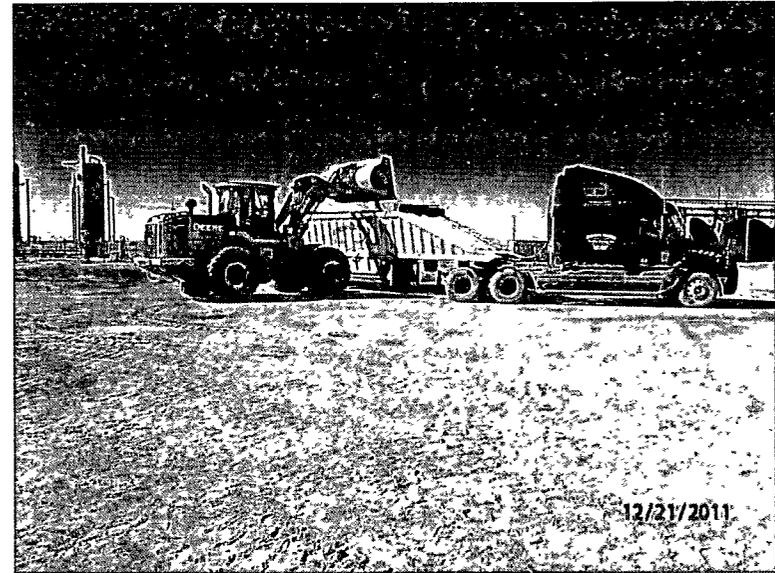
Exporting soil, facing west

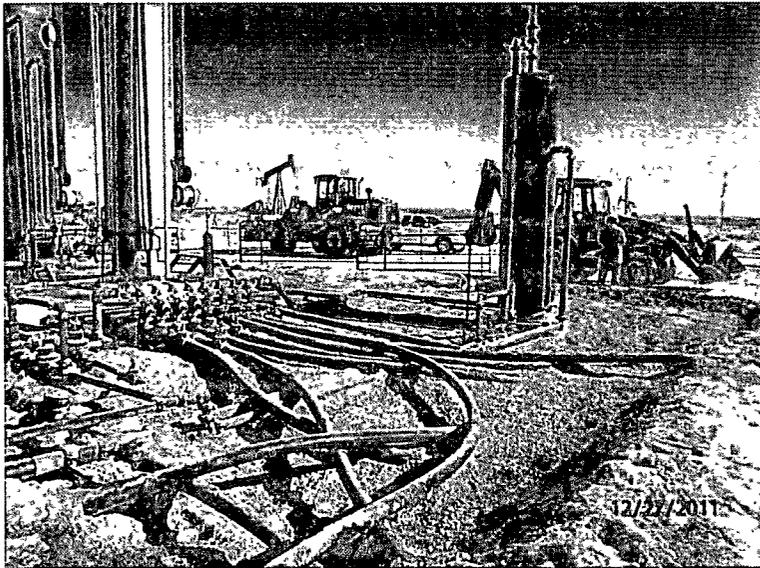
Excavation backfilled, facing east

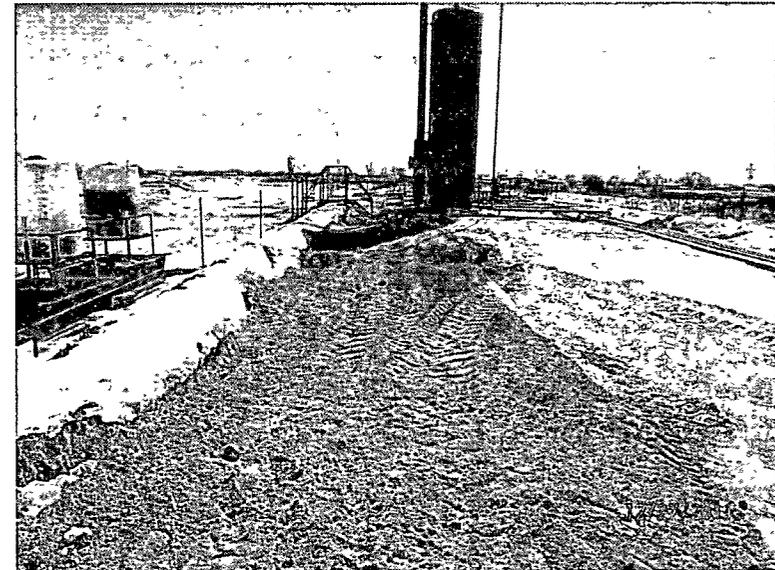
Excavation backfilled, facing south

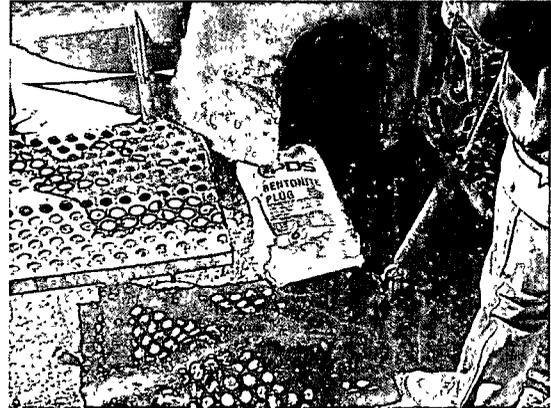
Completed temporary monitor well

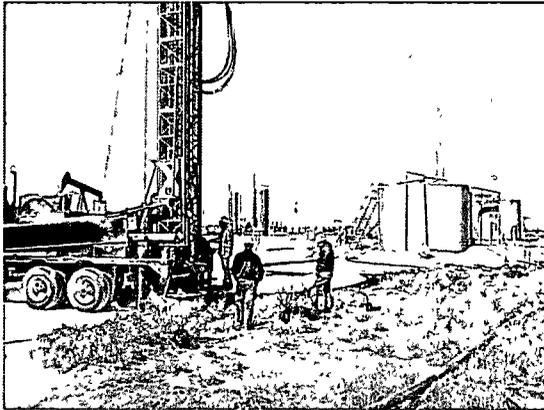
Drilling the temporary monitor well

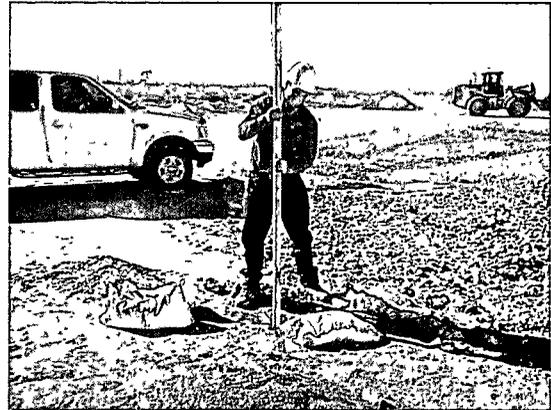
Pulling the casing from well, facing east 5/11/11

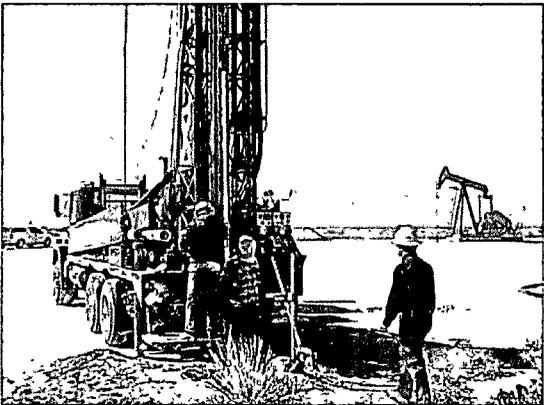
Inserting the casing into the well

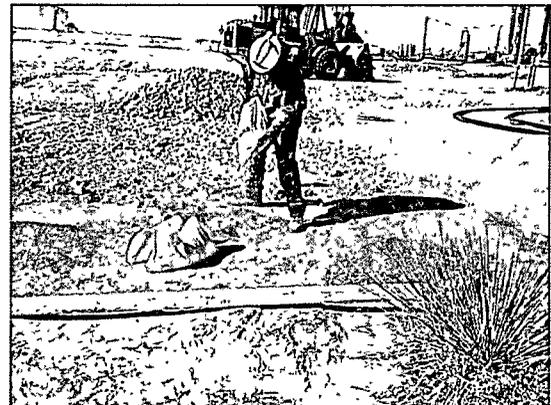
Plugging the well in total with bentonite, facing east 5/11/11
