From: Hansen, Edward J., EMNRD
Sent: Wednesday, September 12, 2012 3:16 PM
To: Hack Conder (hconder@riceswd.com)
Cc: Leking, Geoffrey R, EMNRD; Laura Pena (lpena@riceswd.com); Katie Jones <kjones@riceswd.com> (kjones@riceswd.com); Scott Curtis (scurtis@riceswd.com)
Subject: Remediation Plan (1R425-45) Termination - ROC Vacuum Jct M-35 Site

**RE: Update Report and Termination Request
Rice Operating Company – BD SWD System
Vacuum Jct. M-35 (1R425-45): UL/M sec. 35 T17S R35E**

**RICE OPERATING COMPANY
JUNCTION BOX FINAL REPORT**

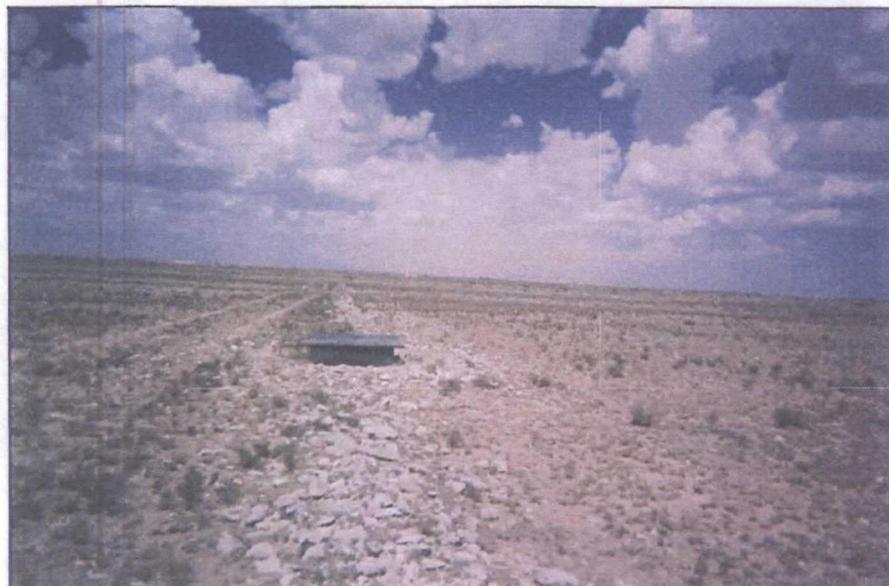
Vacuum jct. M-35

undisturbed junction box

8/4/2003

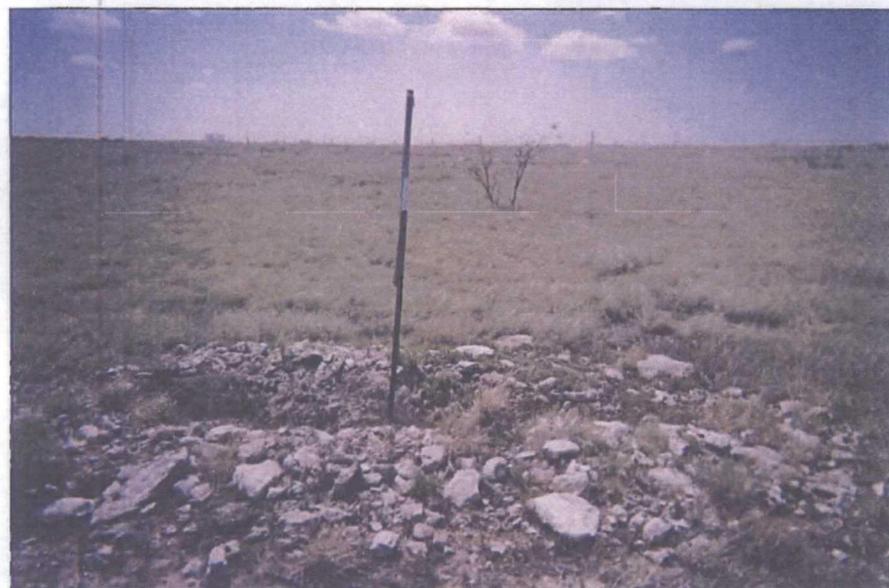
junction box removed; samples collected

7/18/2007

After the box lumber was removed from the former site, the site was inspected and the surrounding soils did not exhibit any signs

of adverse impact from the junction. Soil samples were collected using a hand auger and chloride field tests were conducted on them.

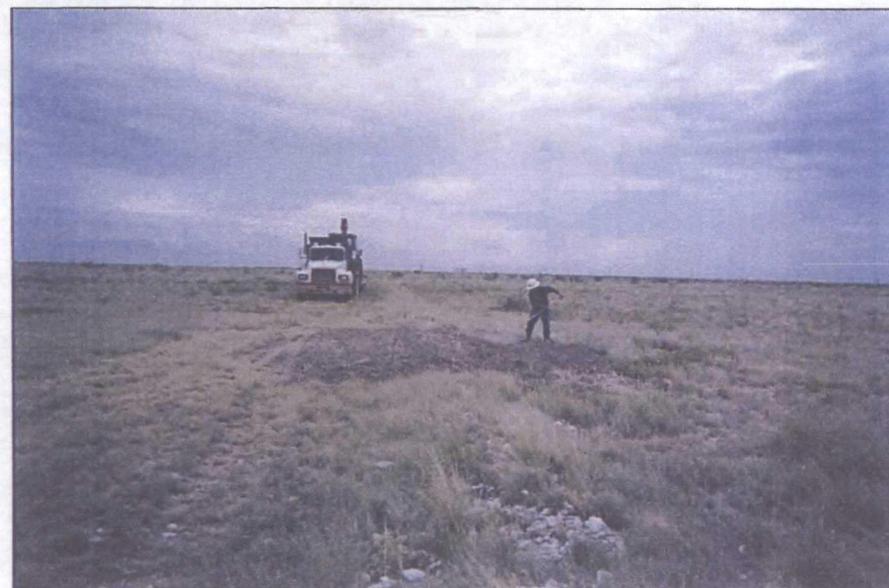
seeding clean, backfilled soil

8/17/2007

former junction box was backfilled with clean, imported soil and contoured to the surrounding surface. The surface was seeded with a blend

of native vegetation on 8/17/2007 and is expected to return to productive capacity at a normal rate.

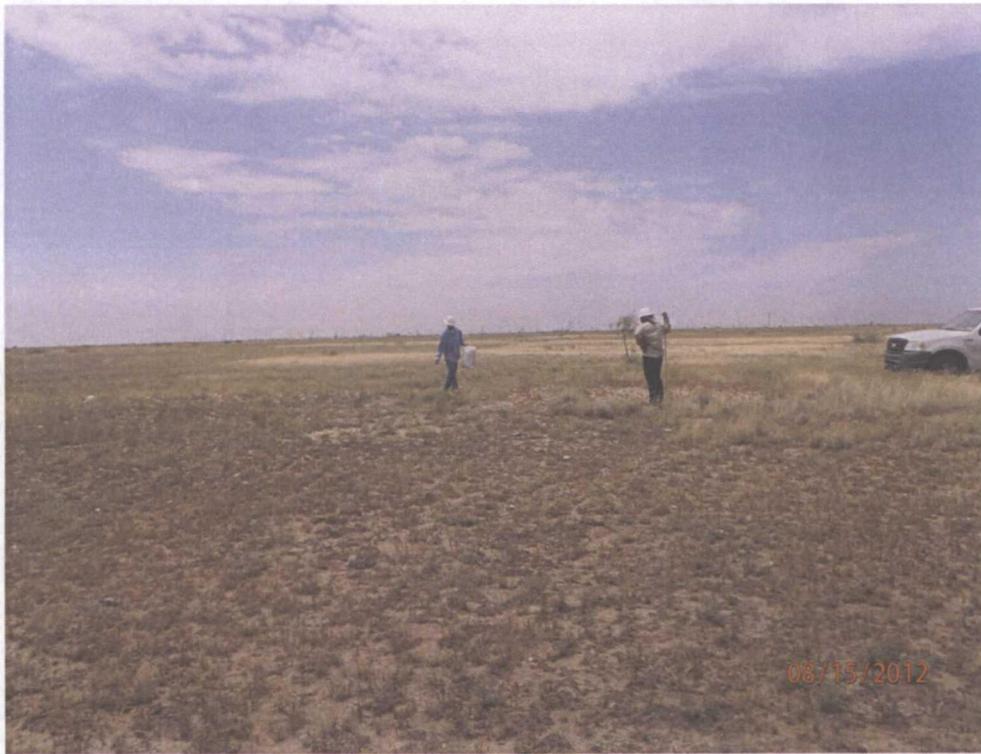
Seeding site, facing southwest

8/15/2012

On March 1st, 2012, NMOCD requested ROC initiate infiltration mitigation via revegetation of the site. On August 15th, 2012, RECS personnel were on site to seed the surrounding area. The site was seeded with a blend of native vegetation and is expected to return to productive capacity at a normal rate (Appendix B).

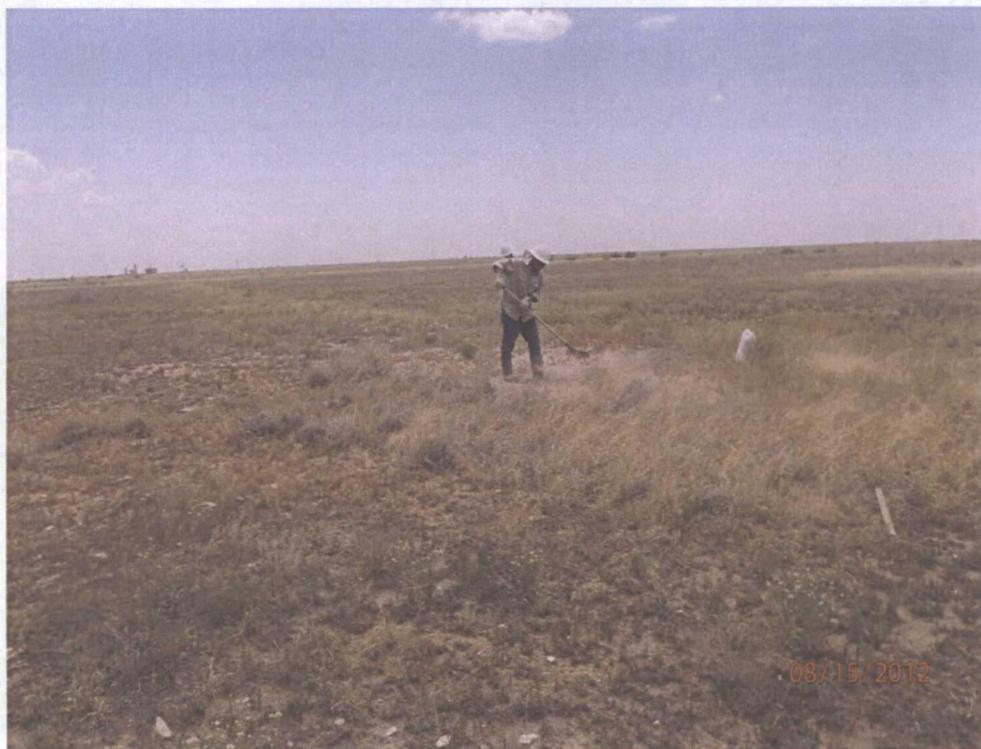
Raking in seed, facing south

8/15/2012

Custom seed mix <input checked="" type="checkbox"/>	Prescribed mix <input type="checkbox"/>	Seed mix name: 1 lb side oats grama 1 lb blue grama	Seeding date: 8/15/2012
Broadcast <input checked="" type="checkbox"/>			
Method: hand broadcast			
Soil conditions during seeding: Dry <input checked="" type="checkbox"/> Damp <input type="checkbox"/> Wet <input type="checkbox"/>			
Photos attached <input type="checkbox"/>	Observations: Seed was raked into soil.		
Number of photos:
