REMEDIATION SUMMARY &

SOIL CLOSURE REQUEST

**PLAINS PIPELINE, LP
CHEVRON GRAYBURG 6-INCH SEC. 6 (HISTORICAL)
Plains SRS Chevron Grayburg 6-Inch Historical
Lea County, New Mexico
Unit Letter "B" (NW/NE), Section 6, Township 18 South, Range 35 East
Latitude 32. 7810858° North, Longitude 103.4924927° West
NMOCD Reference #1RP-2637**

August 2012

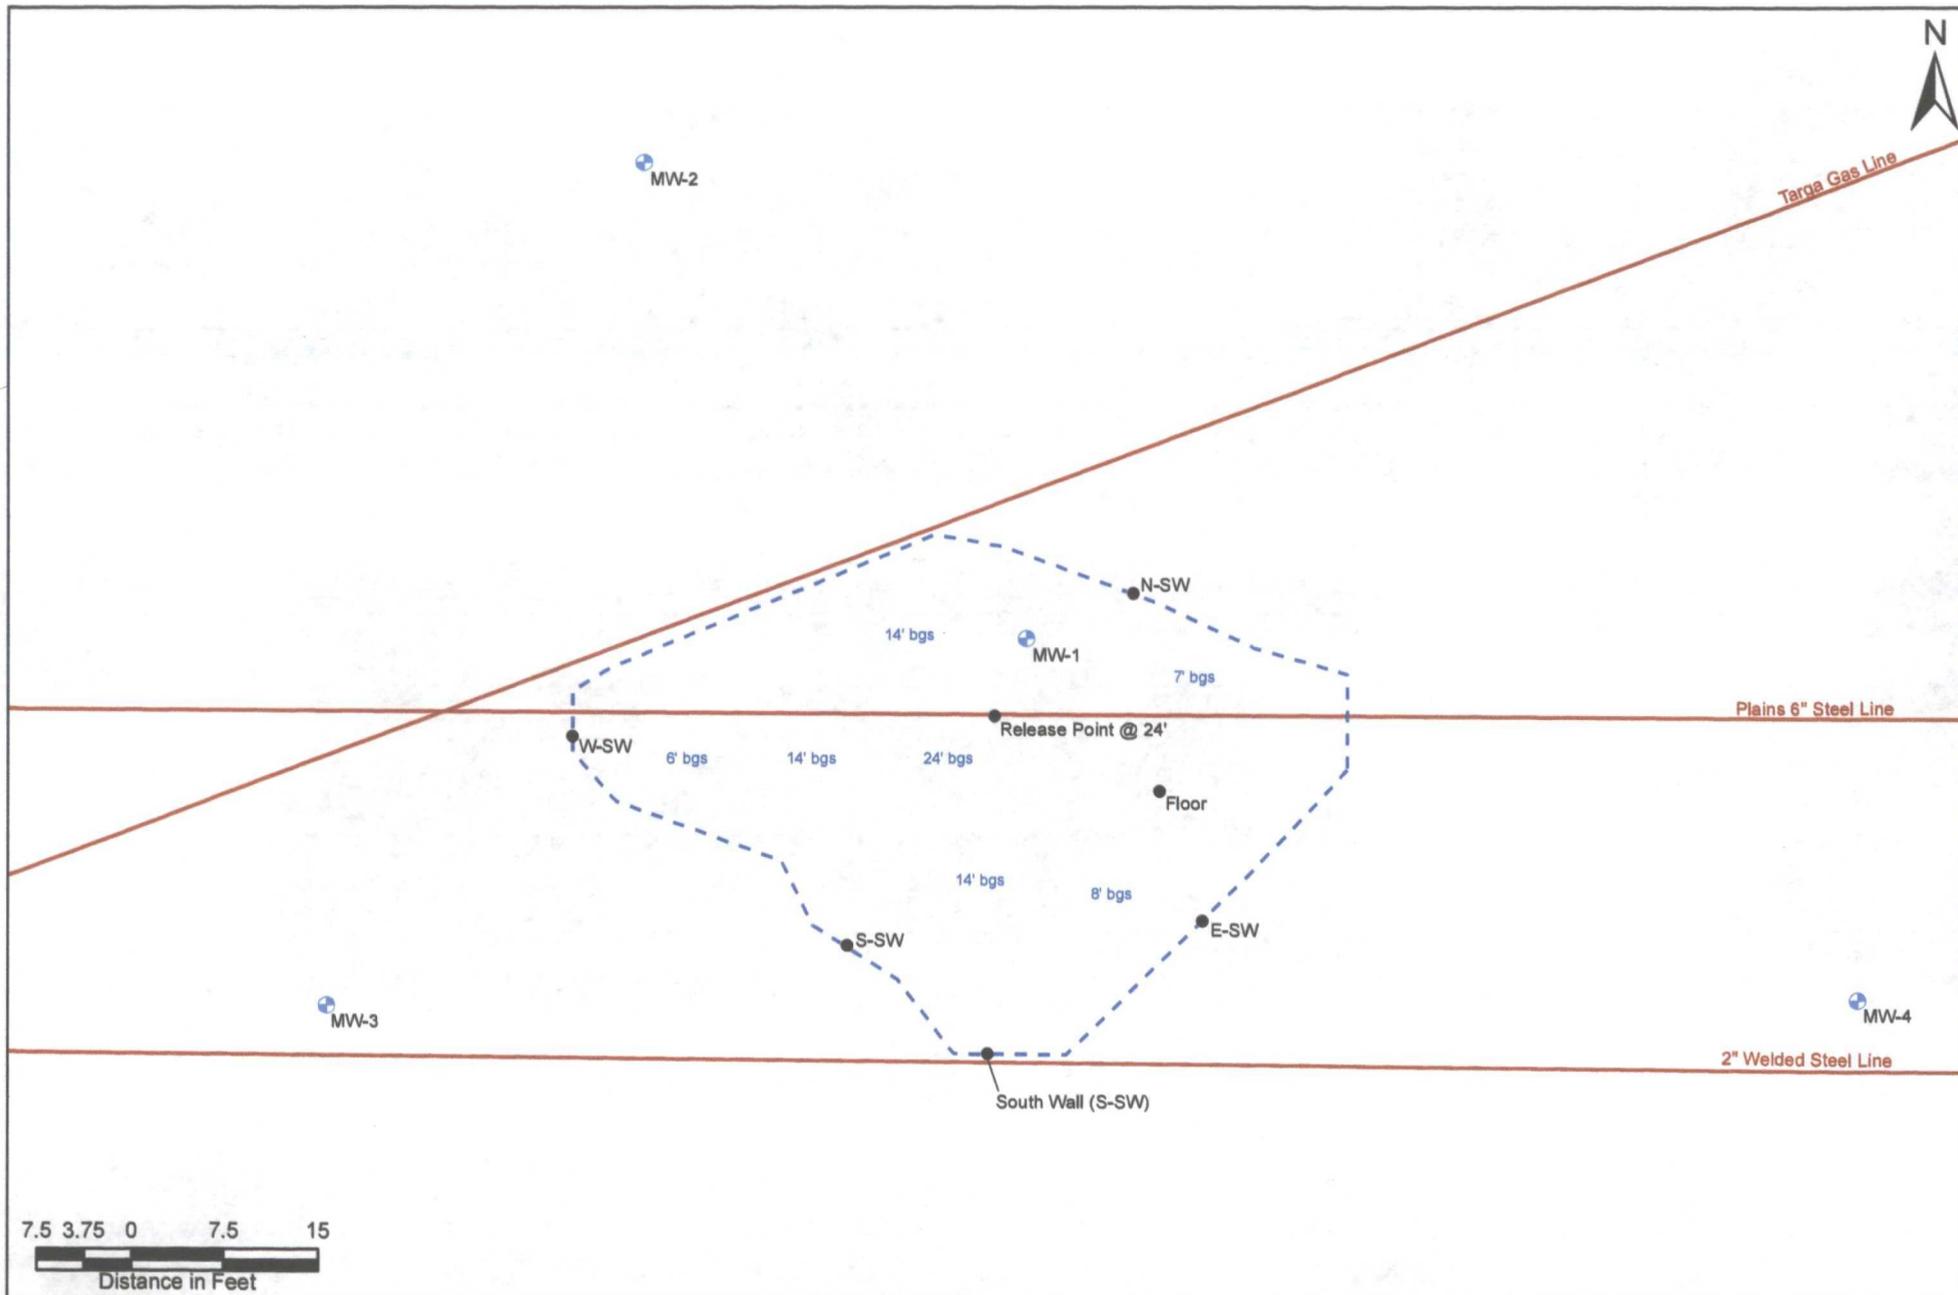
Figure 2
Site & Sample Location Map
Plains Pipeline, LP
Chevron Grayburg 6-Inch Sec. 6 (Historical)
Lea County, New Mexico
SRS #: Chevron Grayburg 6-Inch Historical
NMOCD Ref. #: 1RP-2637

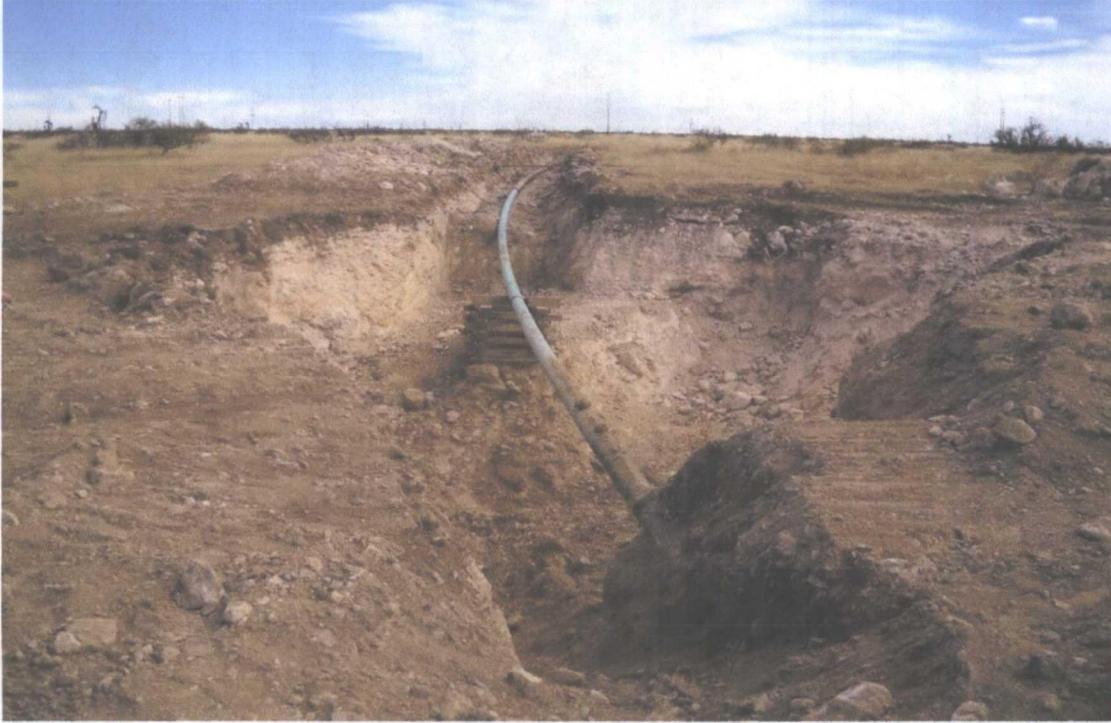
Chevron Grayburg 6-Inch Sec. 6 (Historical) - Release Site (Looking East)

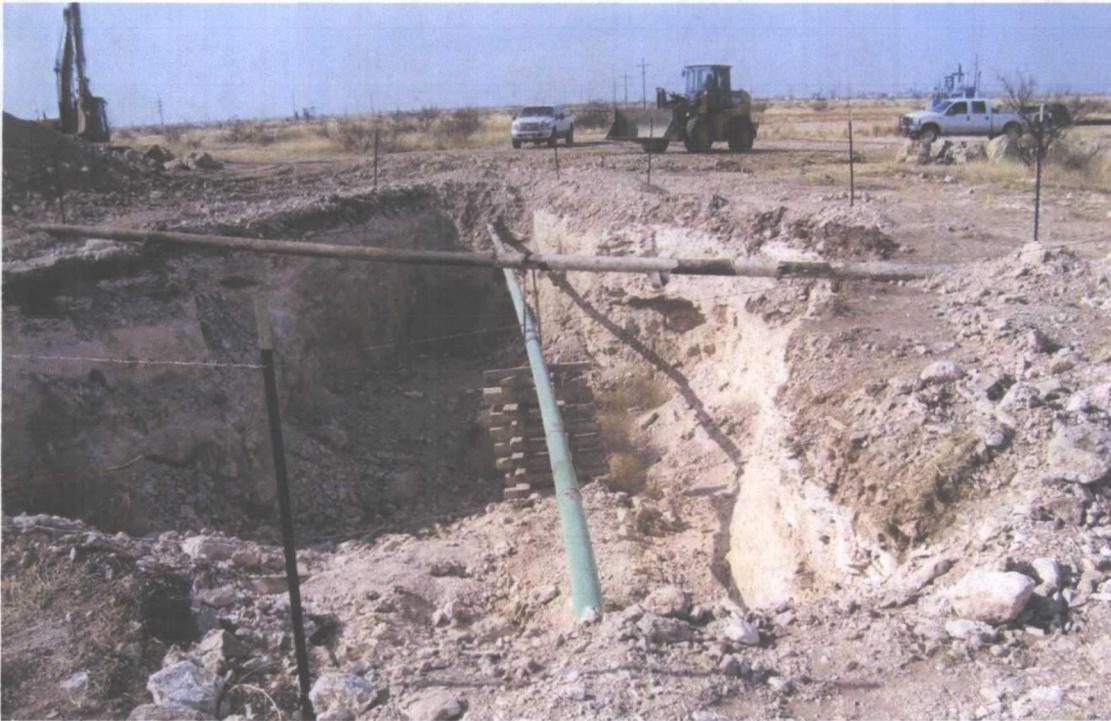
Chevron Grayburg 6-Inch Sec. 6 (Historical) - Release Site (Looking West)

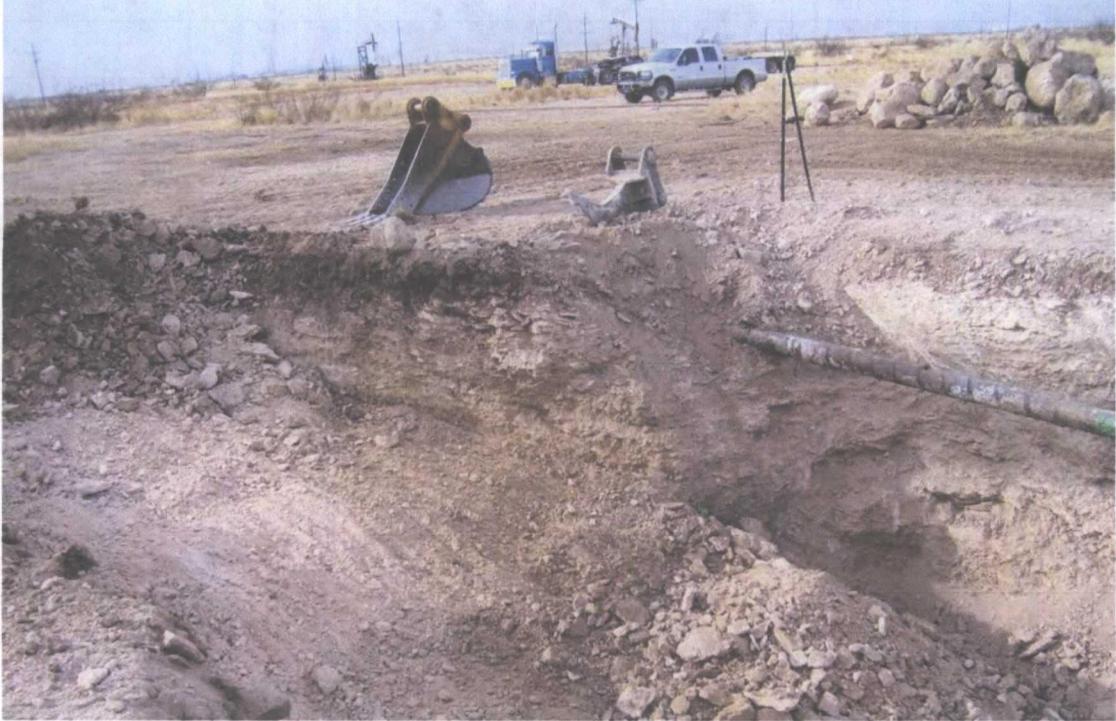
Chevron Grayburg 6-Inch Sec. 6 (Historical) - Release Site (Looking Northwest)

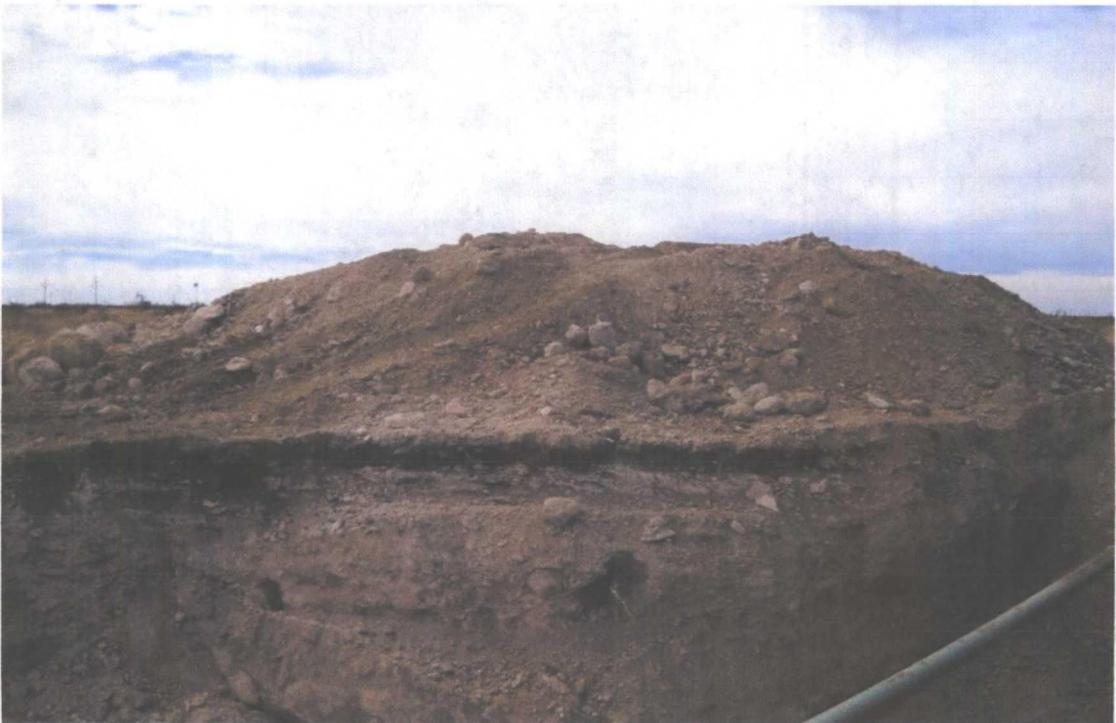
Chevron Grayburg 6-Inch Sec. 6 (Historical) - Stockpile (From Initial Response Activities)

On October 8, 2010, Plains was notified of a release on the Chevron Grayburg 6-inch pipeline. During line replacement activities, an excavator struck a tee connected to the pipeline, resulting in a release of crude oil. The released fluid pooled in the trench next to the pipeline. During initial response activities, a temporary pipe clamp was utilized to mitigate the release, and a vacuum truck was employed to recover free-standing liquid. Heavily impacted and visibly stained soil was excavated and stockpiled on-site, pending final disposition.

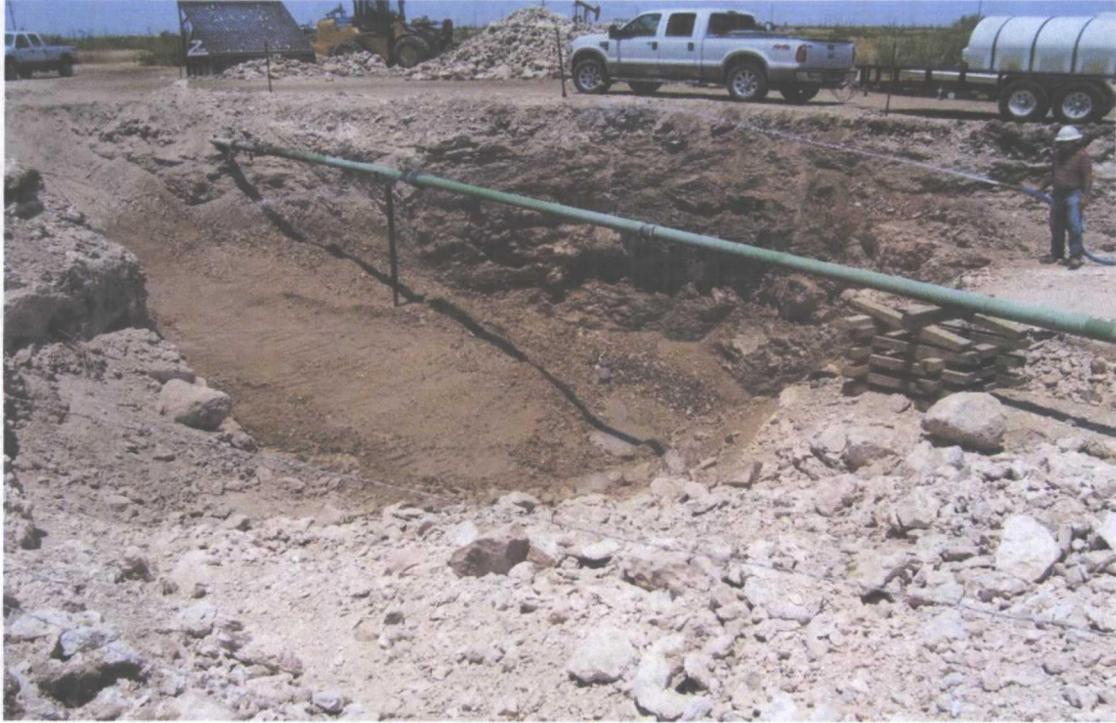
**Chevron Grayburg 6-Inch Sec. 6 (Historical) - Excavation
(Prior to Backfilling; Z-Screen & Screened Stockpile Visible in Background)**

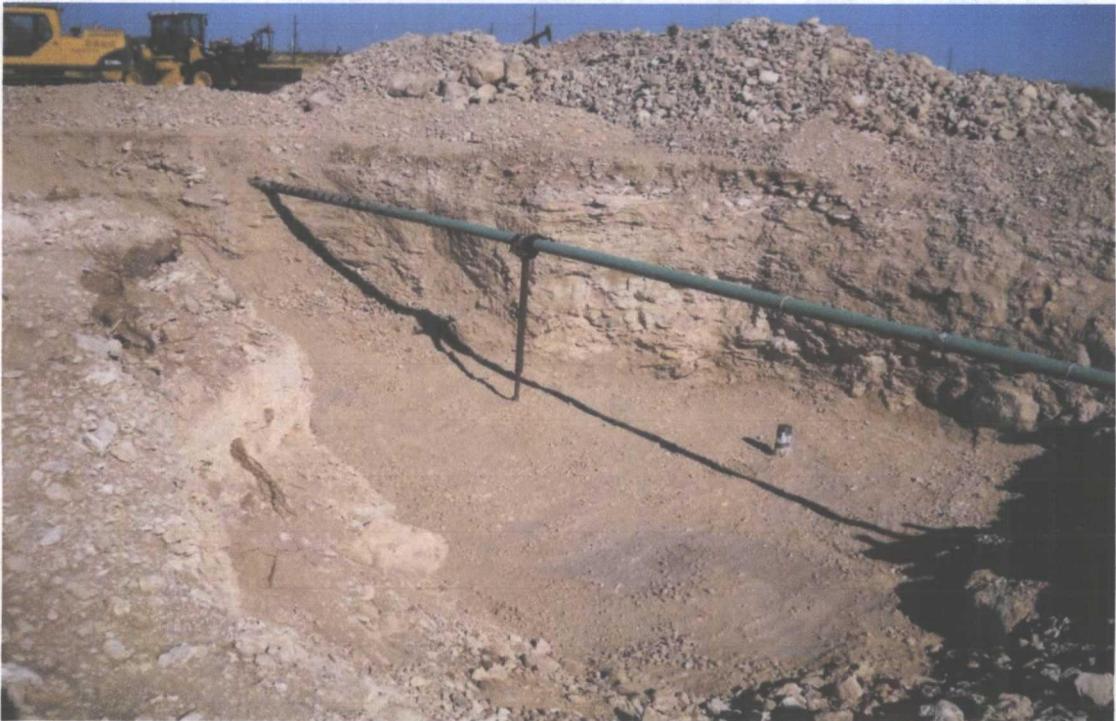
Chevron Grayburg 6-Inch Sec. 6 (Historical) - Excavation (Prior to Backfilling) & PVC Boot

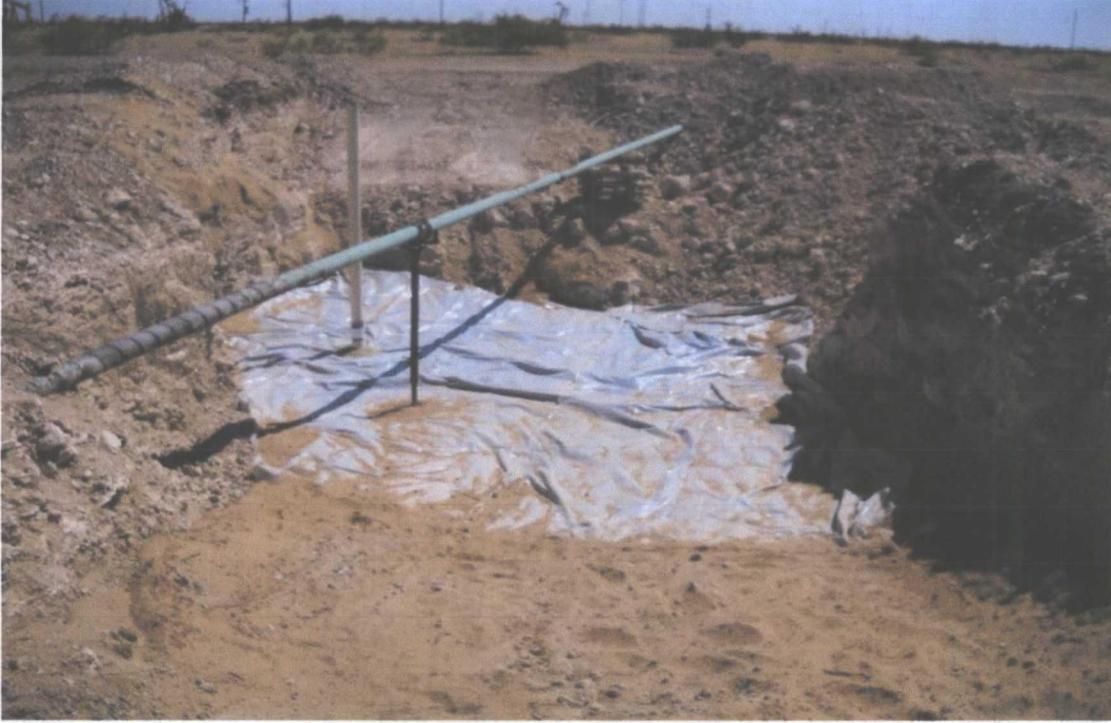
Chevron Grayburg 6-Inch Sec. 6 (Historical) - Excavation
(Following Installation of 20-mil Liner & PVC Conduit)

An impermeable, twenty (20) mil polyurethane liner was installed on the floor of the excavation prior to backfilling. This engineered control will inhibit vertical migration of contaminants from below the liner to the surface, protecting the vegetative zone. In addition, the polyurethane liner will shed moisture to the edge of the liner and beyond the maximum horizontal extent of underlying impacted soil, effectively inhibiting vertical migration of contaminants to groundwater.

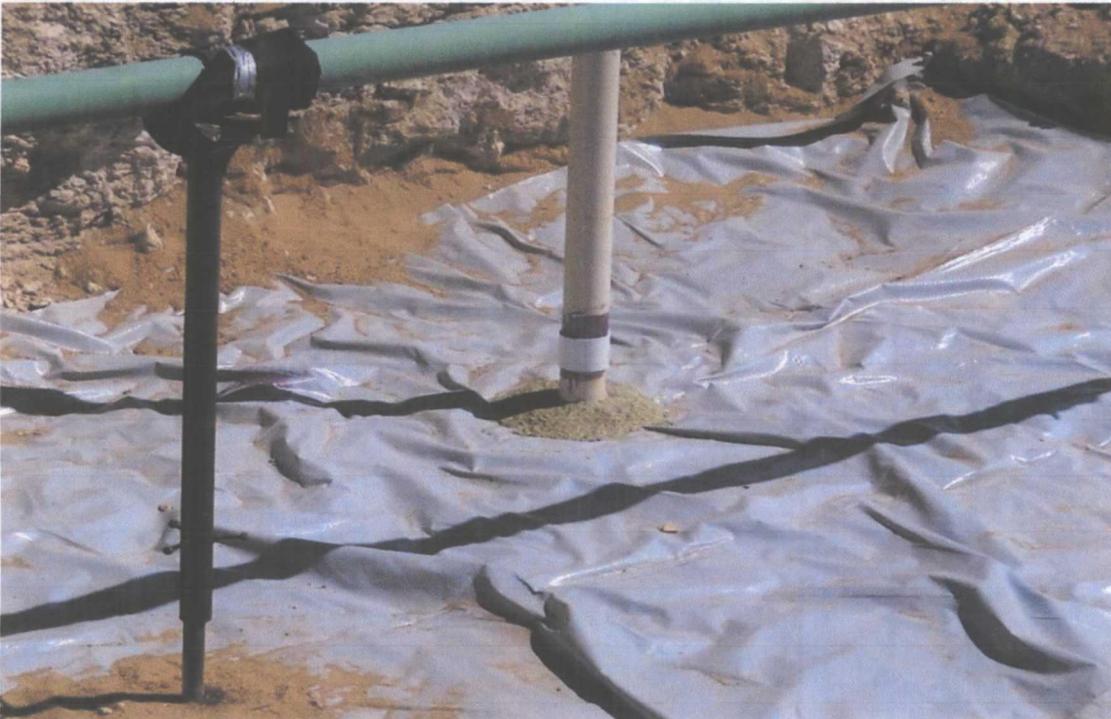
Chevron Grayburg 6-Inch Sec. 6 (Historical) - PVC Conduit & Boot

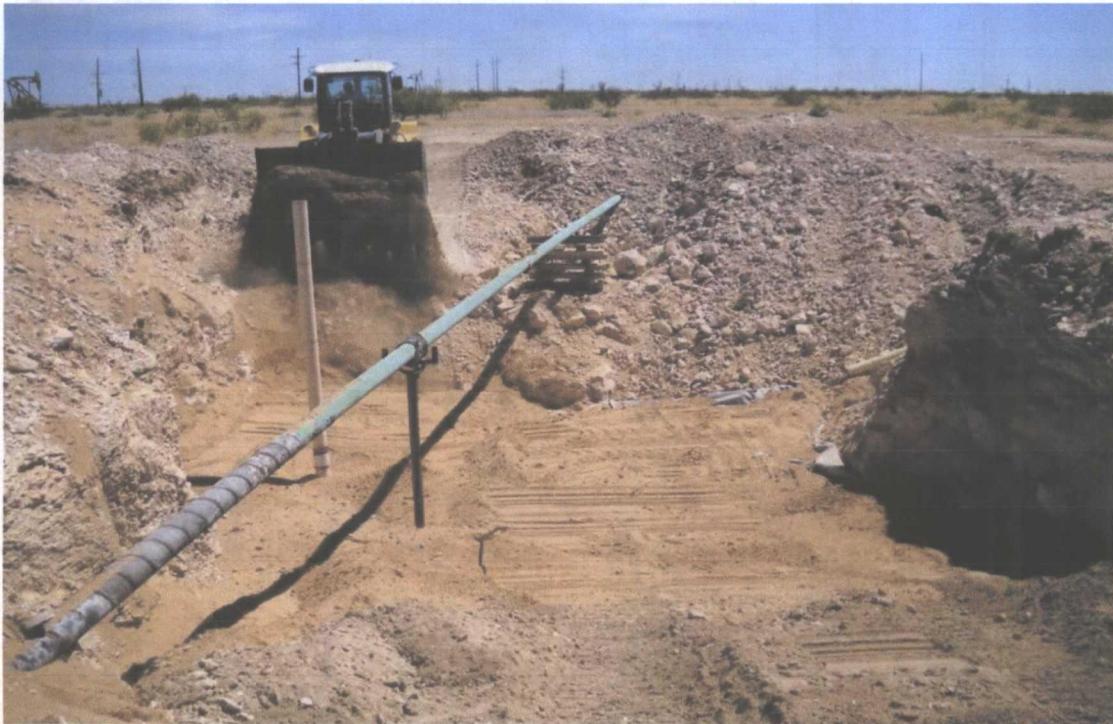
Chevron Grayburg 6-Inch Sec. 6 (Historical) - Installation of Pad Sand

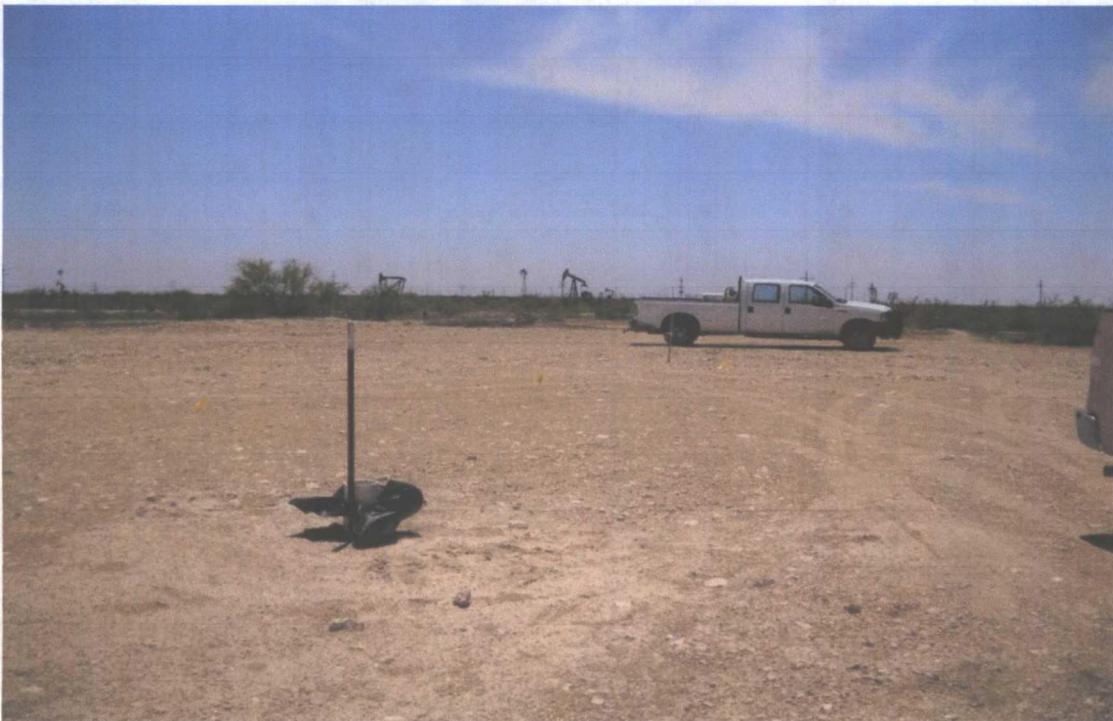
Chevron Grayburg 6-Inch Sec. 6 (Historical) - Excavation
(Following Backfilling; Looking West-southwest; PVC Conduit in Foreground)

Based on laboratory analytical results, and with NMOCD approval, from August 22 through August 25, 2011, the excavation was backfilled with the stockpiled material and the large rocks and boulders that had been previously removed from the excavation. Prior to backfilling, a twenty (20) mil polyurethane liner was installed in the floor of the excavation. A cushion of non-impacted pad sand was installed approximately one foot (1') both above and below the liner to protect the liner from damage during installation and backfilling activities. A six-inch (6") PVC conduit was installed near the release point to facilitate advancement of a soil boring in the floor

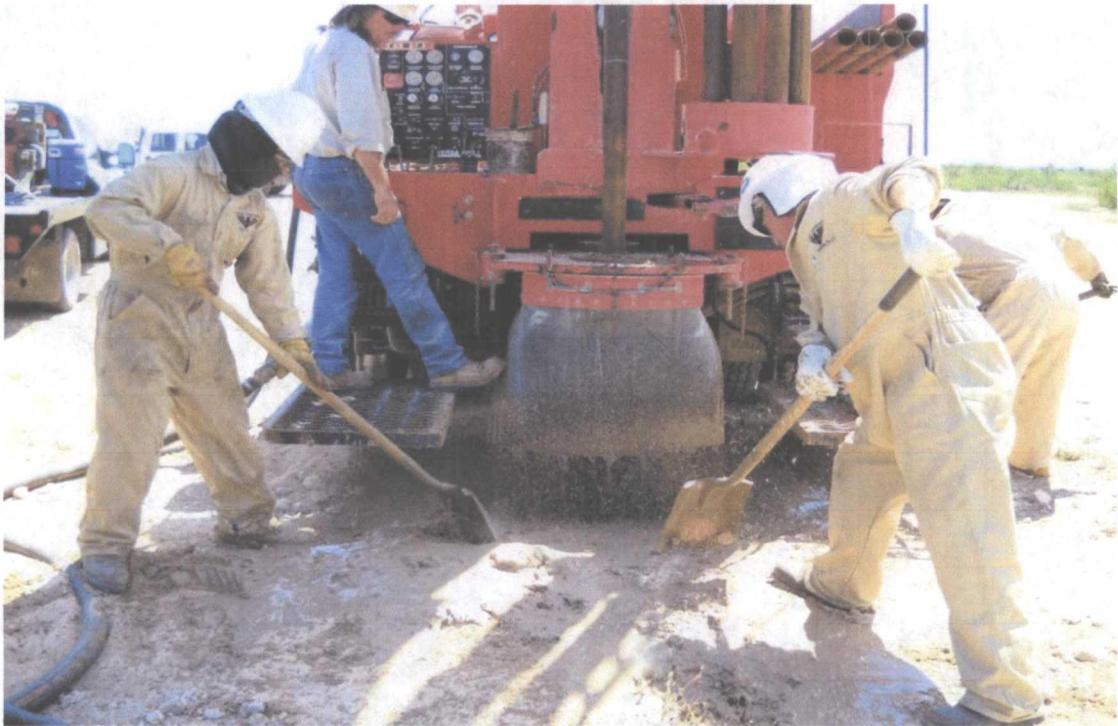
Chevron Grayburg 6-Inch Sec. 6 (Historical) - Advancement of Monitor Well MW-1

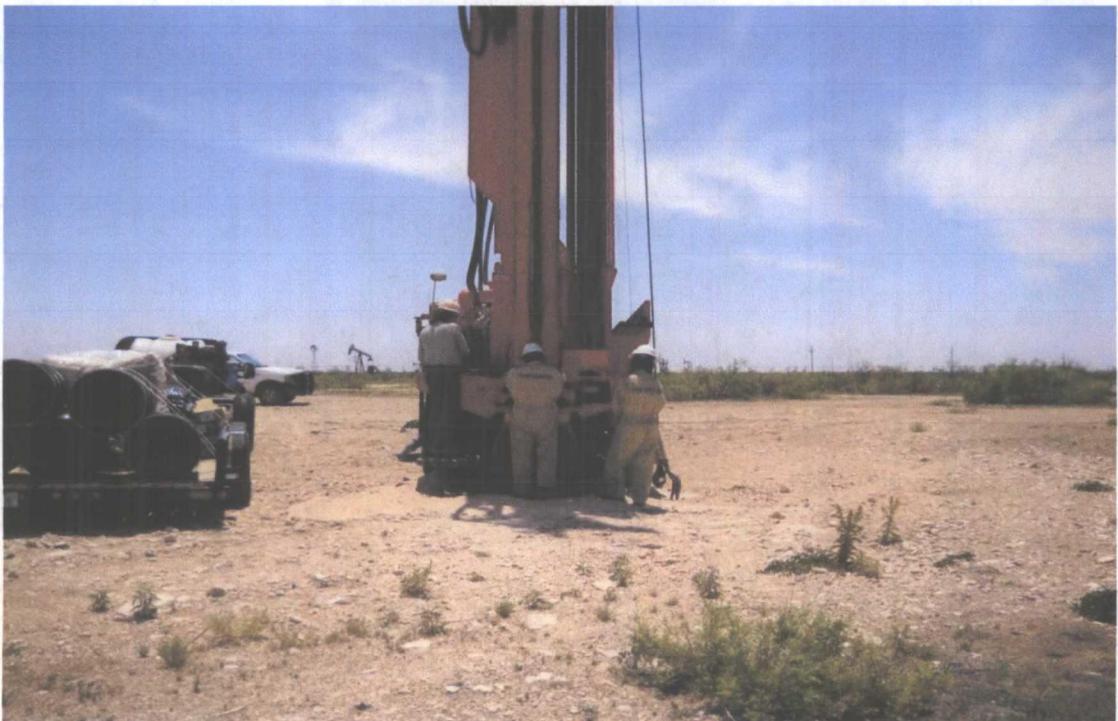
Chevron Grayburg 6-Inch Sec. 6 (Historical) - Advancement of Monitor Well MW-2

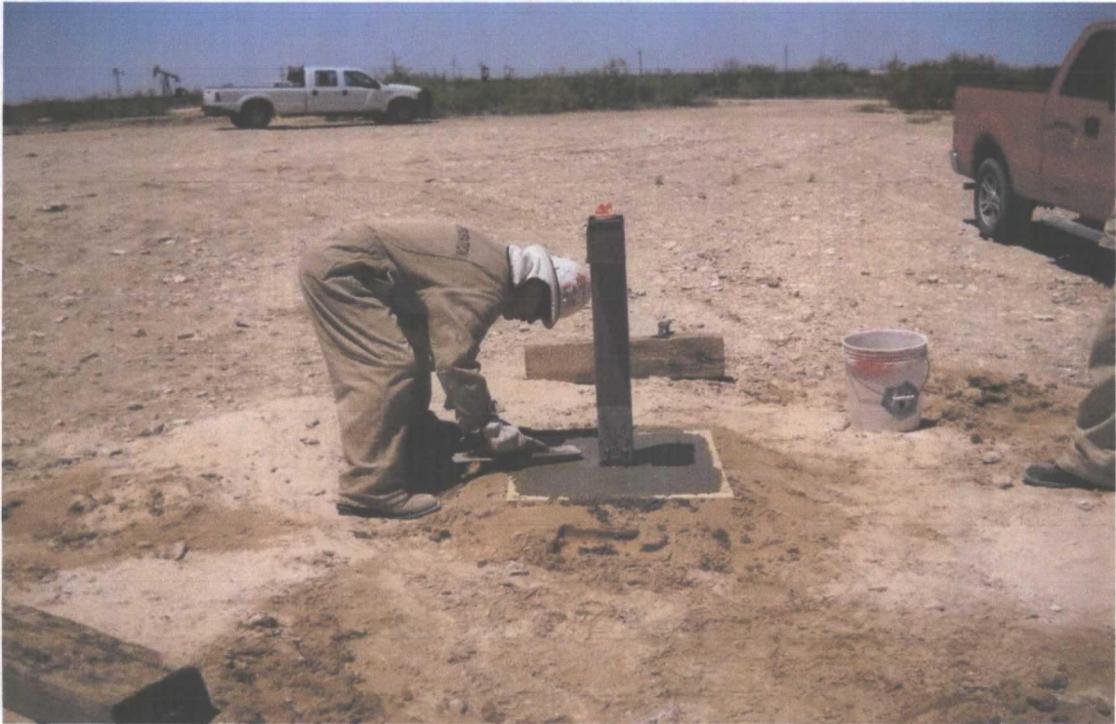
Chevron Grayburg 6-Inch Sec. 6 (Historical) - Completion of Monitor Well MW-2

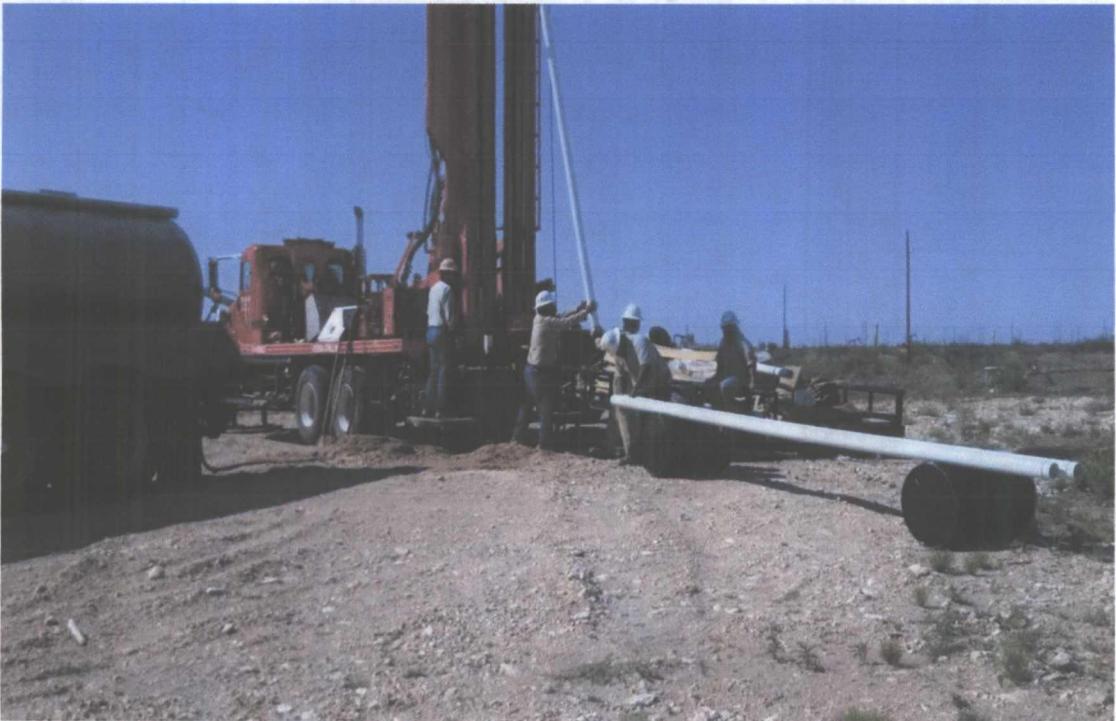
**Chevron Grayburg 6-Inch Sec. 6 (Historical) -
Installation of 4-Inch PVC Riser in Monitor Well MW-4**

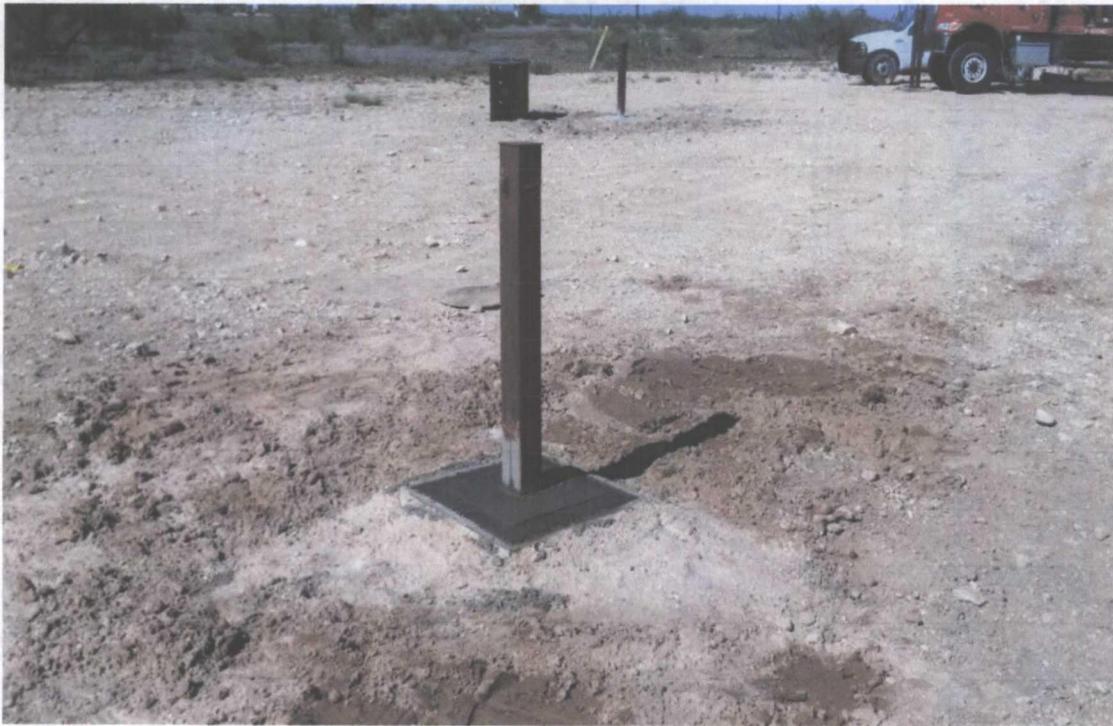
Chevron Grayburg 6-Inch Sec. 6 (Historical) -
Monitor Wells MW-3 (Foreground) & MW-2 (Background)

Monitor well MW-3 was advanced cross-gradient of the release point, approximately sixty feet (60') to the southwest of monitor well MW-1. Moisture was encountered at approximately sixty feet (60') bgs, and the monitor well was allowed to remain undisturbed overnight to determine whether or not groundwater had been reached.

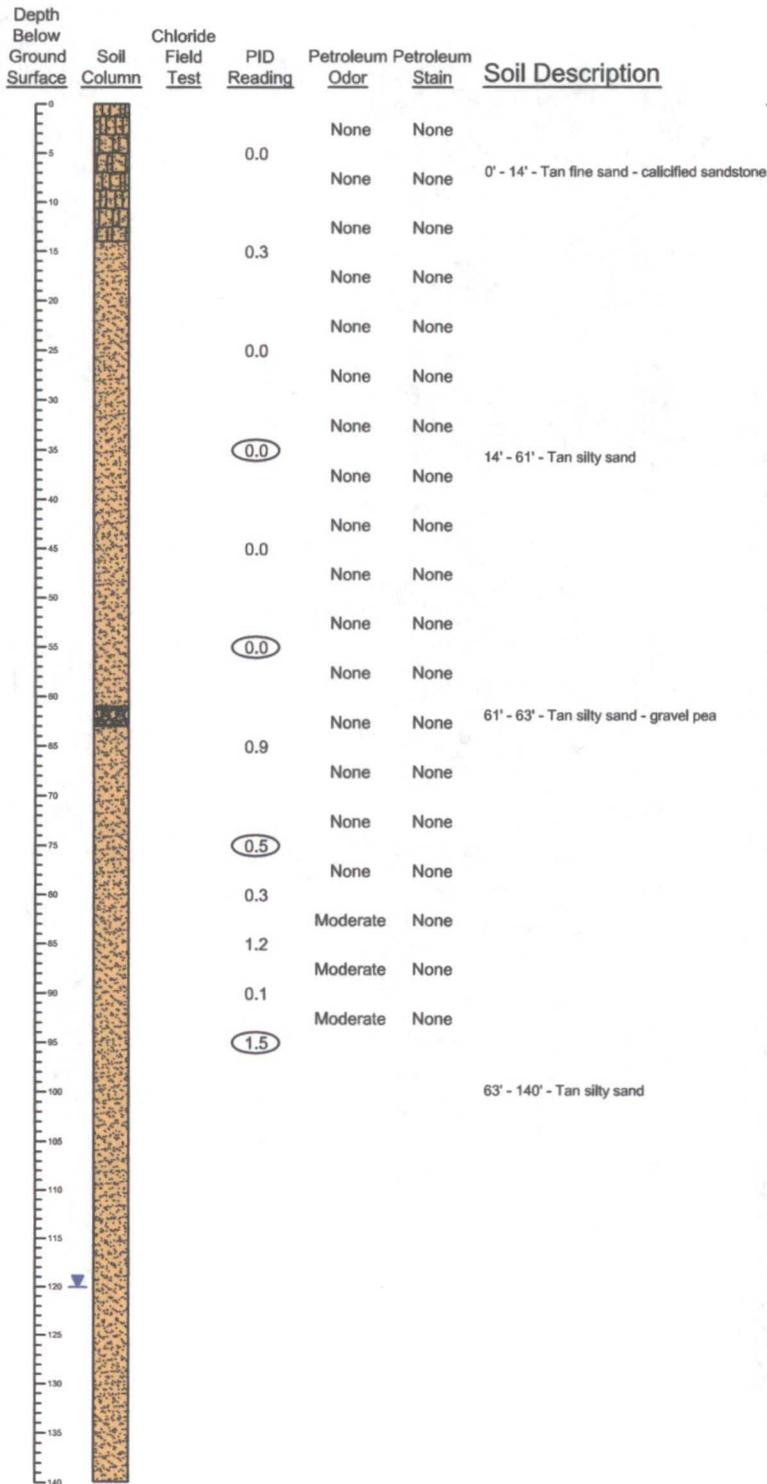
Monitor Well MW-2

Date Drilled June 14, 2012
 Thickness of Bentonite Seal 73 Ft
 Depth of Exploratory Boring 140 Ft bgs
 Depth to Groundwater 120 Ft bgs
 Ground Water Elevation _____

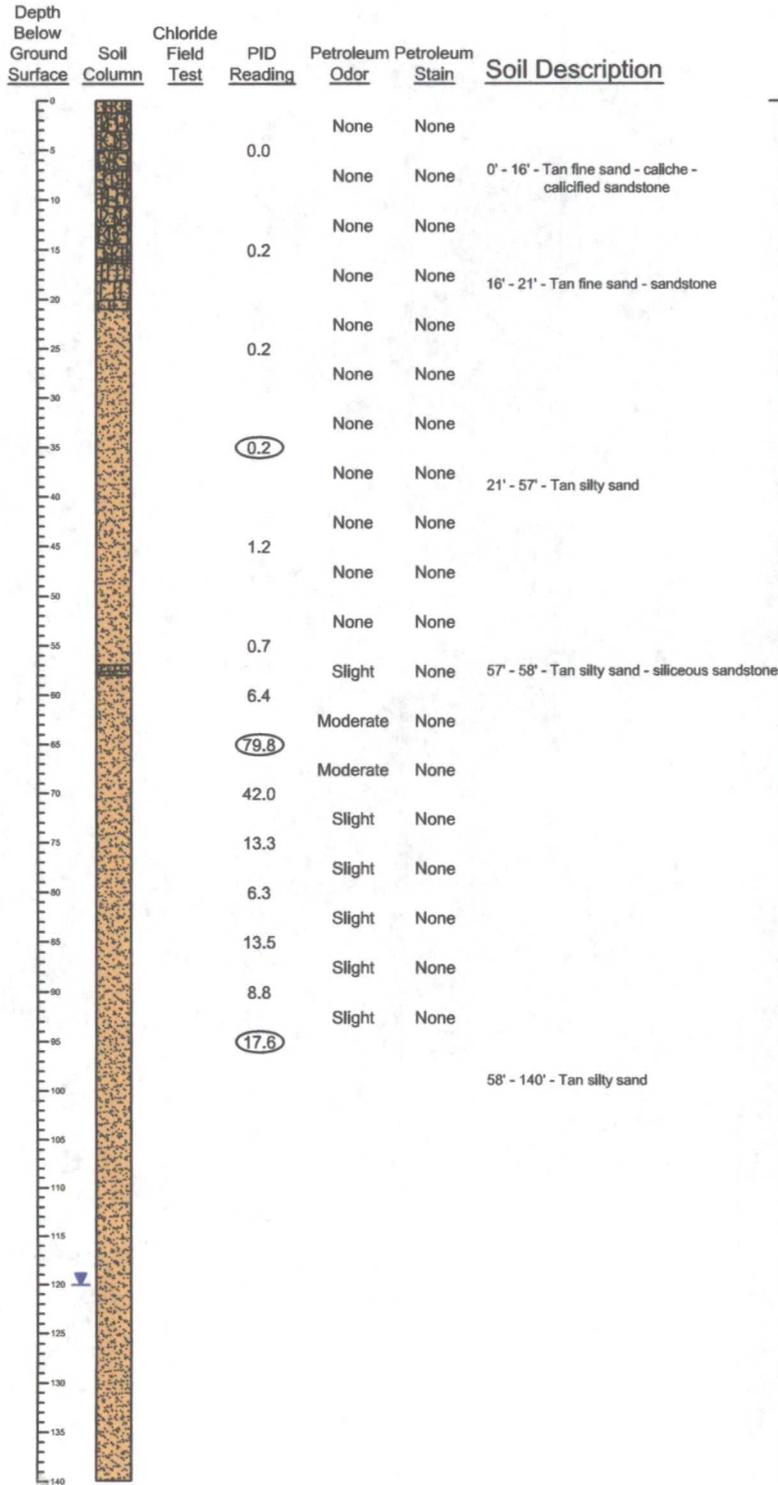
Monitor Well MW-3

Date Drilled June 14 - 15, 2012
 Thickness of Bentonite Seal 79 Ft
 Depth of Exploratory Boring 140 Ft bgs
 Depth to Groundwater 120 Ft bgs
 Ground Water Elevation _____
