# WORKPLANS

**RE: Update Report**

**Rice Operating Company – Abandoned Hobbs SWD System  
Hobbs Jct. E-33-1 (1R428-67): UL/E sec. 33 T18S R38E**

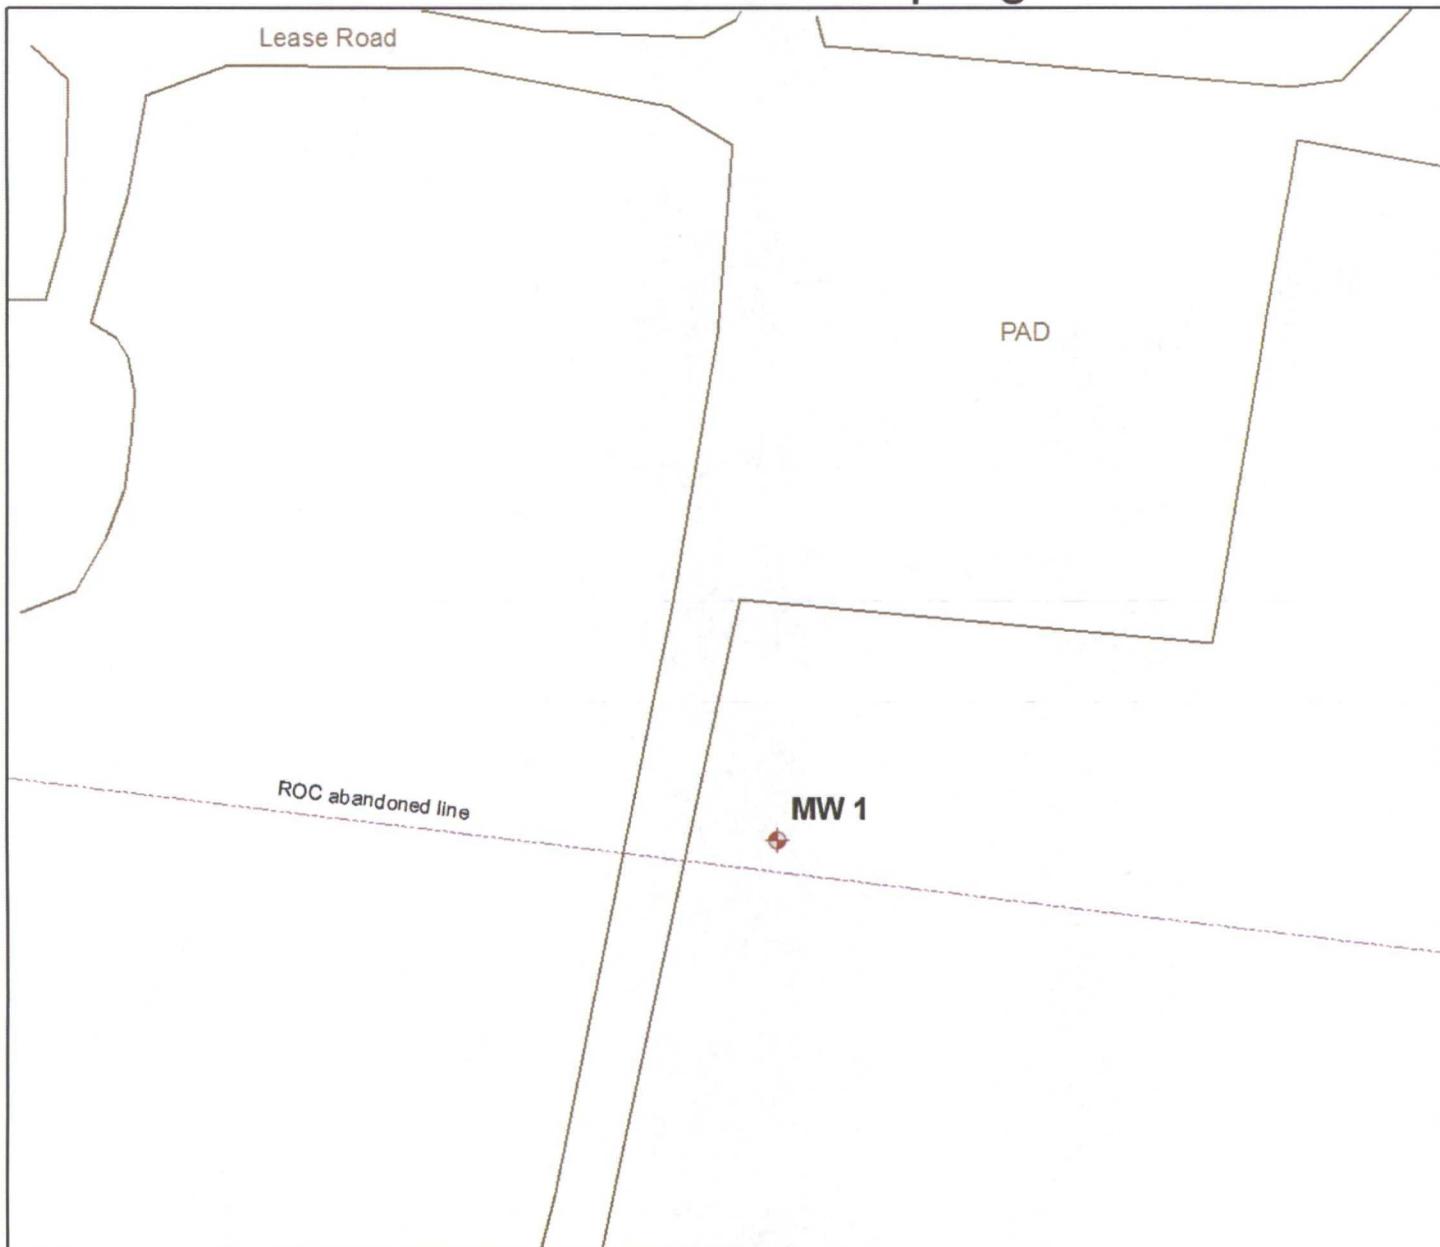
### Figure 2

# Monitor Well Sampling

MW	Depth to Water	Total Depth	Sample Date	Cl	TDS	Sulfate
1	66.68	79.38	3/23/2011	510	1490	193
	66.84	79.38	6/20/2011	470	1290	188
	66.94	79.38	9/20/2011	500	1420	221
	67.14	79.38	12/15/2011	480	1330	222
	67.27	79.38	3/13/2012	456	1300	214
	67.46	79.38	6/11/2012	400	1200	220
	67.69	79.38	9/6/2012	343	1090	195

BTEX sampling was suspended in 2009.

The monitor well (MW-1) has been sampled quarterly since its installation (Figure 2). Laboratory chloride and TDS values for the well remain slightly above WQCC standards.

During the last sampling event on September 6<sup>th</sup>, 2012, the laboratory chloride reading was 343 mg/L and the TDS reading was 1,090 mg/L (Appendix A). Because of the elevated chloride and TDS readings in MW-1, RECS recommends that ROC install an up gradient monitor well to determine if an up gradient source exists to account for these elevated constituents. The monitor well (MW-2) will be sampled quarterly per NMOCD standards.
