**From:** Hansen, Edward J., EMNRD  
**Sent:** Thursday, January 17, 2013 4:17 PM  
**To:** Hack Conder (hconder@riceswd.com)  
**Cc:** Leking, Geoffrey R, EMNRD; Laura Pena (lpena@riceswd.com); Katie Jones <kjones@riceswd.com> (kjones@riceswd.com); Scott Curtis (scurtis@riceswd.com)  
**Subject:** Remediation Plan (1R427-19) Termination - ROC EME Cooper Fed 'D' EOL Site

**RE: Termination Request  
for the Rice Operating Company's  
EME Cooper Fed 'D' EOL Site  
Unit Letter E, Section 26, T20S, R36E, NMPM, Lea County, New Mexico  
Remediation Plan (1R427-19) Termination**

RE: Termination Request  
EME Cooper Fed 'D' EOL (1R427-19): UL/E Sec. 26, T20S, R36E  
RICE Operating Company – Eunice Monument Eumont SWD System

**RICE OPERATING COMPANY  
JUNCTION BOX FINAL REPORT**

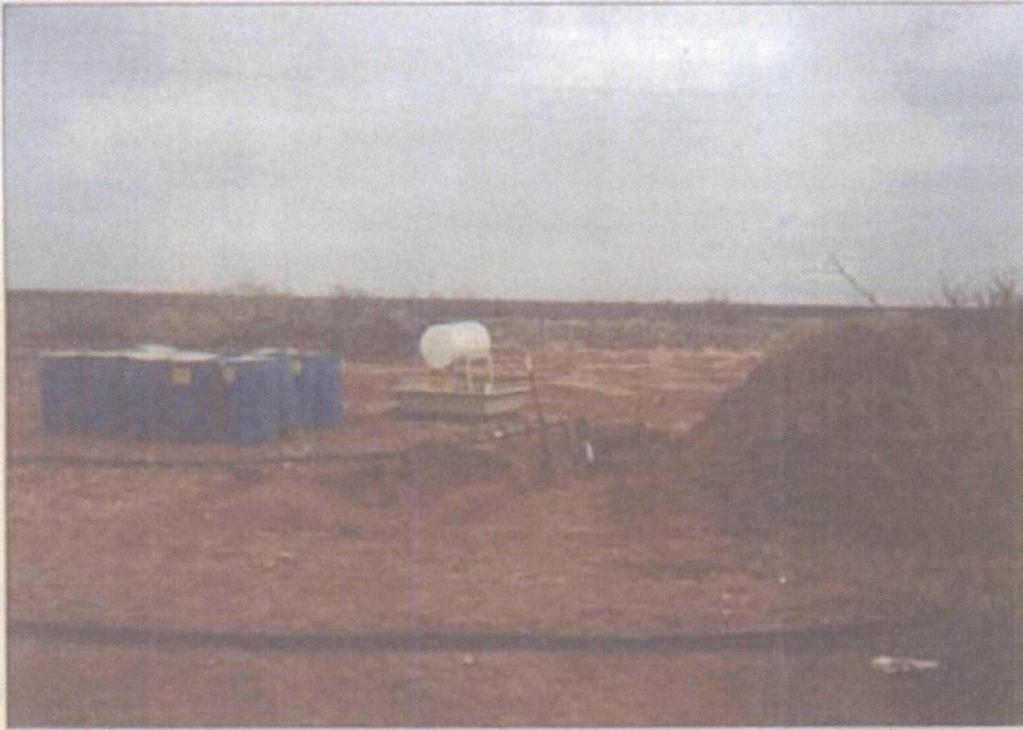
NORM Removal

**General Description of Remedial Action:** This junction is located near an active production facility. The site was delineated vertically and laterally producing a 20' x 10' x 12' bgs excavation. Groundwater is 106'. There were no signs of TPH impact and samples taken to a lab resulted in concentrations below NMOCD guidelines. ROC believes that chloride concentrations of this magnitude does not present a threat to groundwater that is 90+ feet below. The excavated soil was blended at the location and then backfilled into the hole. A water-tight junction box has been build over the site.

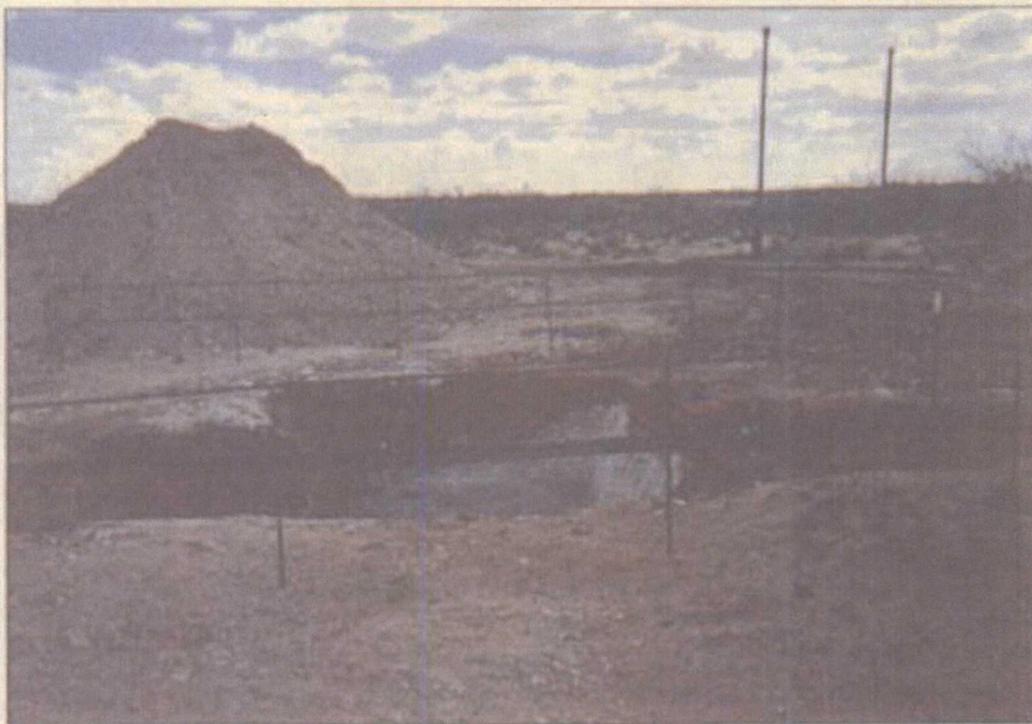
Impact Excavation

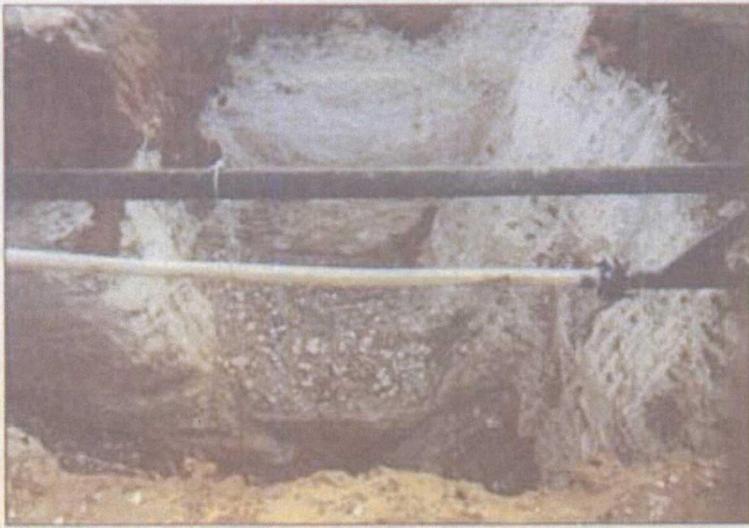
Impact Excavation

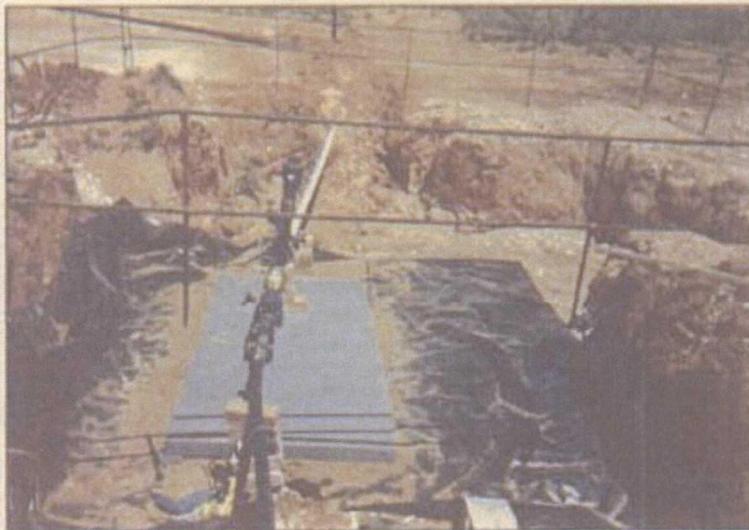
Box Construction (with poly liner)

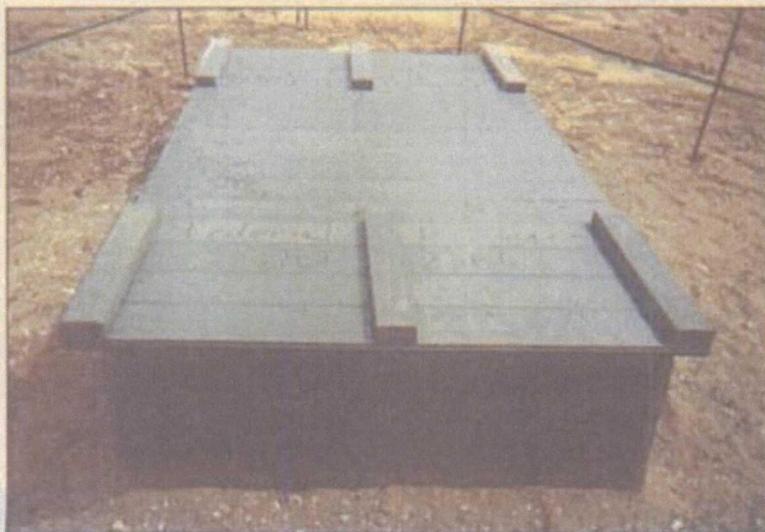
New Junction Box

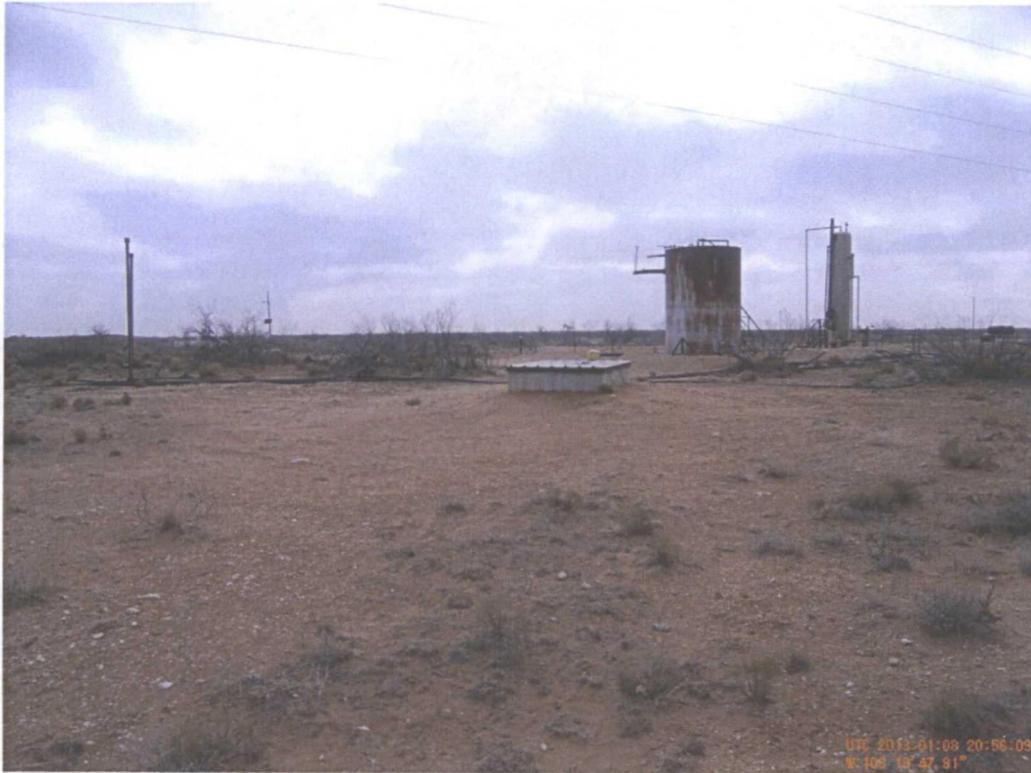
1/8/2013

Facing South

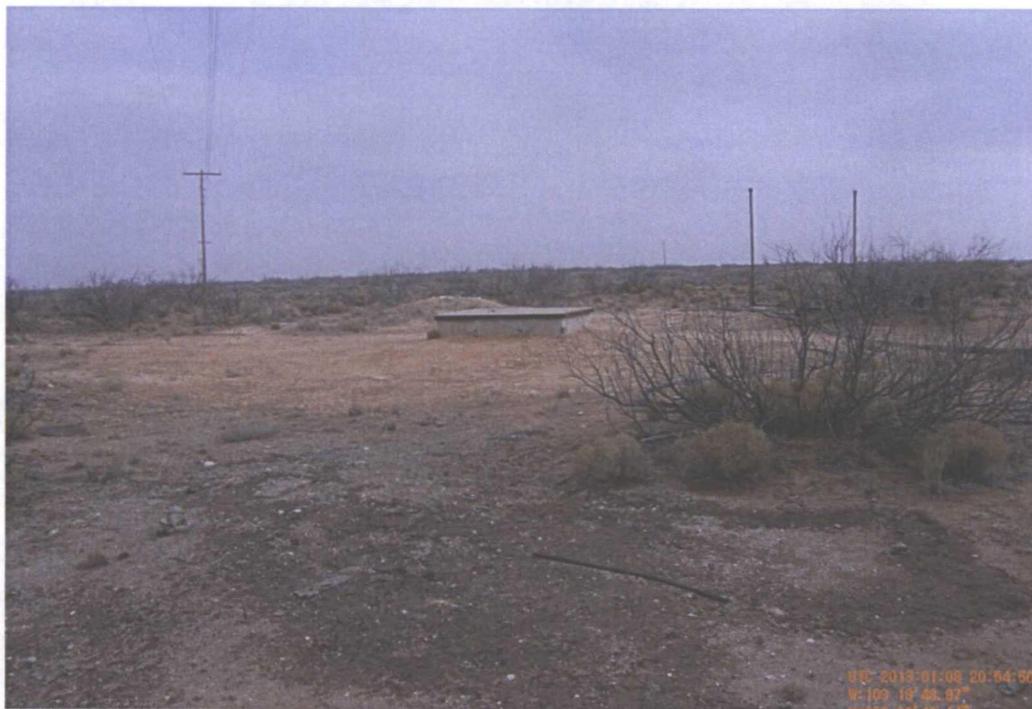
1/8/2013

Facing East
