**RE: Termination Request  
for the Rice Operating Company's  
EME H-35 EOL Site  
Unit Letter H, Section 35, T20S, R36E, NMPM, Lea County, New Mexico  
Remediation Plan (1R427-20) Termination**

RE: Termination Request  
EME H-35 EOL (1R427-20): UL/H Sec. 35, T20S, R36E  
(formerly EME A-35 EOL)  
RICE Operating Company – Eunice Monument Eumont SWD System

**EME  
H-35 EOL**

**RICE OPERATING COMPANY  
JUNCTION BOX FINAL REPORT**

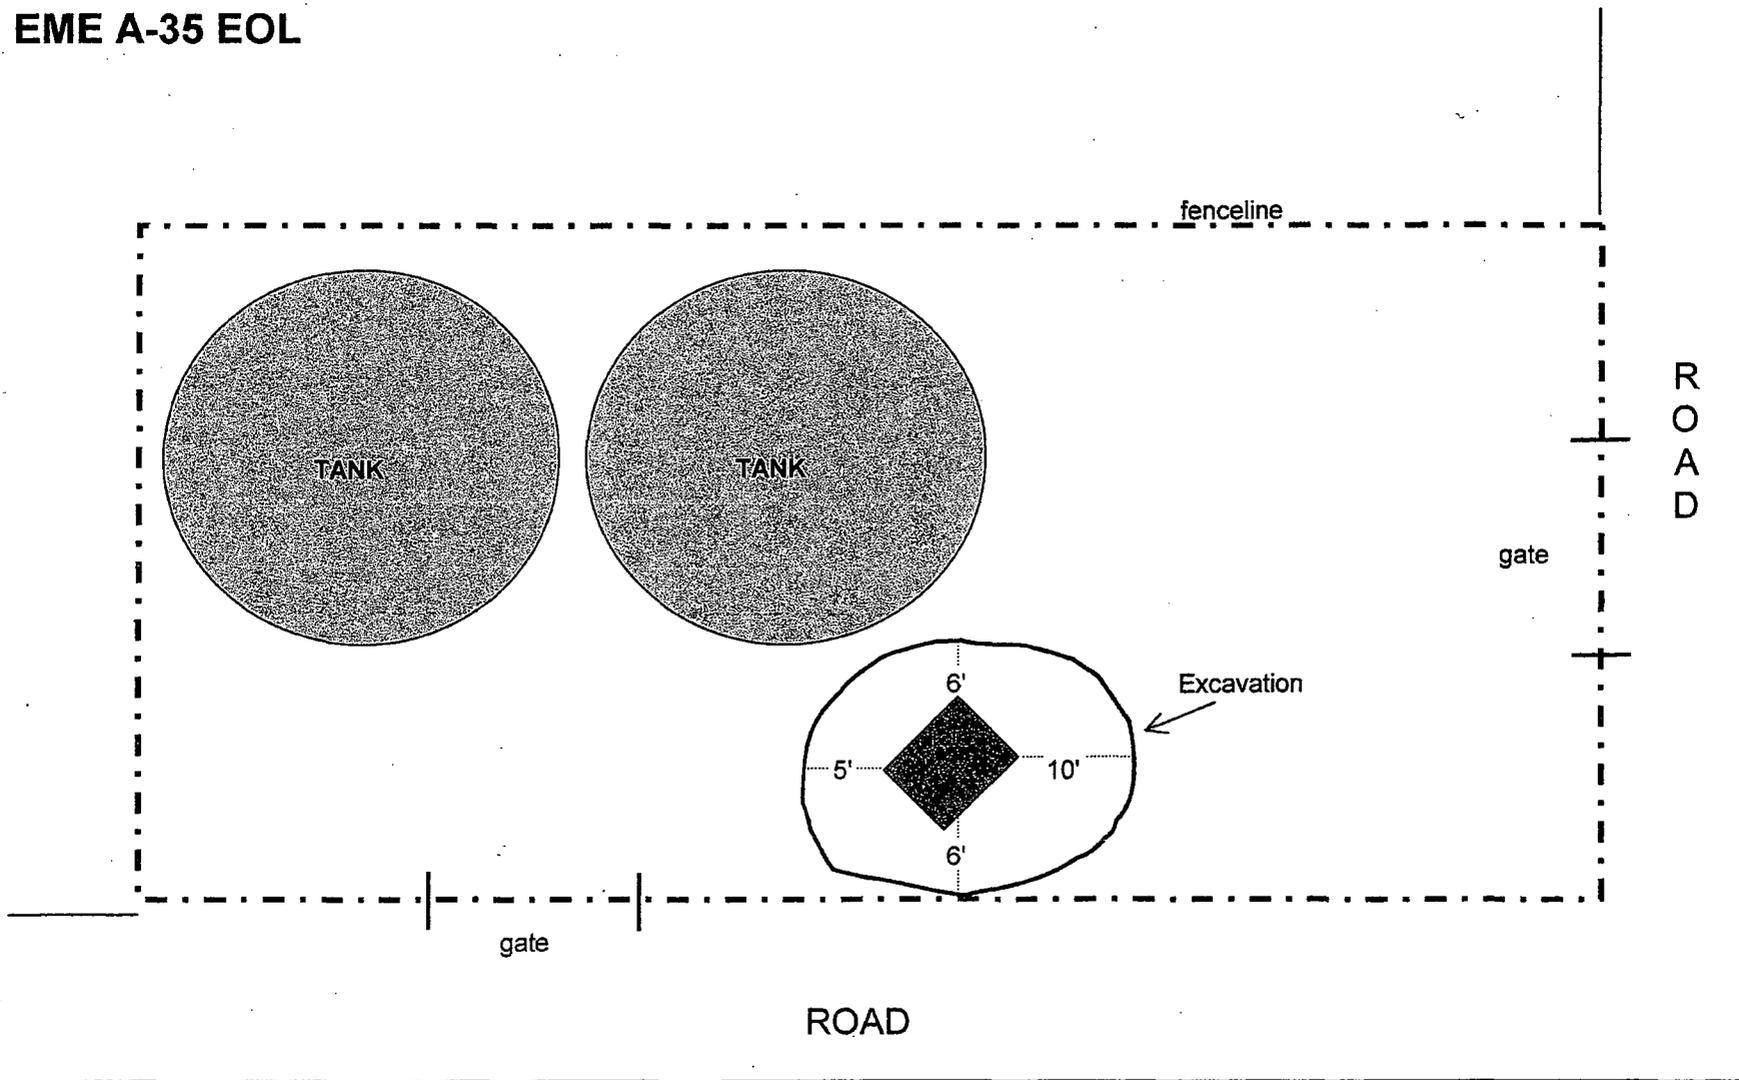
EME A-35 EOL

new  
jct-box

**EME A-35 EOL box upgrade**

**General Description of Remedial Action:** This junction box was located inside an active production battery and surrounded by aged hardpan. Chlorides field-tested around 400 ppm down to 12' bgs while TPH drastically declined from 4' to 8' bgs. ROC originally planned to excavate a 10' radius surrounding the box, but due to space constraints in the battery, a 15' x 12' area was excavated to 8' bgs (where TPH impact ceased). A compacted clay barrier was installed at 8' bgs to hinder vertical migration of impact and the soil was blended and backfilled into the excavation. Since the facility is still active, the principle objective of the upgrade was to remove the source of impact. Since groundwater is 122' bgs, ROC does not consider the chloride left in place threatening to the groundwater or public health.

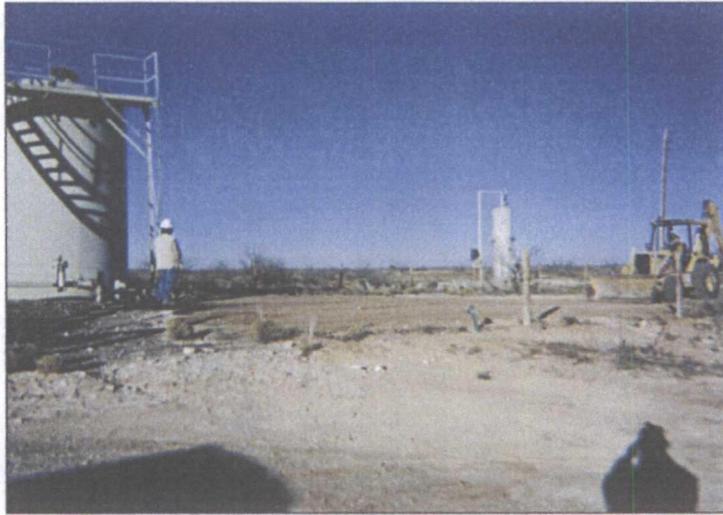
**Backfilled**

detectable limits in all samples. From 8-7 ft BGS, a 1 ft thick clay liner was installed. The remediated backfill was returned to the excavation to ground surface and contoured to the surrounding area. The site was not seeded as it is located within an active production battery.

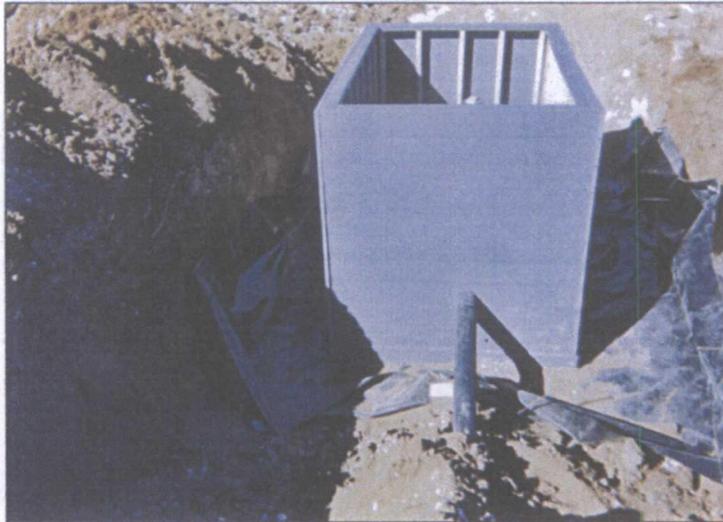
**Box Construction**

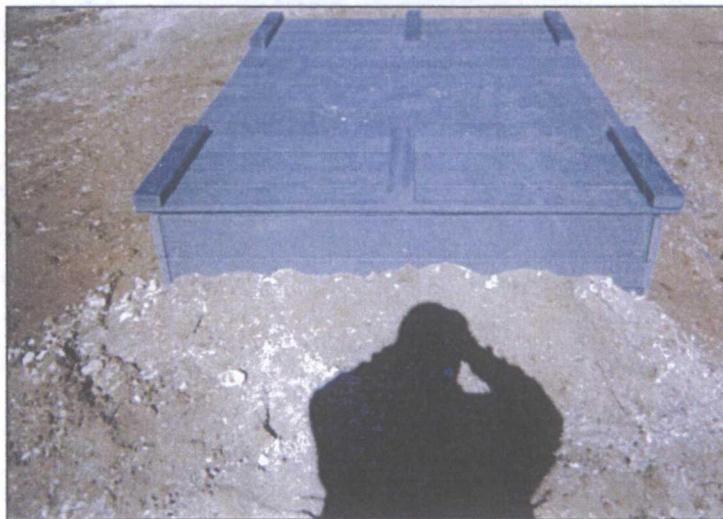
**Complete Box**

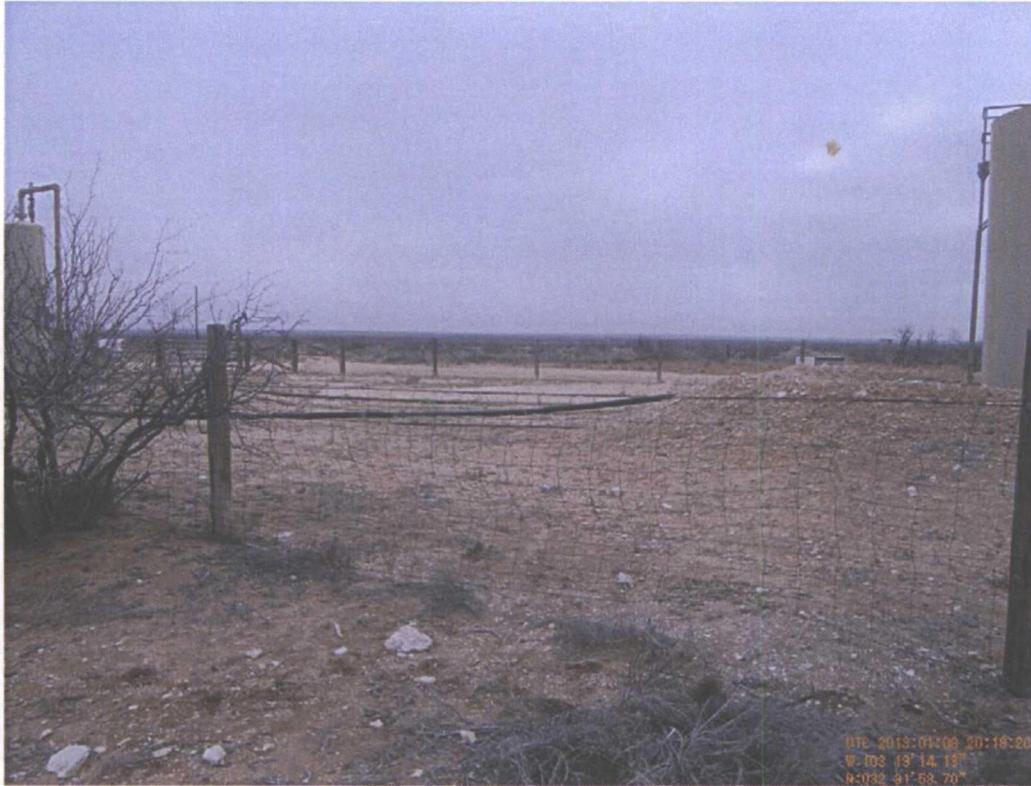
1/8/2013

Facing South

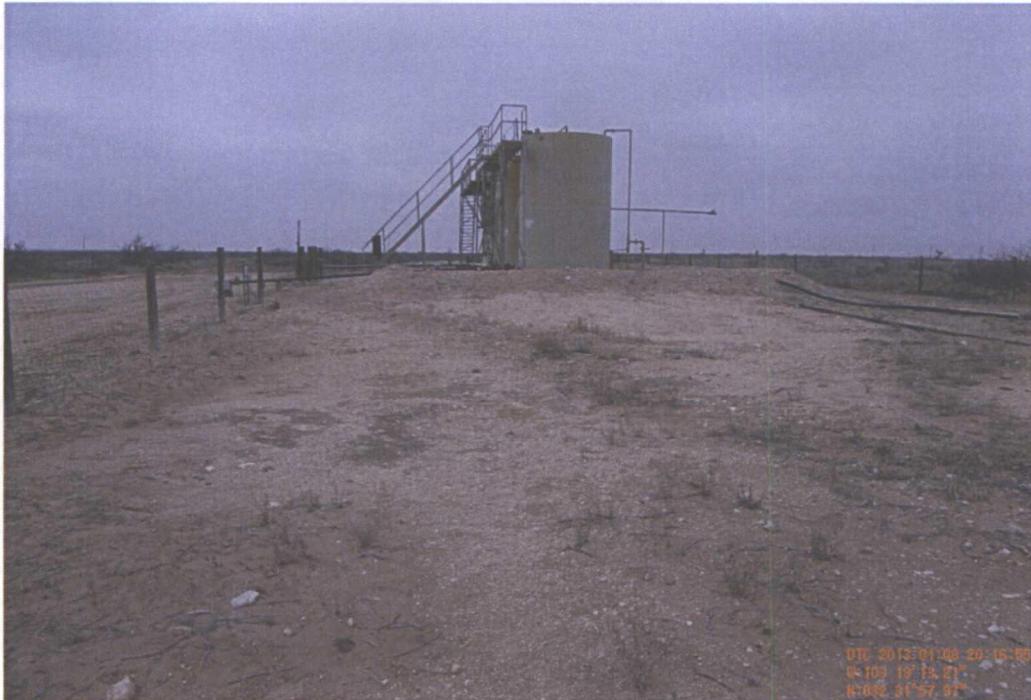
1/8/2013

Facing West
