From: Hansen, Edward J., EMNRD
Sent: Wednesday, January 30, 2013 10:56 AM
To: Hack Conder (hconder@riceswd.com)
Cc: Leking, Geoffrey R, EMNRD; Laura Pena (lpena@riceswd.com); Katie Jones <kjones@riceswd.com> (kjones@riceswd.com); Scott Curtis (scurtis@riceswd.com)
Subject: Remediation Plan (1R427-25) Termination - ROC EME C-12-North Site

**RE: Termination Request
for the Rice Operating Company's
EME C-12-North Site
Unit Letter C, Section 12, T20S, R36E, NMPM, Lea County, New Mexico
Remediation Plan (1R427-25) Termination**

RE: Termination Request
EME C-12-North (1R427-25): UL/C Sec. 12, T20S, R36E
RICE Operating Company – Eunice Monument Eumont SWD System

**RICE OPERATING COMPANY
JUNCTION BOX FINAL REPORT**

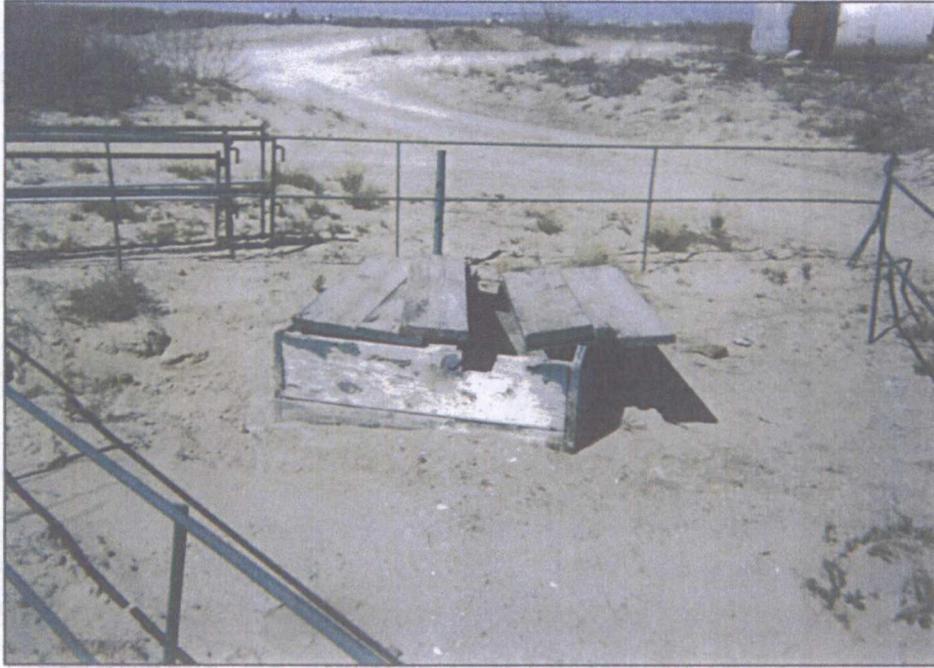
EME C-12-1 North

Before Excavation

General Description of Remedial Action: The site was delineation vertically where TPH dissipated at 4' bgs and chloride impact declined substantially at 8' bgs. The excavation was extended laterally in all directions until chloride and TPH impact exhibited a decline from the source. A 1' clay barrier was installed at the bottom of the 13' x 12' x 8' excavation to hinder vertical migration of any remaining impact. The excavated soil was landfarmed on location, backfilled into the clay-lined hole, and then contoured to the surrounding area. A junction box is no longer required at this location. Remaining TPH is expected to naturally attenuate.

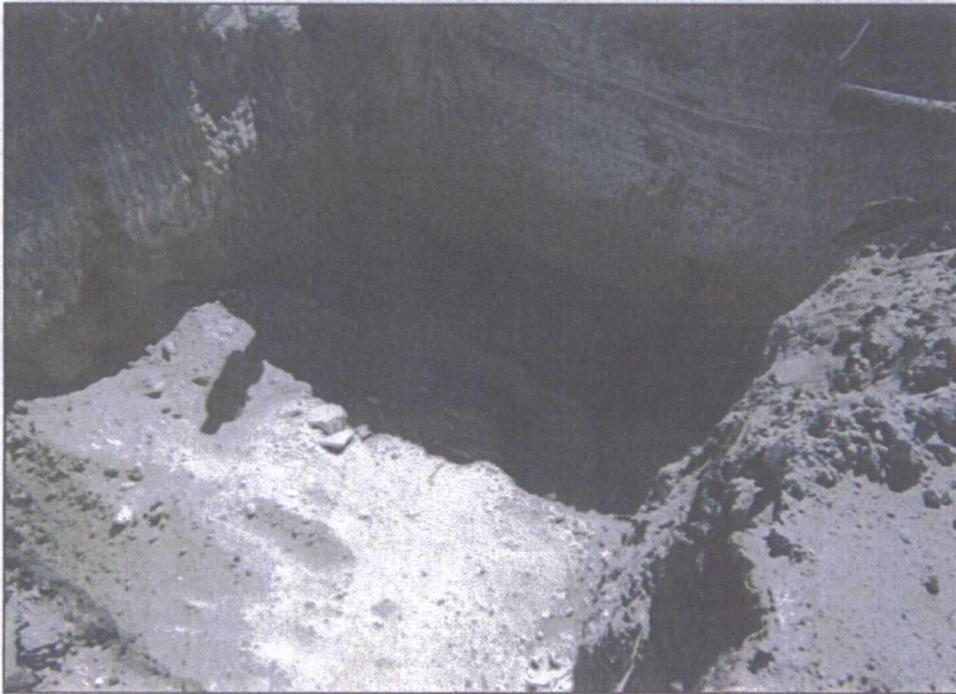
Soil Excavated 46 cubic yards Excavation Length 13 Width 12 Depth 8 feet

Excavation

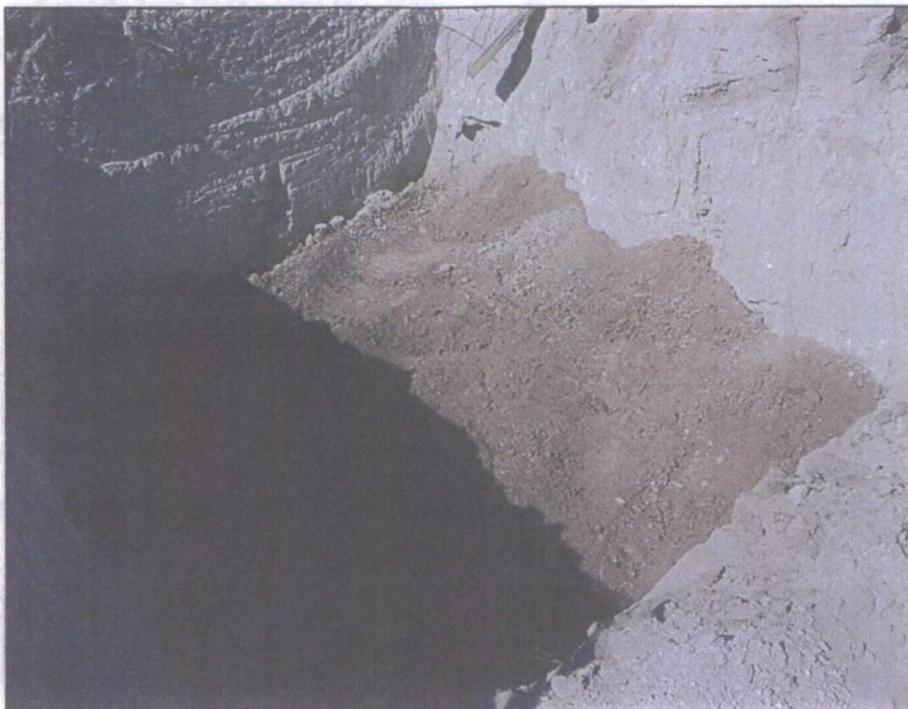
EME C-12-1 North

Clay Barrier

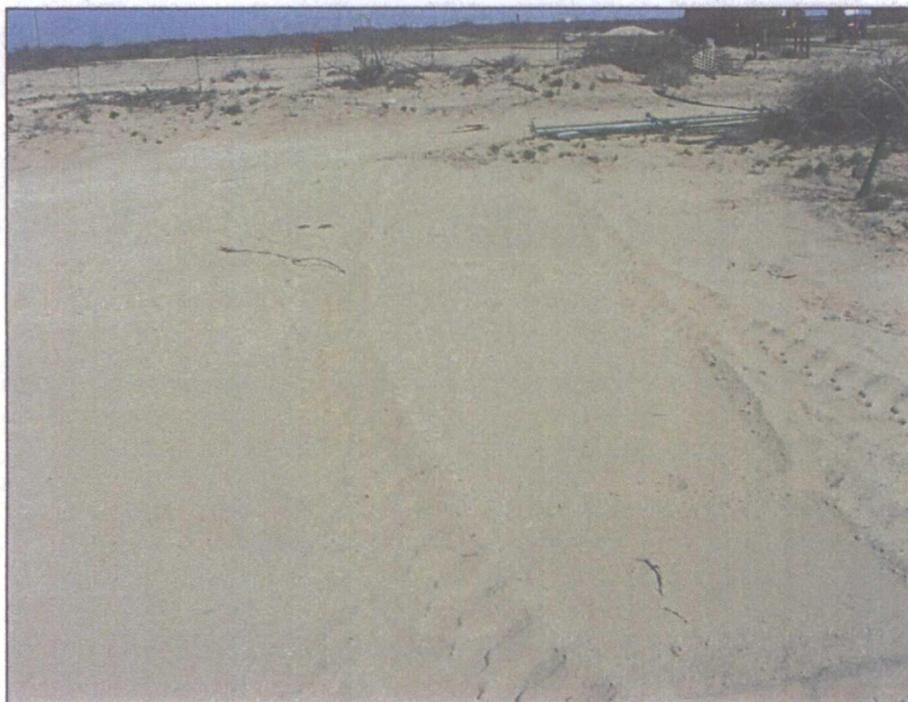
Backfilled

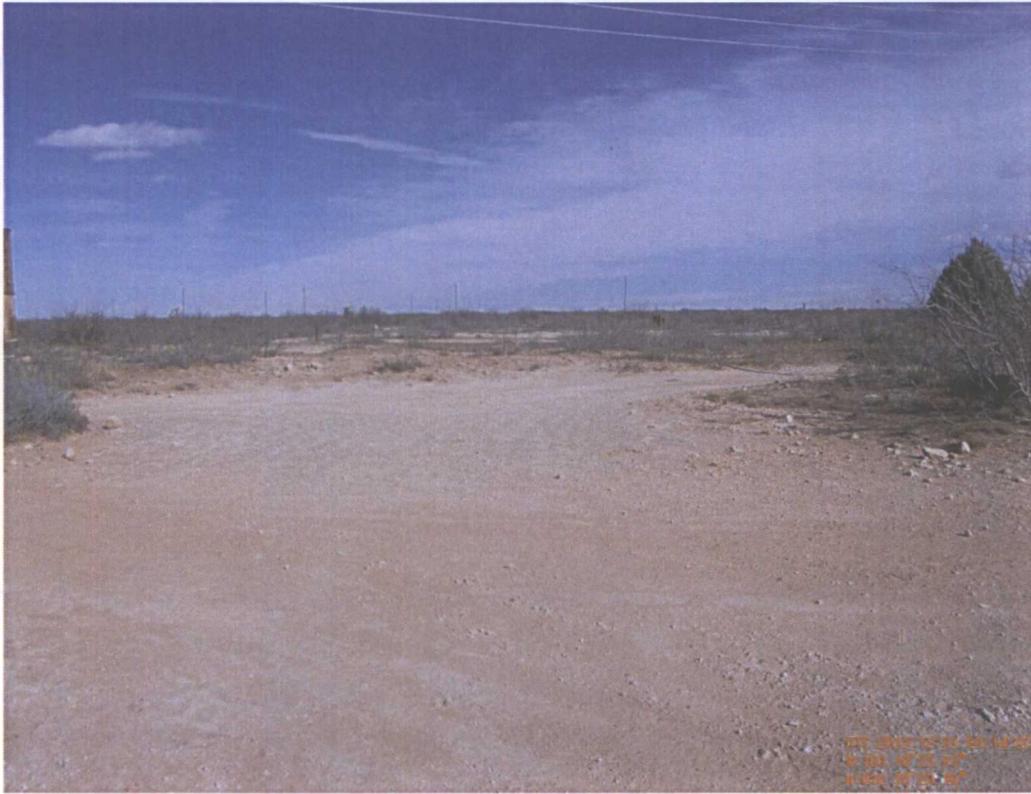
12/31/2012

Facing Northeast

contoured to the surrounding area. This site is located on the edge of two lease roads; therefore, seeding was not necessary.

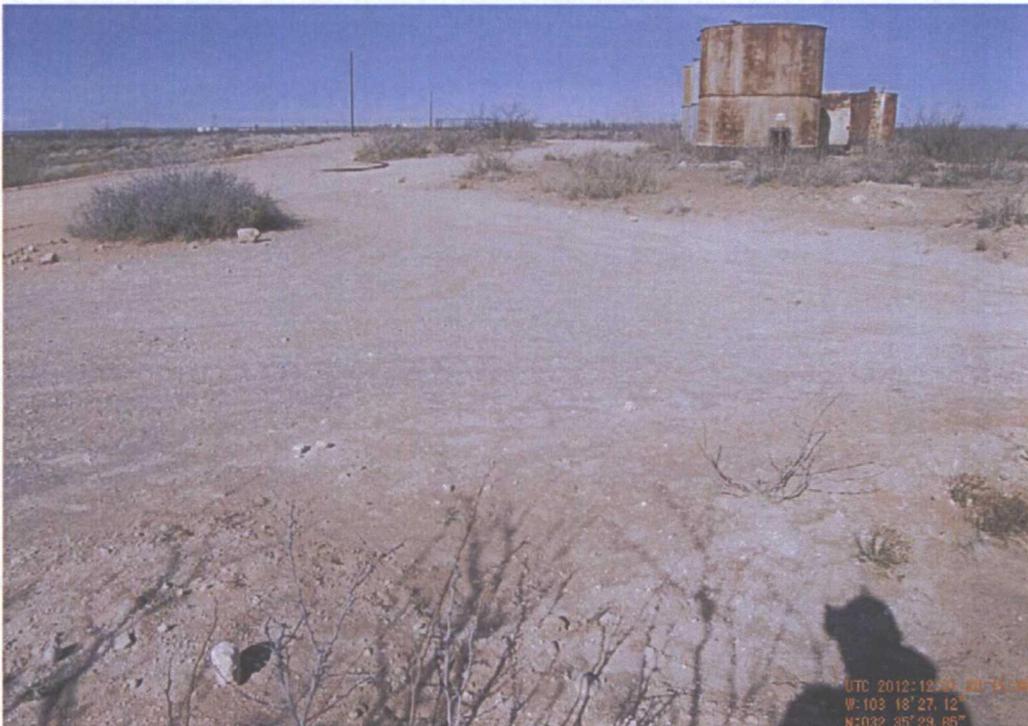
12/31/2012

Facing Northwest
