**RE: Termination Request
for the Rice Operating Company's
EME H-12 Site
Unit Letter H, Section 12, T21S, R35E, NMPM, Lea County, New Mexico
Remediation Plan (1R427-36) Termination**

RE: Termination Request
EME H-12 (1R427-36): UL/H Sec. 12, T21S, R35E
RICE Operating Company – Eunice Monument Eumont SWD System

**RICE OPERATING COMPANY
JUNCTION BOX FINAL REPORT**

EME H-12 (1R427-36)
Unit Letter H, Section 12, T21S, R36E

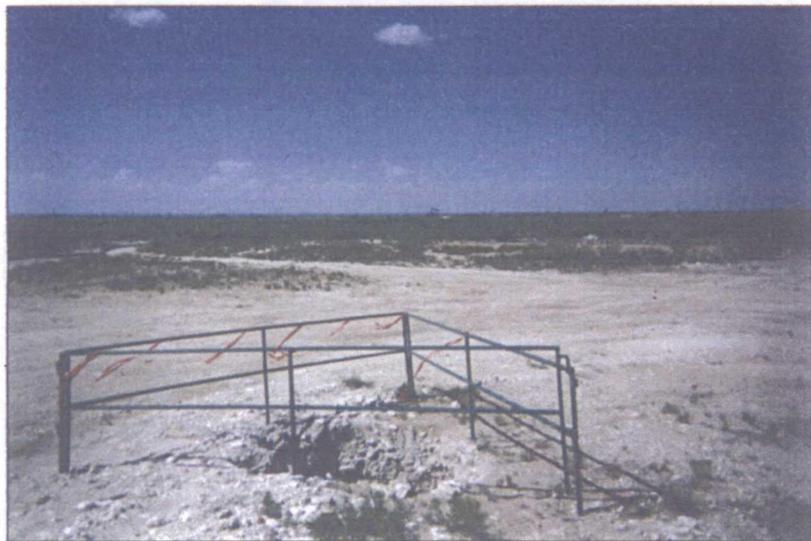
Jct. Box Site (after NORM removal)

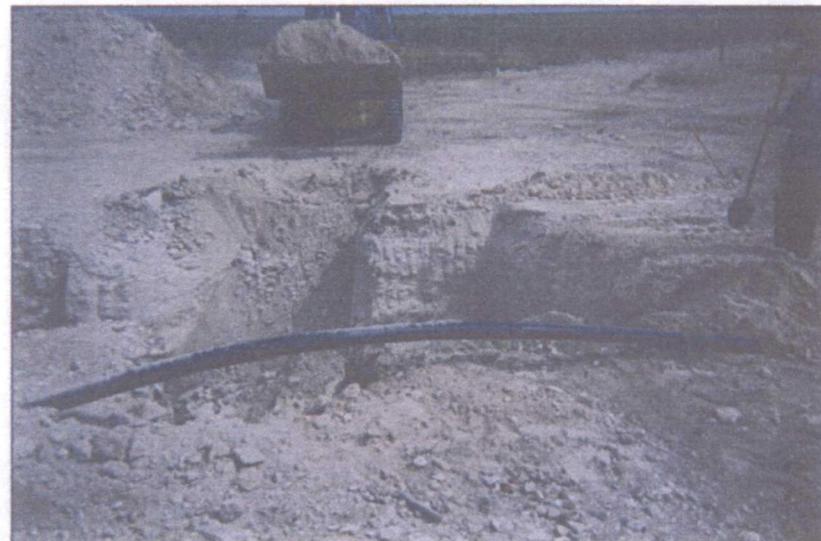
Excavation

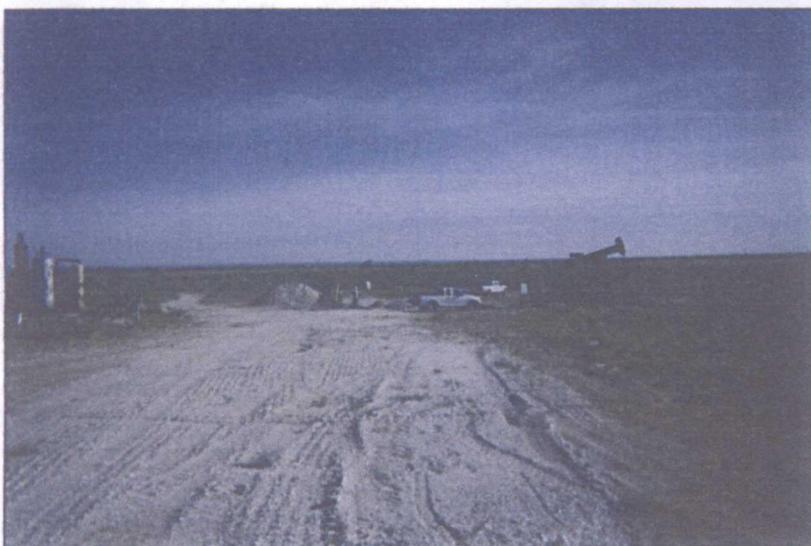
Excavation (looking North)

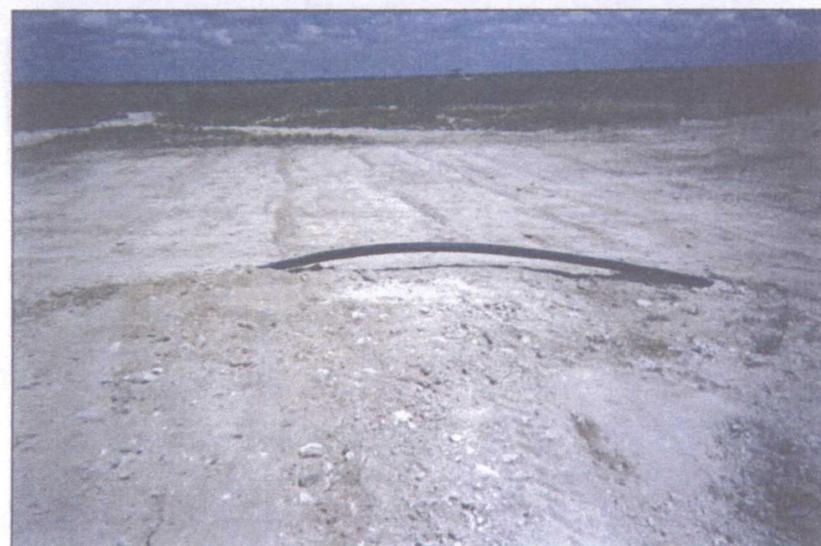
chloride concentration declines vertically and laterally in relation to the original junction. There was no evidence of TPH impact. PID readings were taken regularly which consistently yielded minimal readouts. The excavated soil from the 23 x 14 x 13-ft-deep hole was blended and then backfilled and contoured to the surrounding surface. A new junction box will not be re-built over the location as it was re-plumbed straight through with a new poly pipeline. The disturbed surface will not be re-seeded due to the site's proximity to active oilfield facilities, structures, and a road (see photos). The site is expected to naturally re-vegetate at a normal rate.

Backfilled

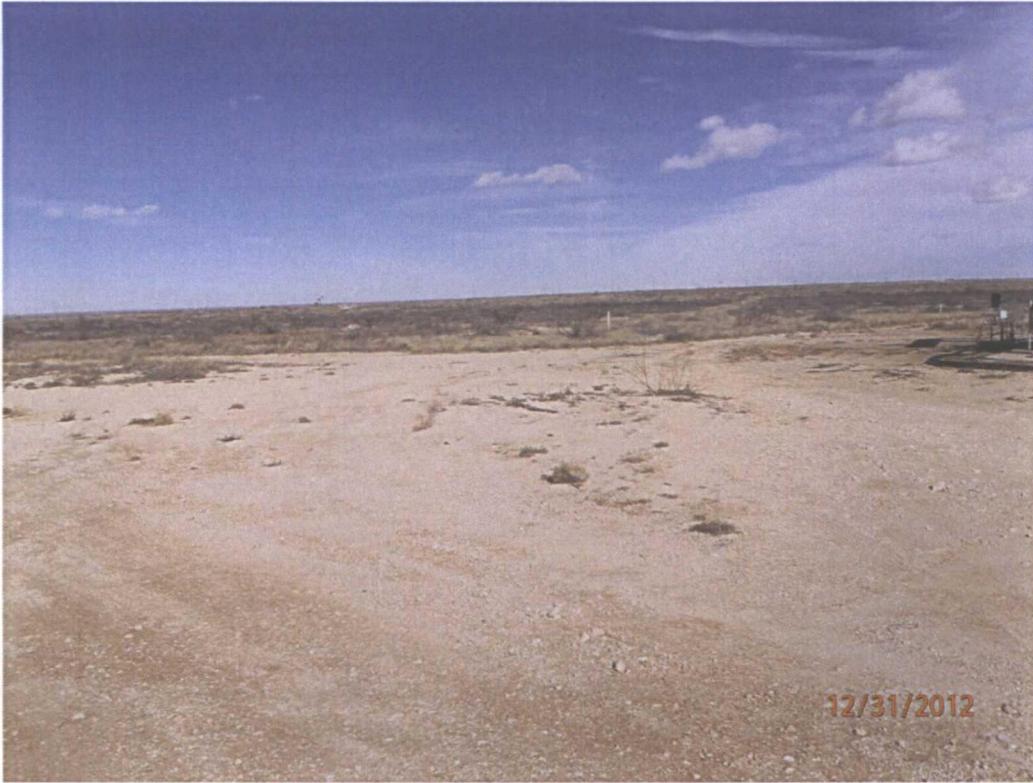
Facing Northeast

the surrounding area. The site was not reseeded due to the close proximity of active facilities and lease roads.

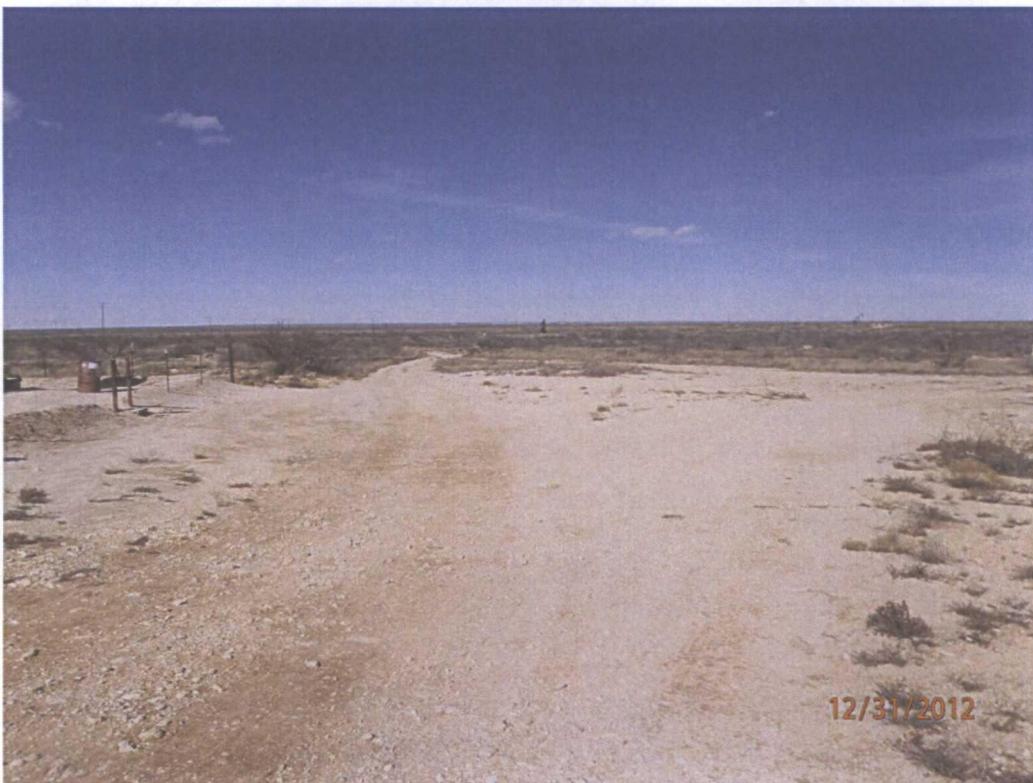
Facing North
