RE: Termination Request
EME P-34 (1R427-29): UL/P Sec. 34, T19S, R36E
RICE Operating Company – Eunice Monument Eumont SWD System

**EME
P-34**

**UL P SECTION 34
T-19-S R-36-E
LEA COUNTY, NM**

**RICE OPERATING COMPANY
JUNCTION BOX FINAL REPORT**

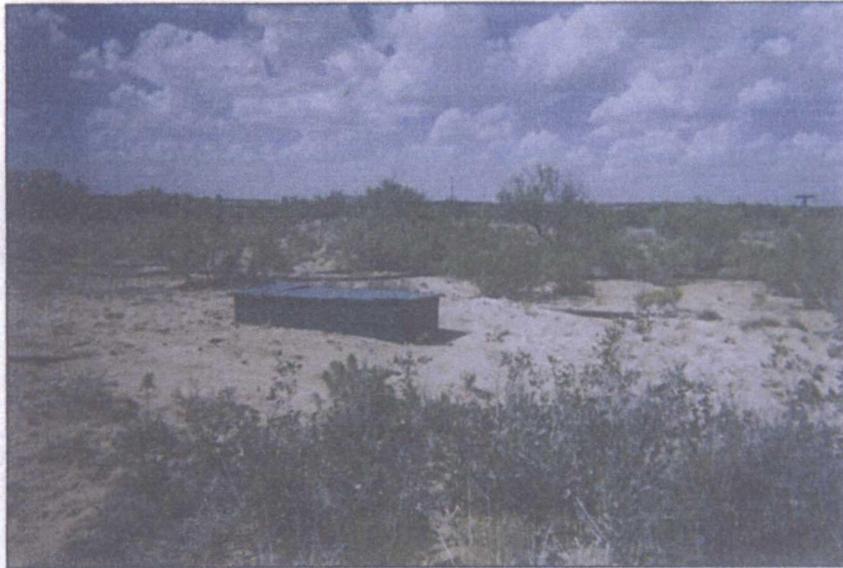
Undisturbed Junction Box Prior to NORM Removal

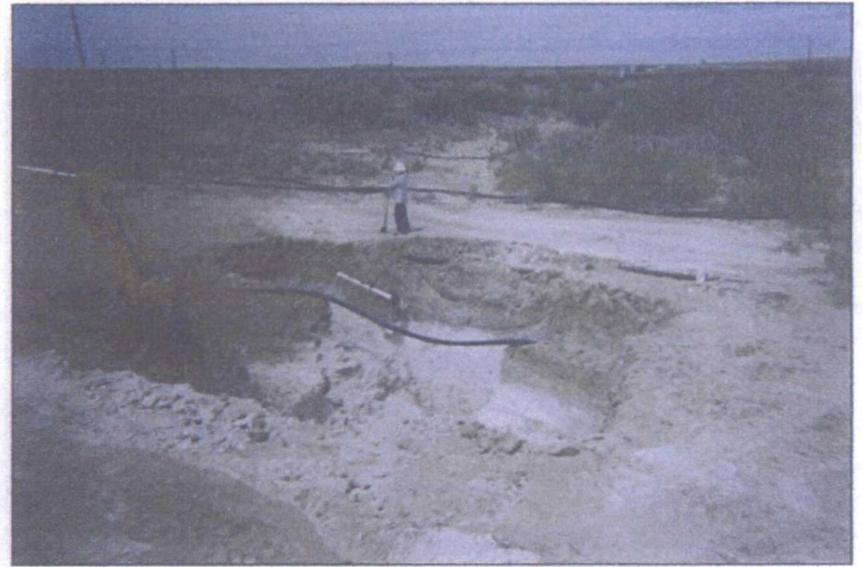
Excavation Sept. 2003

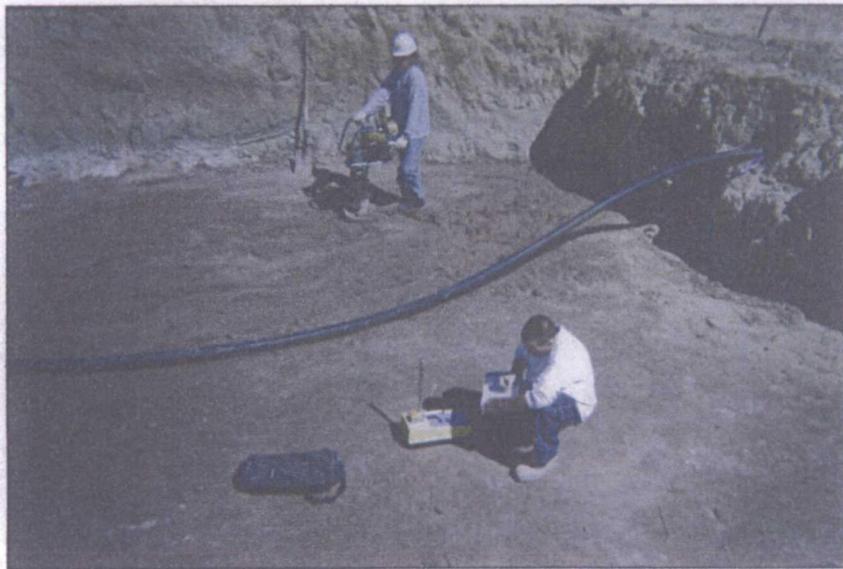
Compacting and Testing Clay Liner at 6 ft BGS 10/2/2003

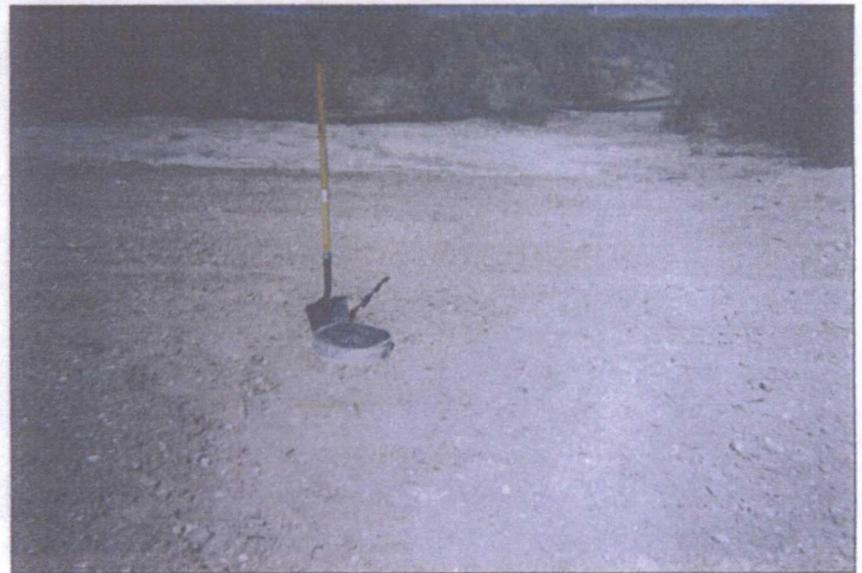
Backfilled Site with ID Plate Marking Clay Below

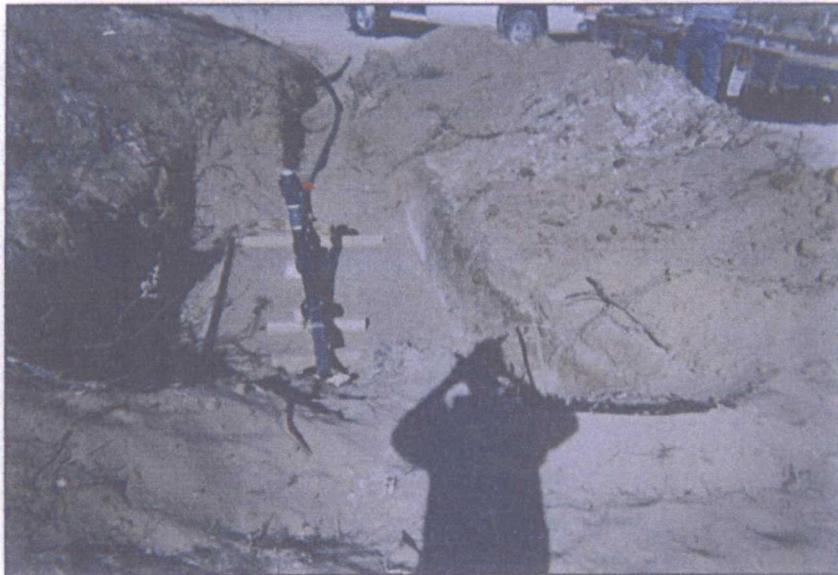
Construction of New Junction Box With New Plumbing

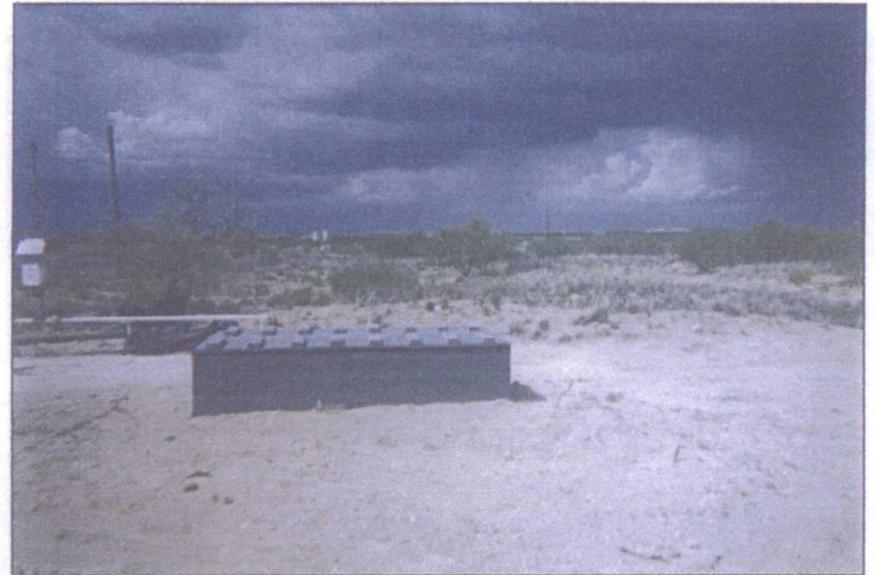
Completed Box 73 ft SW 8/29/2003

remaining blended material to ground surface and contoured to the surrounding area. On 10/15/2003, the site was seeded with a blend of native vegetation and is expected to return to a productive capacity at a normal rate. A new, water-tight junction box was built 73 ft southwest.

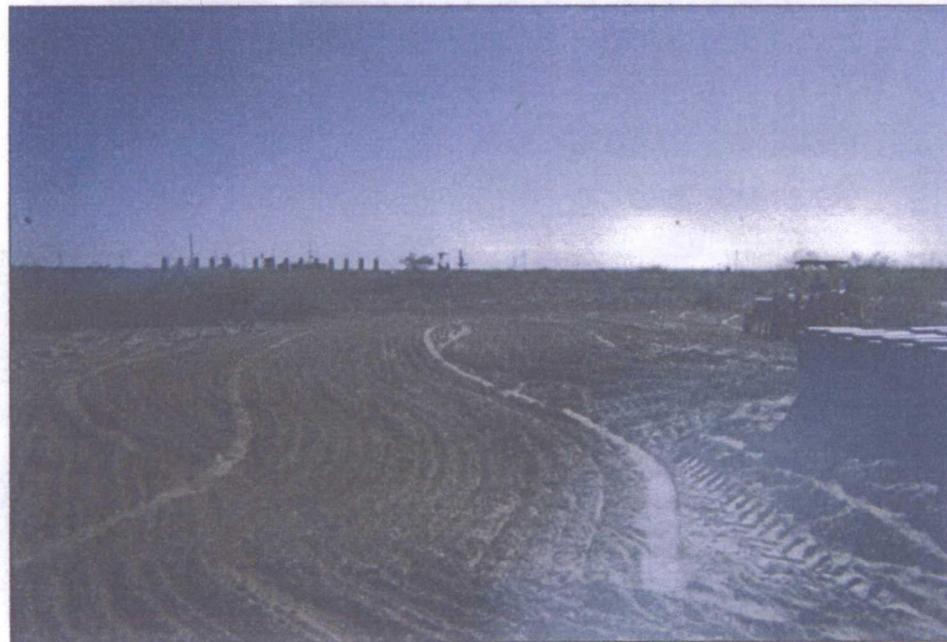
Seeding Disturbed Area 10/15/2003

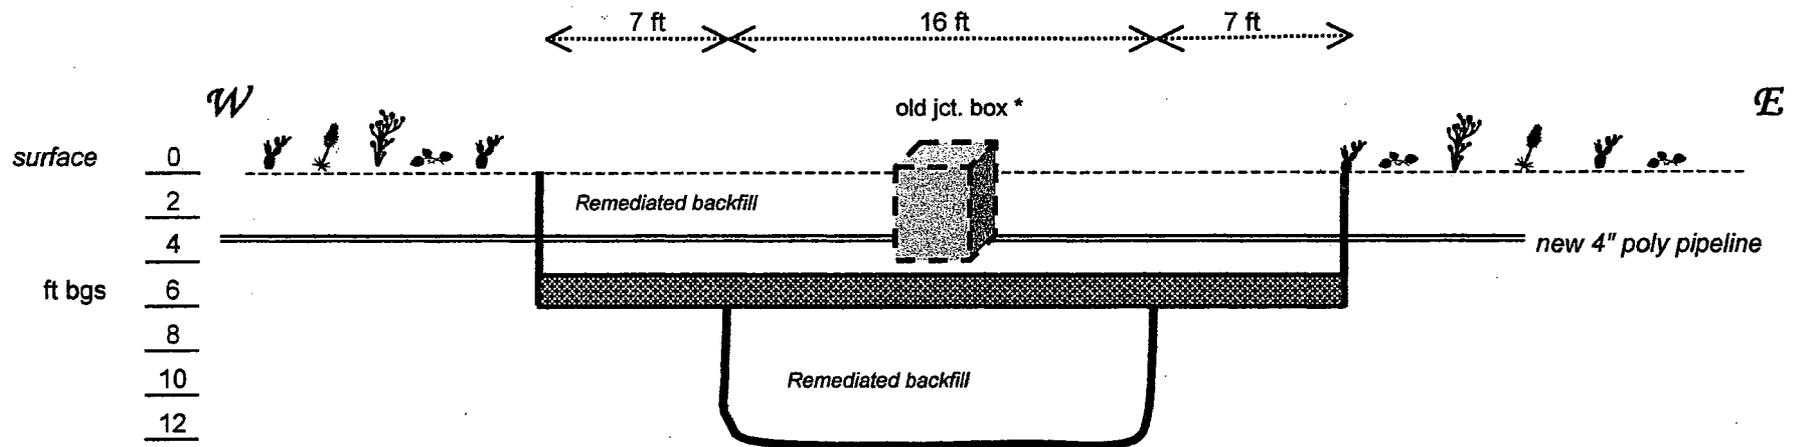
EME jct. P-34
Impact Excavation
Cross-Section

* New junction box has been built 73 ft Southwest from old junction.

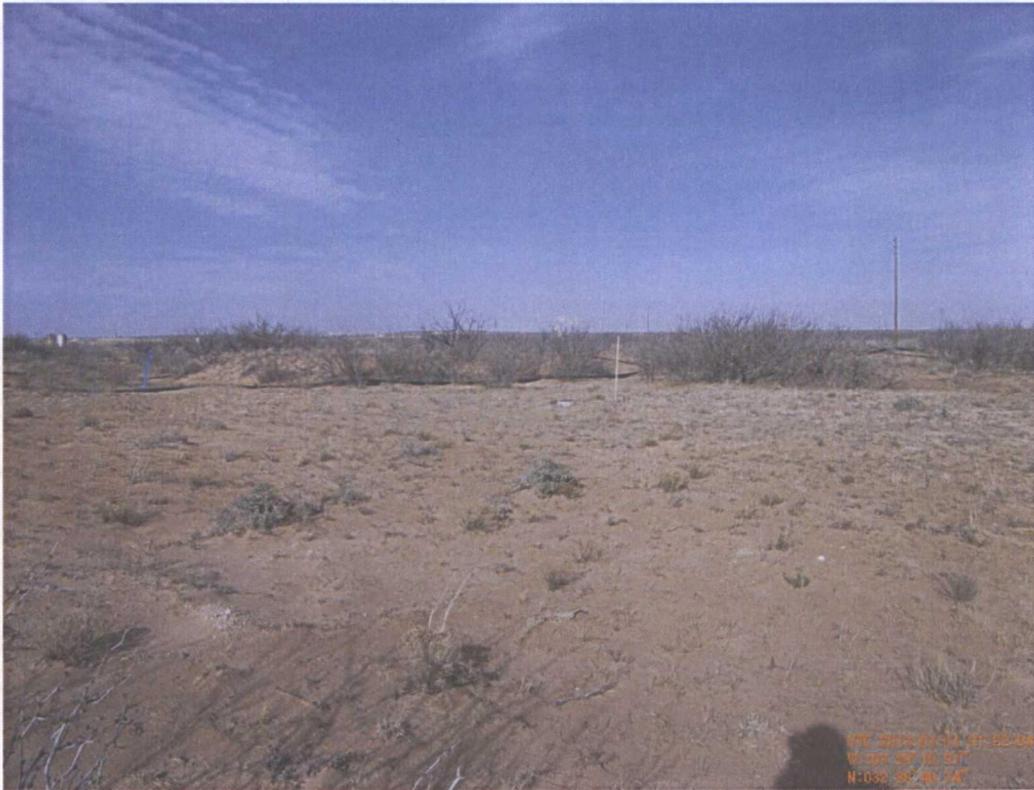
Facing North

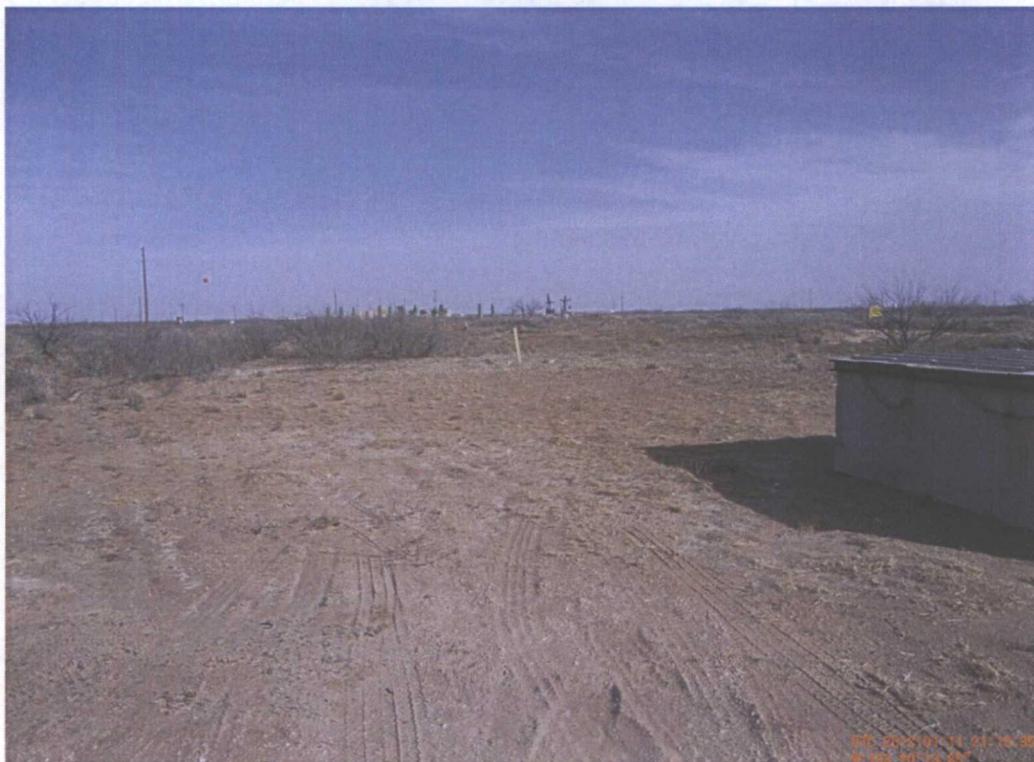
Facing East
