**RE: Termination Request  
for the Rice Operating Company's  
EME M-10-1 Site  
Unit Letter M, Section 10, T21S, R36E, NMPM, Lea County, New Mexico  
Remediation Plan (1R427-37) Termination**

RE: Termination Request  
EME M-10-1 (1R427-37): UL/M Sec. 10, T21S, R36E  
RICE Operating Company – Eunice Monument Eumont SWD System

**RICE OPERATING COMPANY  
JUNCTION BOX FINAL REPORT**

EME M-10-1 (1R427-37)  
Unit Letter M, Section 10, T21S, R36E

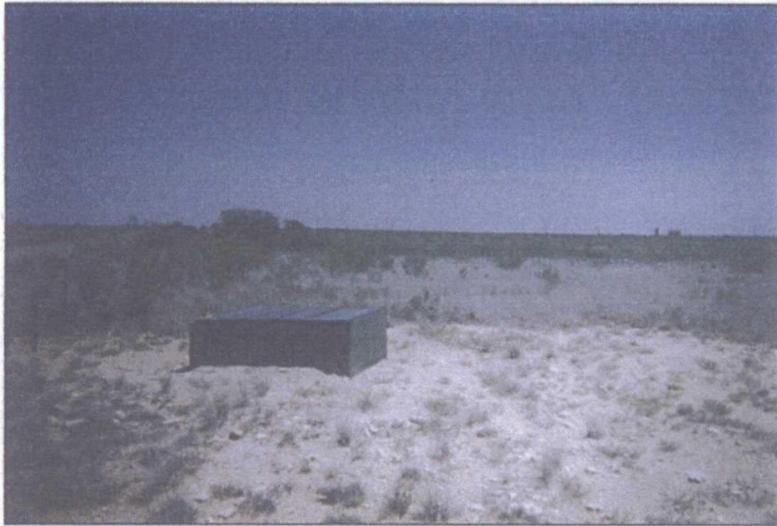
Old wooden box prior to excavation

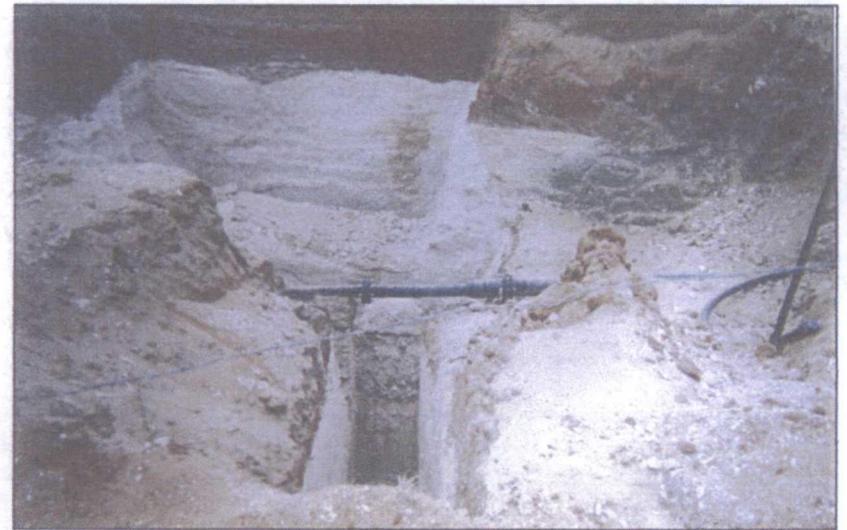
Backhoe excavation & delineation

General Description of Remedial Action: Delineation with a backhoe did not yield a sufficient decline in chloride concentrations with depth. PID readings were minimal and lab results confirmed that TPH concentrations are well below NMOCD guidelines.  
The location was bored to determine the vertical extent of chloride impact and tests of the returns conclusively indicate that chloride ceases well above groundwater depth (see graphs).  
A 1.5 ft compacted clay barrier was installed at the bottom of the 25 x 24 x 12-ft-deep excavation to inhibit further downward migration of chloride. The excavated soil was landfarmed at the location and then backfilled into the hole and leveled. The disturbed surface has been re-seeded with a blend of native vegetation and will be monitored for growth. A new watertight junction box has been built over this site.  
enclosed: lab results, chloride graphs, diagram, photos, clay compaction test

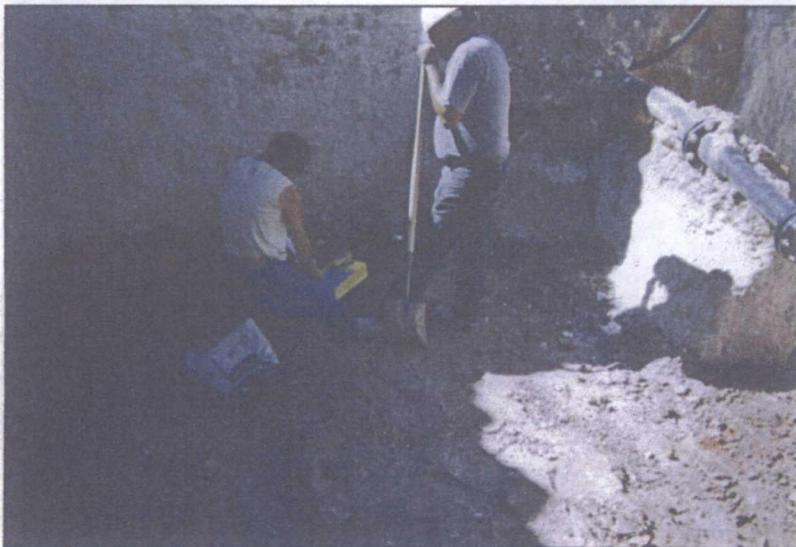
Density & compaction test of clay

From 12-10.5 ft BGS, a 1.5 thick clay liner was installed with a compaction test performed on October 13, 2003. The backfill was returned to the excavation to ground surface and contoured to the surrounding area. On 12/12/2003, the site was seeded with a blend of native vegetation and is expected to return to a productive capacity at a normal rate.

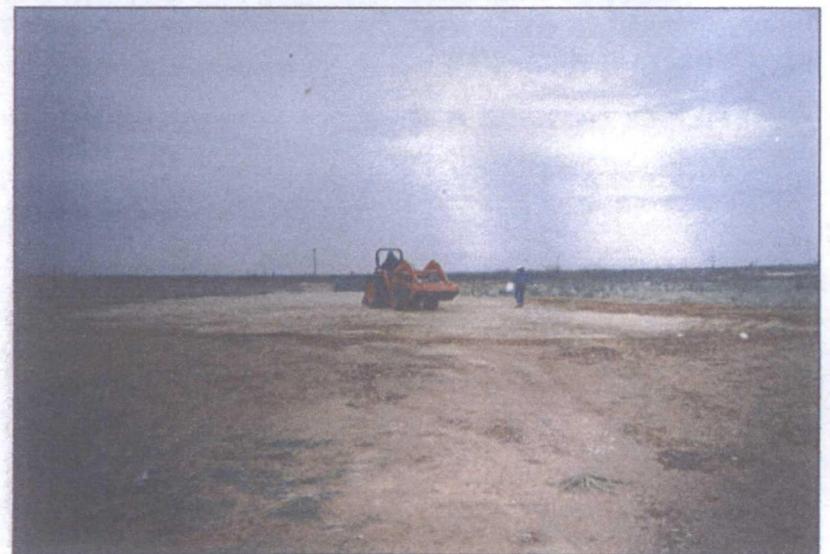
Seeding disturbed area; new plastic junction box in background

A new, watertight junction box was built over this site, and is now an access point for pigging and scrapping, as line maintenance. This requires a drivable surface around the junction box, making caliche necessary, and vegetation not necessary.
