From: Hansen, Edward J., EMNRD
Sent: Thursday, February 07, 2013 1:07 PM
To: Hack Conder (hconder@riceswd.com)
Cc: Leking, Geoffrey R, EMNRD; Laura Pena (lpena@riceswd.com); Katie Jones <kjones@riceswd.com> (kjones@riceswd.com); Scott Curtis (scurtis@riceswd.com)
Subject: Remediation Plan (1R427-26) Termination - ROC EME H-10-1 Site

**RE: Termination Request
for the Rice Operating Company's
EME H-10-1 Site
Unit Letter H, Section 10, T20S, R36E, NMPM, Lea County, New Mexico
Remediation Plan (1R427-26) Termination**

RE: Termination Request
EME H-10-1 (1R427-26): UL/H Sec. 10, T20S, R36E
RICE Operating Company – Eunice Monument Eumont SWD System

**RICE OPERATING COMPANY
JUNCTION BOX FINAL REPORT**

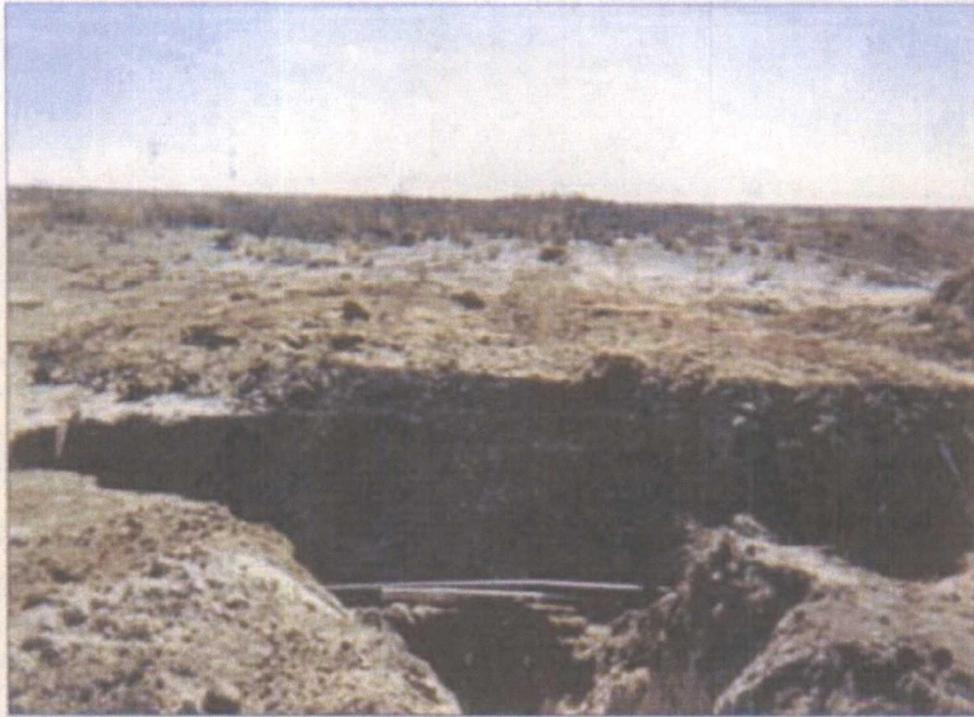
Before Remediation

General Description of Remedial Action: During the jct. box upgrade, it was discovered that the junction was adjacent to an abandoned production facility that was never remediated. The area surrounding the box and that to the south is barren and overlain by hardpan. 15' in every direction was excavated to the depth of 17'bgs where TPH concentrations met OCD guidelines. Chloride impact was minimal. The 30' x 30' x 17' excavation was lined with 20 mil plastic that extended up the sides to about 5'bgs to encapsulate the impacted soil. However, on-site landfarming remediated the soil to OCD guidelines. With the liner already in place, the excavation was backfilled with the remediated soil. The site has been re-seeded with native vegetation and will be monitored for growth. Remaining TPH is expected to naturally attenuate. This site is no longer a junction so a box is not required.

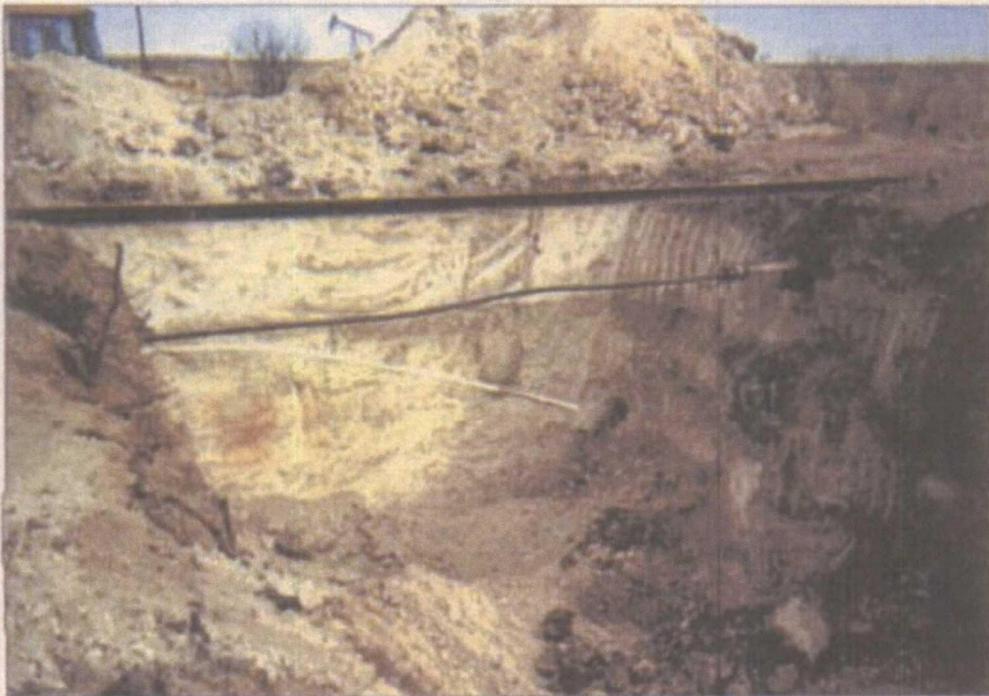
Impact Excavation

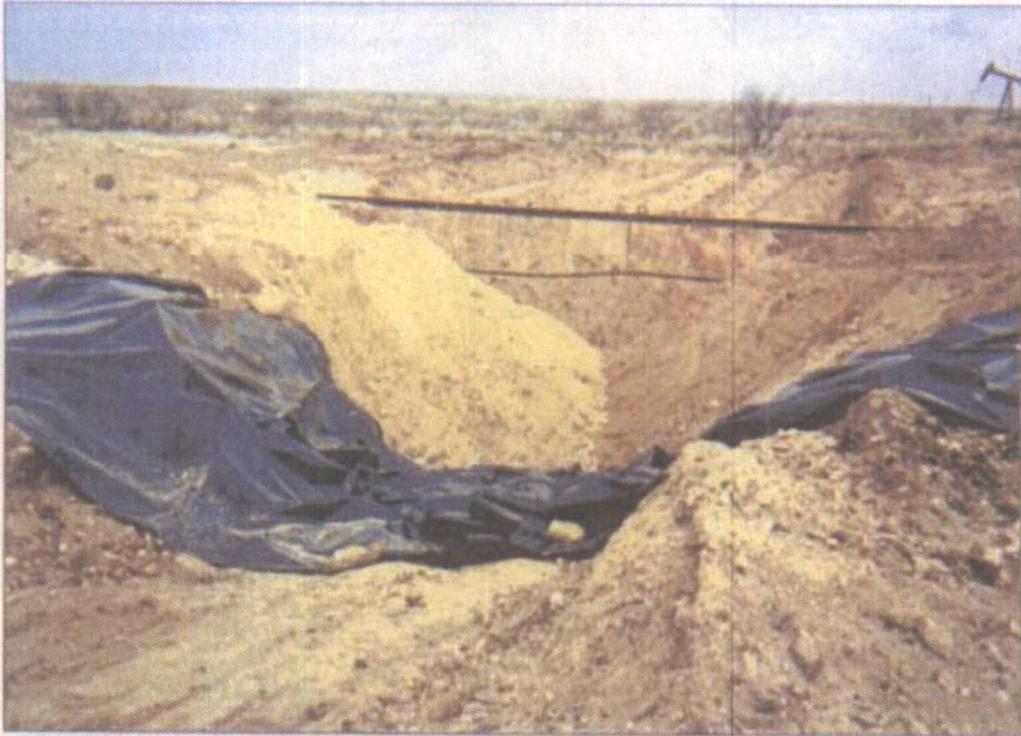
Backfilling Poly Liner

In 2003, ROC initiated work on the former H-10-1 junction box. The site is located in UL/H, Sec. 10, T20S, R36E. NM OSE records indicate that groundwater would likely be encountered at a depth of approximately 31 +/- feet. After the junction box was eliminated, the site was delineated using a backhoe to collect soil samples at regular intervals, creating a 30 x 30 x 17 ft deep excavation. Each sample was field titrated for chlorides, resulting in chloride concentrations that decreased with depth. The excavated soil was blended on site and representative composite samples of the excavation bottom, the excavation walls, and the backfill were sent to a commercial for analysis of chloride and TPH, resulting in a sidewall chloride concentration of 338 mg/kg, a gasoline range organics (GRO) concentration below detectable limits and a diesel range organics (DRO) concentration of 189 mg/kg. The bottom composite resulted in a chloride concentration of 145 mg/kg, a GRO concentration below detectable limits and a DRO concentration of 49.2 mg/kg. The backfill resulted in a chloride concentration below detectable limits, a GRO concentration below detectable limits, and a DRO concentration of 113 mg/kg. BTEX was also analyzed, resulting in concentrations below detectable limits in all samples. On February 13, 2003, a 20-mil plastic liner was installed at approximately 17 ft

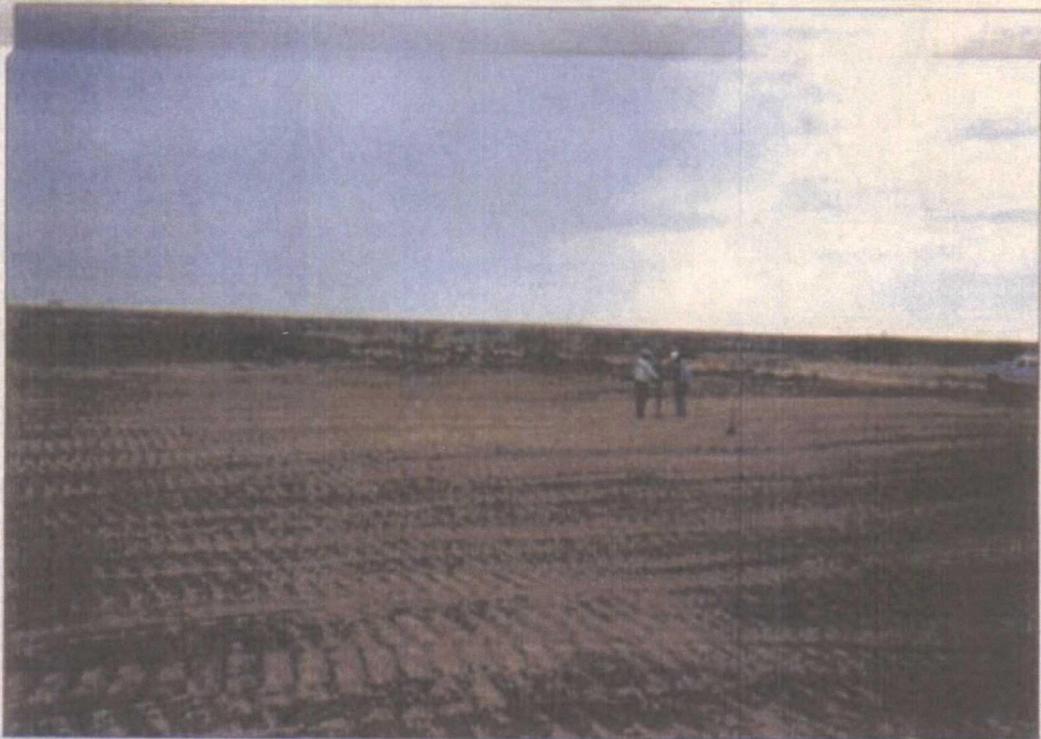
Backfilled (looking north)

bgs. The remediated soil was returned to the excavation to ground surface and contoured to the surrounding area. On April 21, 2003, the site was seeded with a blend of native vegetation and is expected to return to a productive capacity at a normal rate.

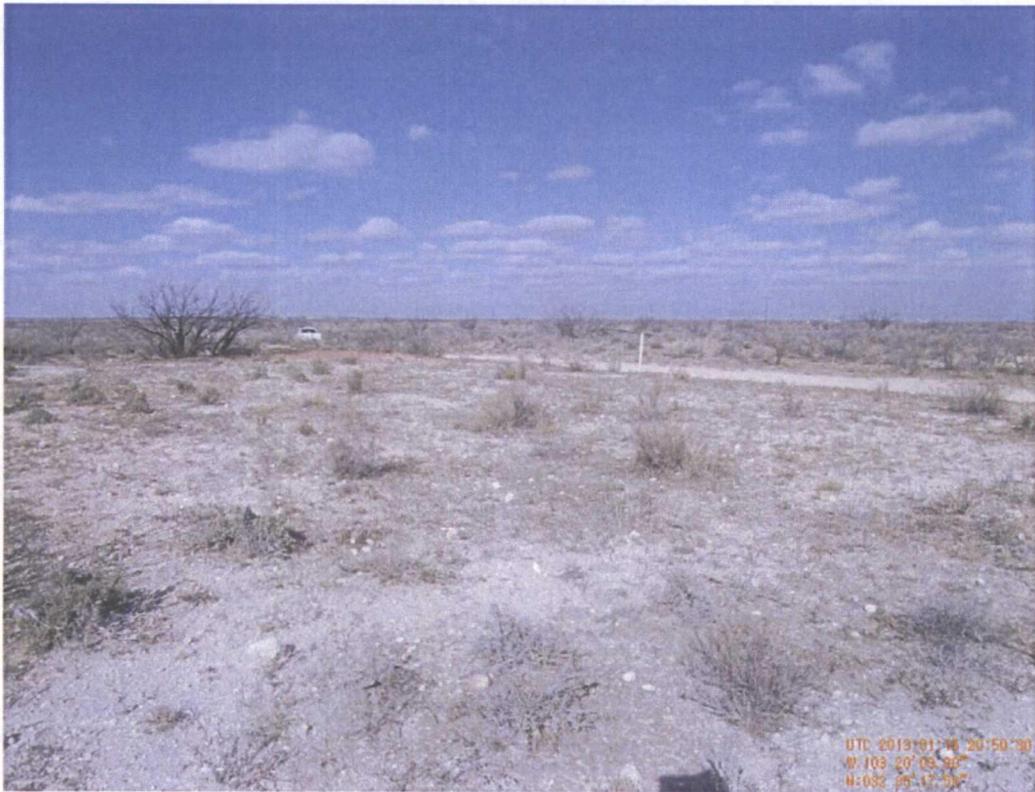
1/15/2013

Facing North

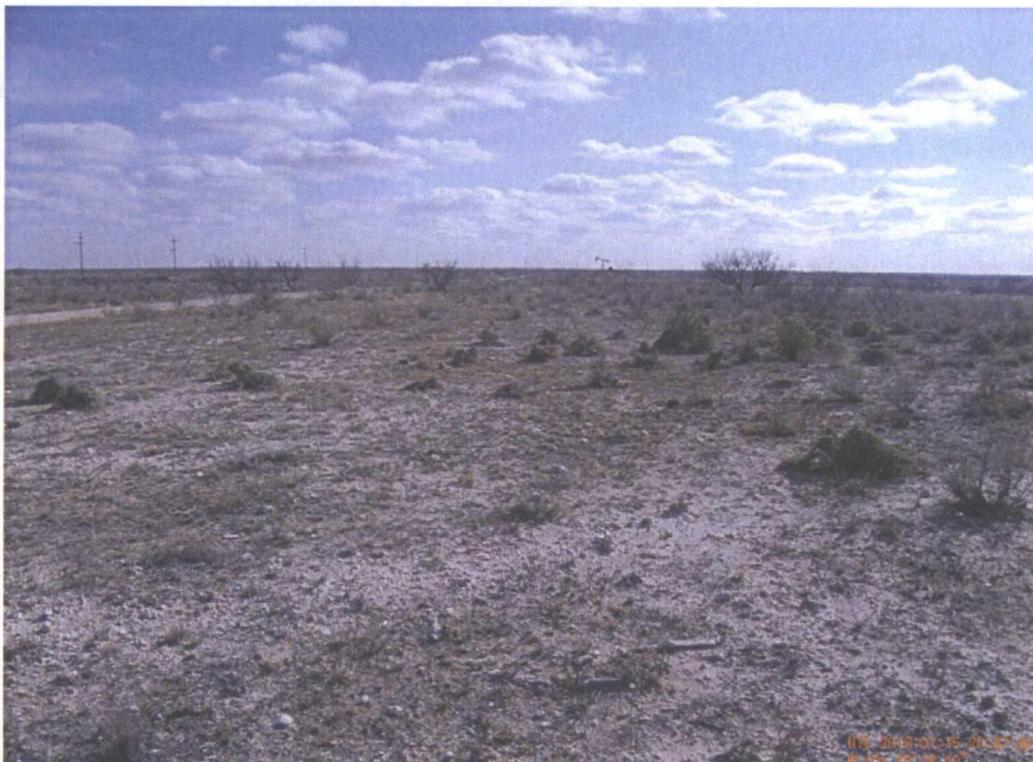
1/15/2013

Facing South

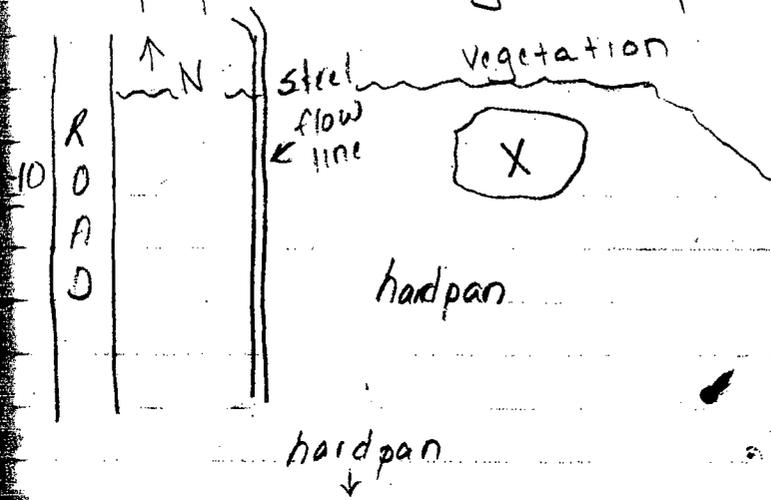
EME Jct. H-10-1

2" poly line @ 3' bgs; Sandy; stressed vegetation.

3'	338	TPH	149	CI-	NO	Sand
3'	5000		8300		50	Dark sand
5'	2490		1716		"	Sand w/caliche
7'	1349		199		NO	"
9'	1080		201		"	"
11'	6000	LAB 4631	284		"	"
13'	9200					
15'	625

Excavation w trackhoe to 17'

17'	—	TPH	259	CI-	NO	Caliche
19'	—	TPH	800	CI-	NO	Caliche

Btm. Comp @ 17' = $\frac{93}{RR}$ TPH $\frac{189}{LAB=49}$ CI- $\frac{189}{LAB=145}$

Wall Comp. = $\frac{LAB=189}{TPH}$ $\frac{LAB=338}{CI-}$

2/13 Install 20 mil. poly liner + backfill

2/22 Backfill = $\frac{113}{220}$ TPH } LAB
 CI-
