From: Hansen, Edward J., EMNRD
Sent: Wednesday, February 20, 2013 11:32 AM
To: Hack Conder (hconder@riceswd.com)
Cc: Leking, Geoffrey R, EMNRD; Laura Pena (lpena@riceswd.com); Katie Jones <kjones@riceswd.com> (kjones@riceswd.com); Scott Curtis (scurtis@riceswd.com)
Subject: Remediation Plan (1R427-347) Termination - ROC EME Jct G-13 Site

RE: Termination Request
EME Jct. G-13 (1R427-347): UL/G, Sec. 13, T20S, R36E
RICE Operating Company – Eunice Monument Eumont SWD System

**EME
JCT G-13**

**RICE OPERATING COMPANY
JUNCTION BOX FINAL REPORT**

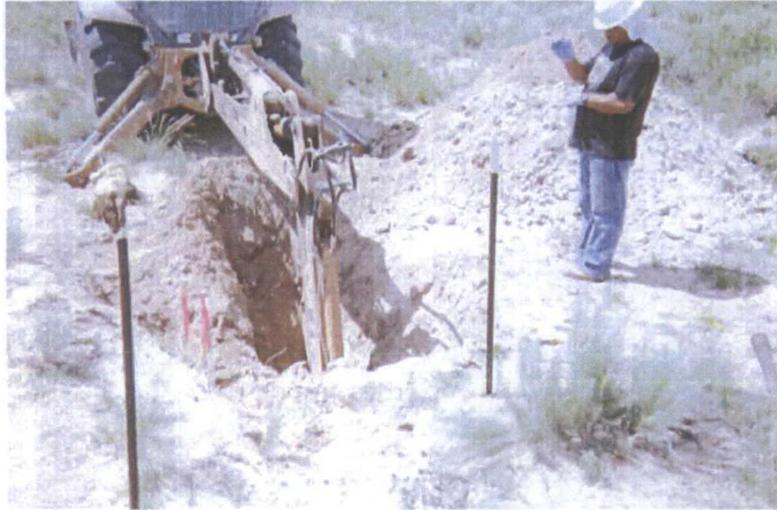
DELINEATION TRENCH BEING EXCAVATED

6/14/10

General Description of Remedial Action: This junction and line were eliminated during the pipeline replacement/upgrade program. After the former junction box was removed, an investigation was conducted using a backhoe to collect soil samples at regular intervals producing a 5X3X8-ft. deep excavation. Chloride field tests performed on each sample yielded low concentrations. Organic vapors were measured using a PID, which yielded low concentrations. The deepest sample, 8 ft. BGS, was sent to a commercial laboratory for analysis of chloride and TPH, which confirmed low concentrations of each. The excavated soil was returned to the excavation to ground surface and contoured to the surrounding area. On 7/08/2010, the site was seeded with a blend of native vegetation and is expected to return to a normal capacity at a normal rate.

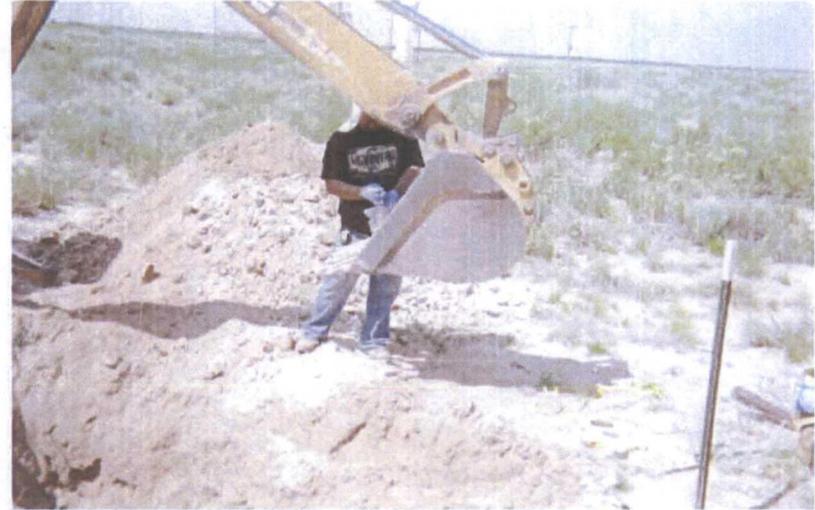
COLLECTING SAMPLE

6/14/10

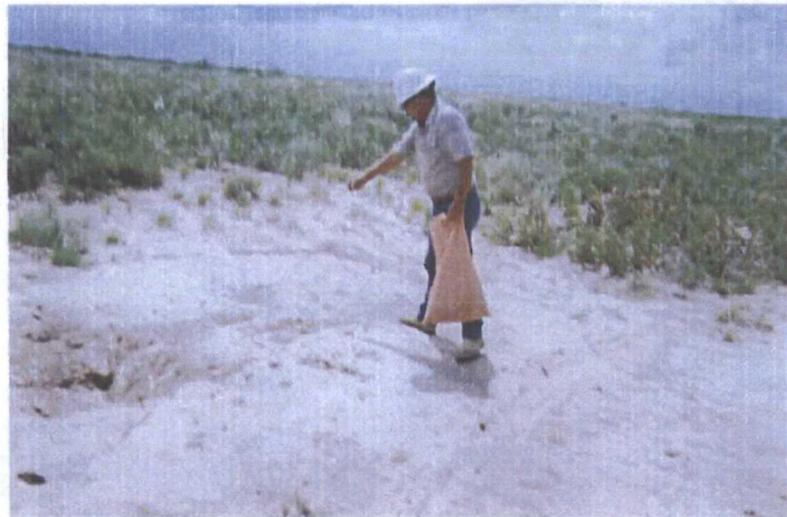
SEEDING SITE

7/8/10

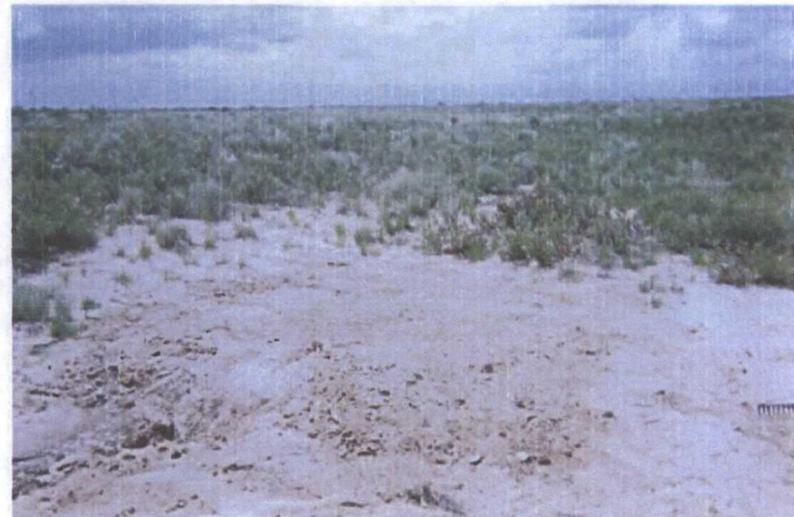
SITE COMPLETE

7/14/10

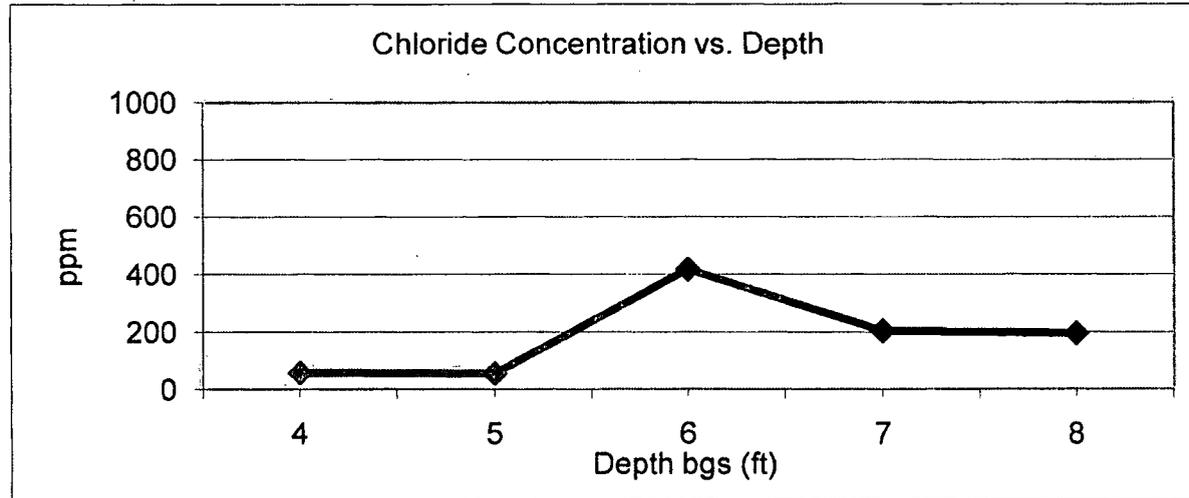
CHLORIDE CONCENTRATION CURVE

Delineation of Source

Depth bgs (ft)	[Cl ⁻] ppm
4	59
5	56
6	418
7	204
8	196

Groundwater = 34 ft

LOCATION	DEPTH	mg/kg
Background	6"	56
vertical delineation of junction (source)	4'	59
	5'	56
	6'	418
	7'	204
	8'	196

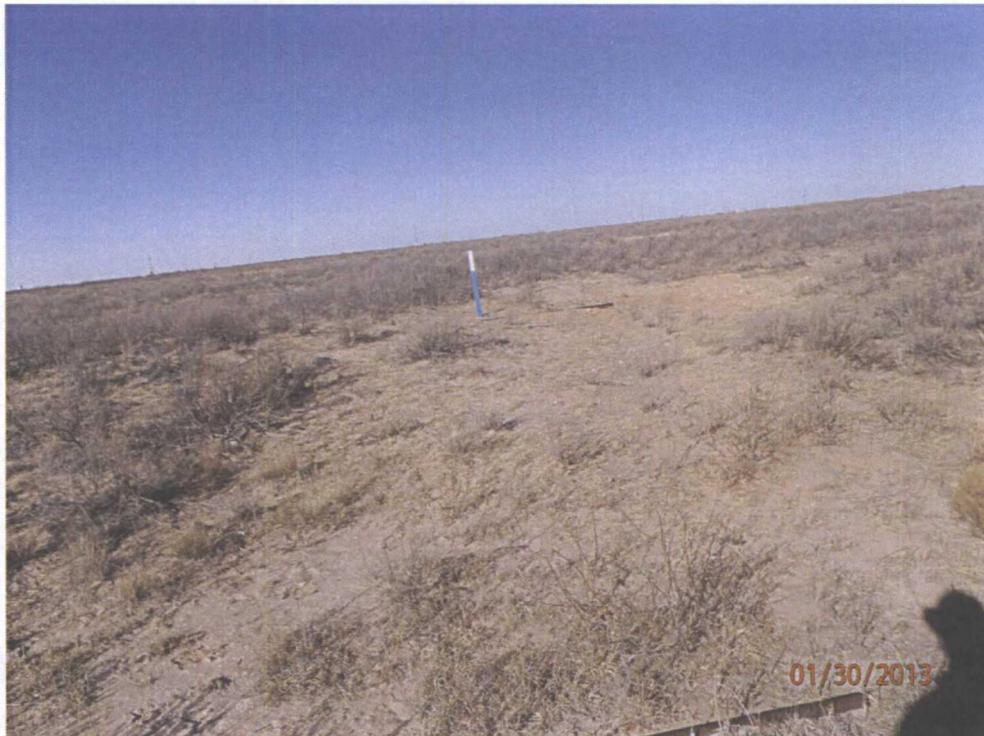
Facing west

1/30/2013

In 2010, ROC initiated work on the former G-13 junction box. The site is located in UL/G, Sec. 13, T20S, R36E. NM OSE records indicate that groundwater would likely be encountered at a depth of approximately 34 +/- feet. The site was delineated using a backhoe to collect soil samples at regular intervals, creating a 5x3x8 ft deep excavation. Each sample was field titrated for chlorides and field screened using a PID for hydrocarbons, resulting in chloride concentrations that decreased with depth. The 8 ft sample was sent to a commercial laboratory for analysis of chloride and TPH, resulting in a chloride concentration of 192 mg/kg and concentrations of gasoline range organics (GRO) and diesel range organics (DRO) below detectable limits. The excavated soil was returned to the excavation and contoured to the surrounding area. On 7/8/2010, the site was seeded with a blend of native vegetation. A junction box is no longer needed at the site. Vegetation has rebounded at the site, so no re-vegetation efforts are needed.

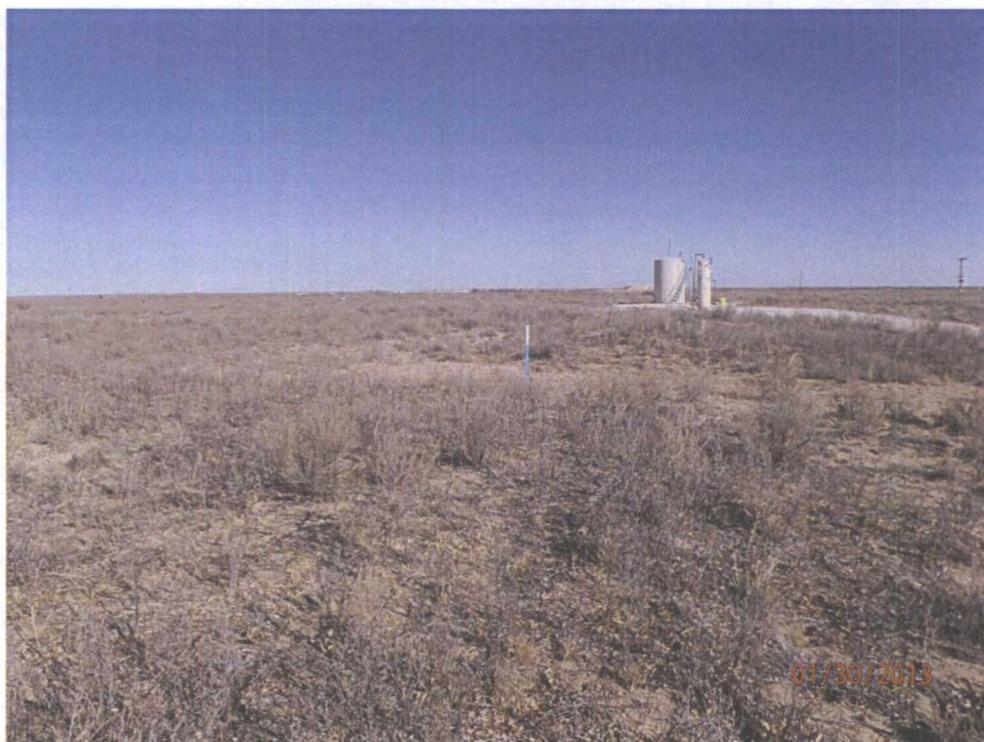
Facing north

1/30/2013
