**RE: Termination Request
for the Rice Operating Company's
EME Jct I-20 Site
Unit Letter I, Section 20, T19S, R37E, NMPM, Lea County, New Mexico
Remediation Plan (1R427-352) Termination**

RE: Termination Request
EME Jct. I-20 (1R427-352): UL/I, Sec. 20, T19S, R37E
RICE Operating Company – Eunice Monument Eumont SWD System

**RICE OPERATING COMPANY
JUNCTION BOX FINAL REPORT**

EME JCT. I-20

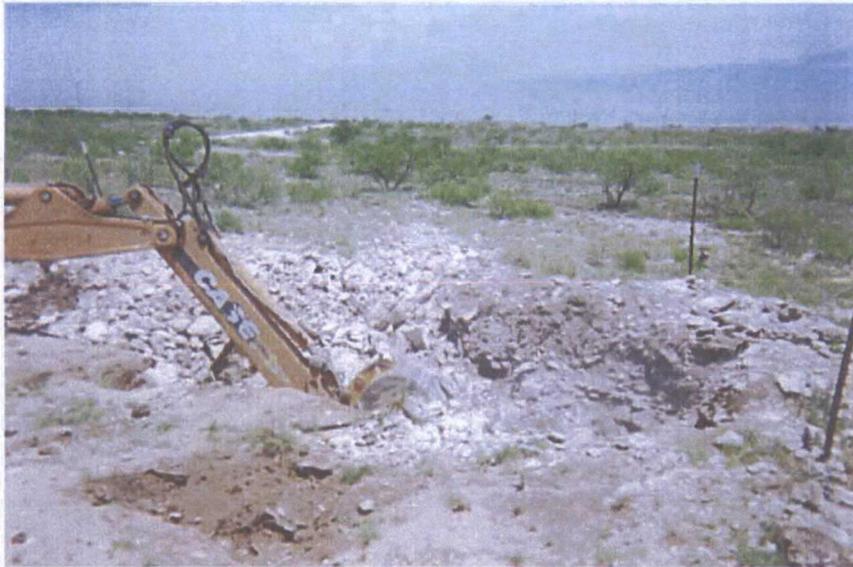
6/8/2010

Digging delineation trench

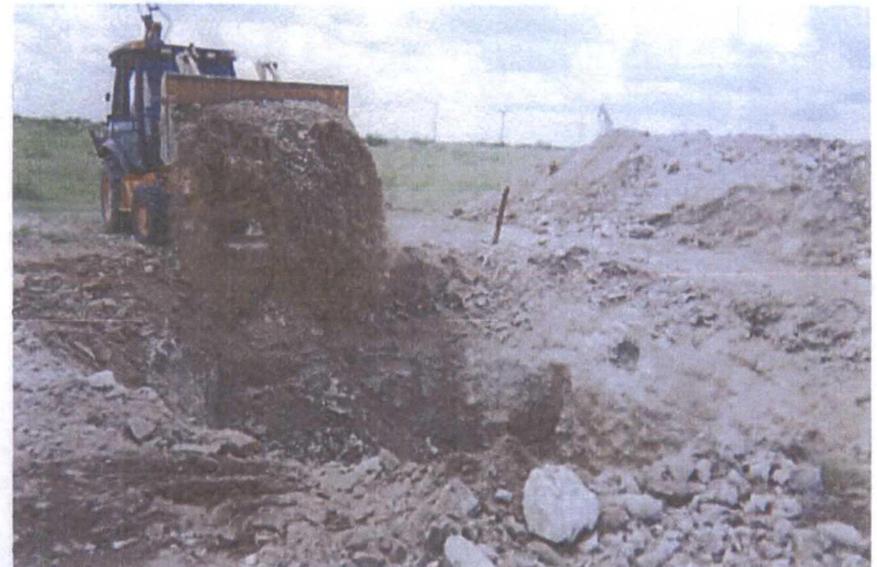
7/29/2010

Backfilling site

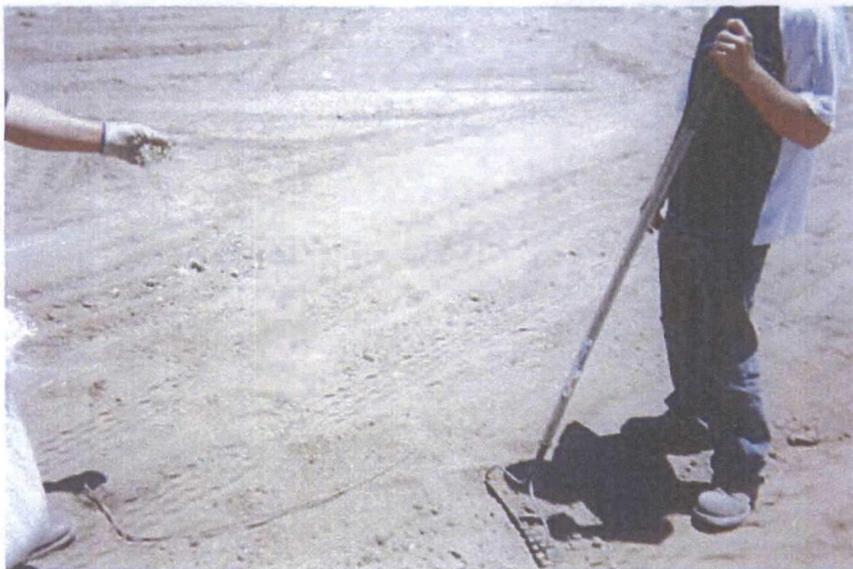
8/23/2010

Seeding site

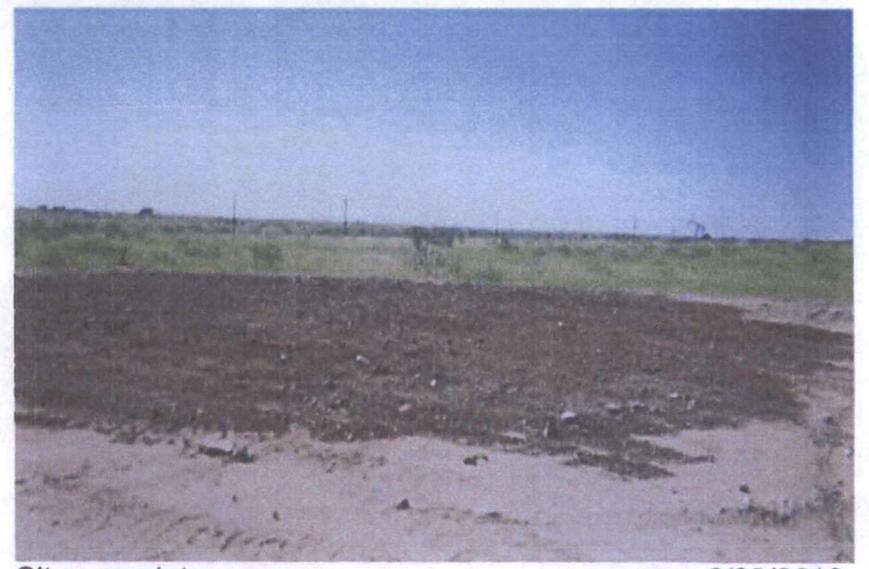
8/23/2010

Site complete

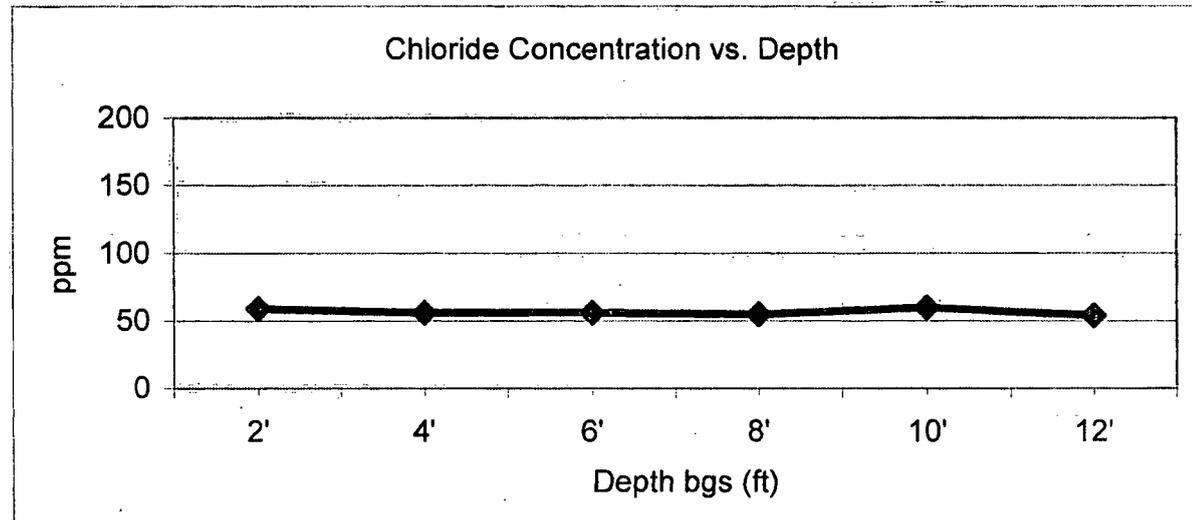
Backhoe samples 5 ft. north of the junction (source)

Depth bgs (ft)	[Cl ⁻] ppm
2'	59
4'	56
6'	56
8'	55
10'	60
12'	54

Groundwater = 35 ft

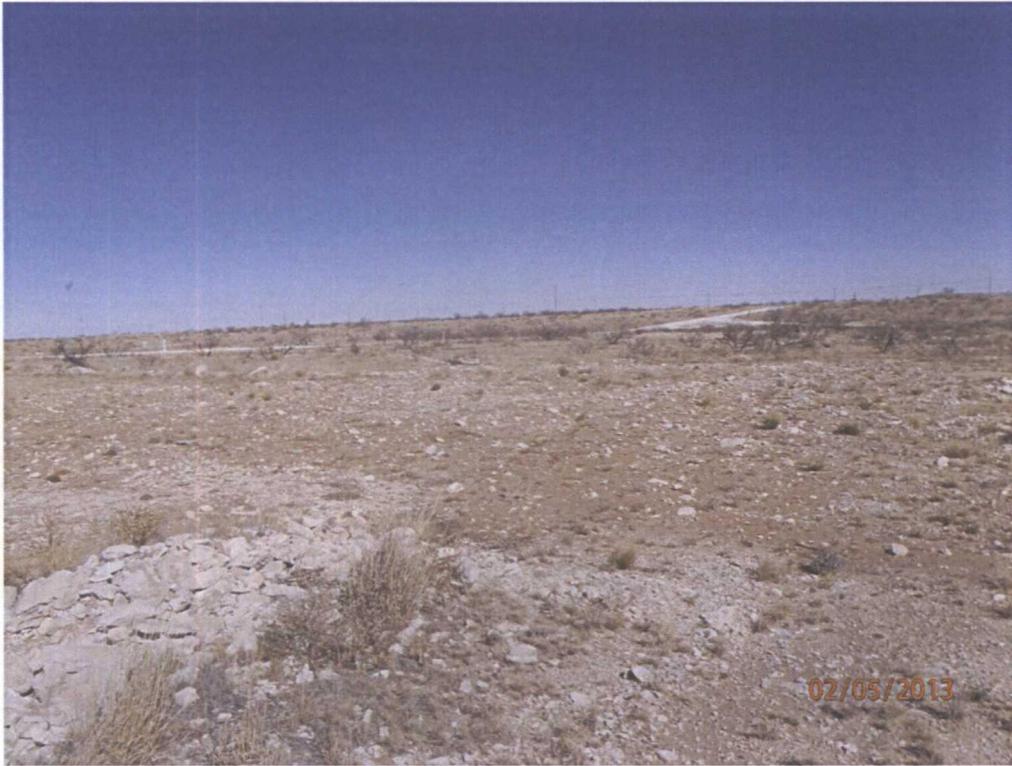
2/5/2013

Facing northeast

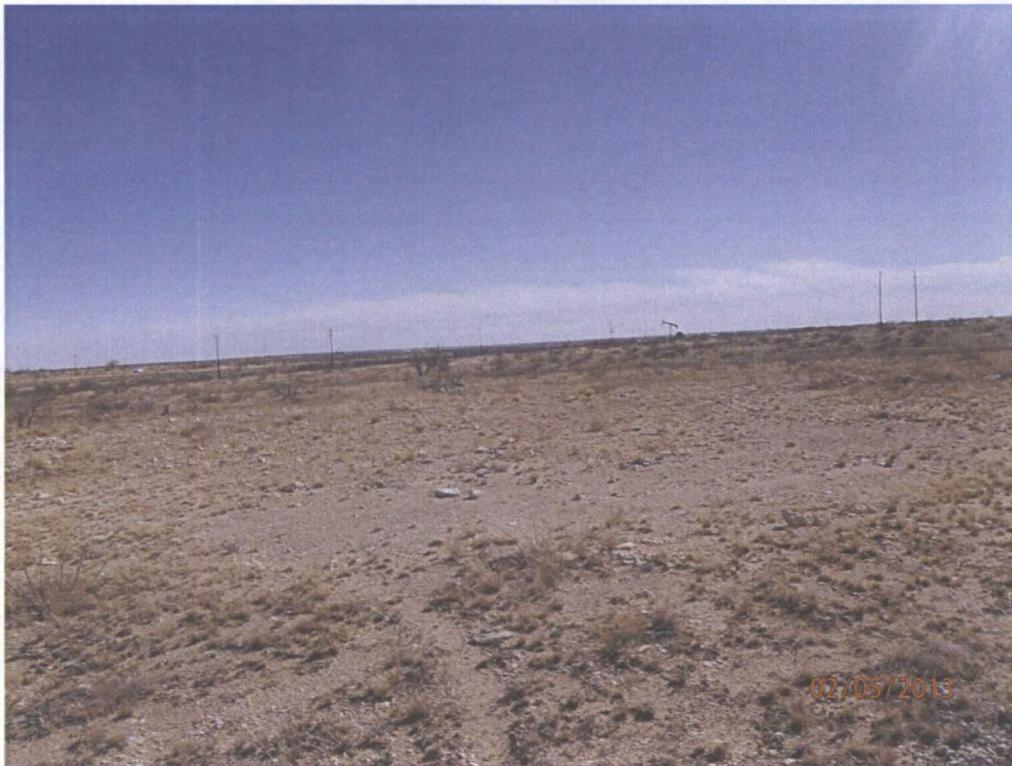
2/5/2013

Facing southeast
