From: Hansen, Edward J., EMNRD
Sent: Thursday, March 14, 2013 5:57 PM
To: Hack Conder (hconder@riceswd.com)
Cc: Leking, Geoffrey R, EMNRD; Laura Pena (lpena@riceswd.com); Katie Jones <kjones@riceswd.com> (kjones@riceswd.com); Scott Curtis (scurtis@riceswd.com)
Subject: Remediation Plan (1R427-333) Termination - ROC EME Jct H-20 Site

RE: Termination Request
EME Jct. H-20 (1R427-333): UL/H, Sec. 20, T19S, R37E
RICE Operating Company – Eunice Monument Eumont SWD System

**EME Jct. H-20
(1R427-333)**

RICE OPERATING COMPANY
JUNCTION BOX FINAL REPORT

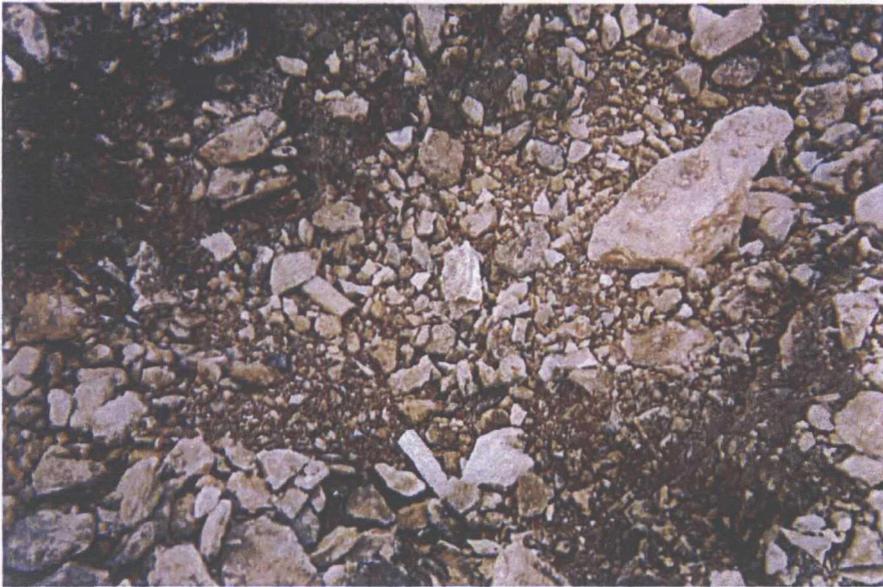
2/08/2010

Site prior to excavation

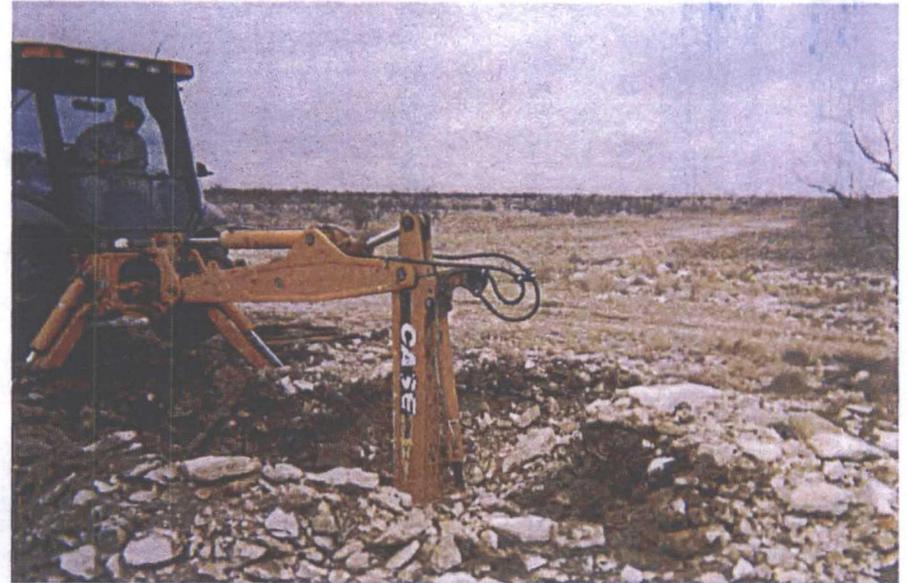
2/08/2010

Delineation trench at former junction box

General Description of Remedial Action: This junction and line were eliminated under the pipeline replacement/upgrade program. After the former junction was removed, an investigation was conducted using a backhoe to collect soil samples at regular intervals. Chloride field tests were performed on each sample, which yielded low concentrations of chloride similar to that of the background sample. Organic vapors were measured using a PID, which also yielded low concentrations. The deepest sample, 8 ft BGS, was sent to a commercial laboratory for analysis, which confirmed low concentrations of chloride and organics. The excavated soil was returned to the excavation to ground surface and contoured to the surrounding area. On 2/17/2010, site was seeded with a blend of native vegetation and is expected to return to a productive capacity at a normal rate.

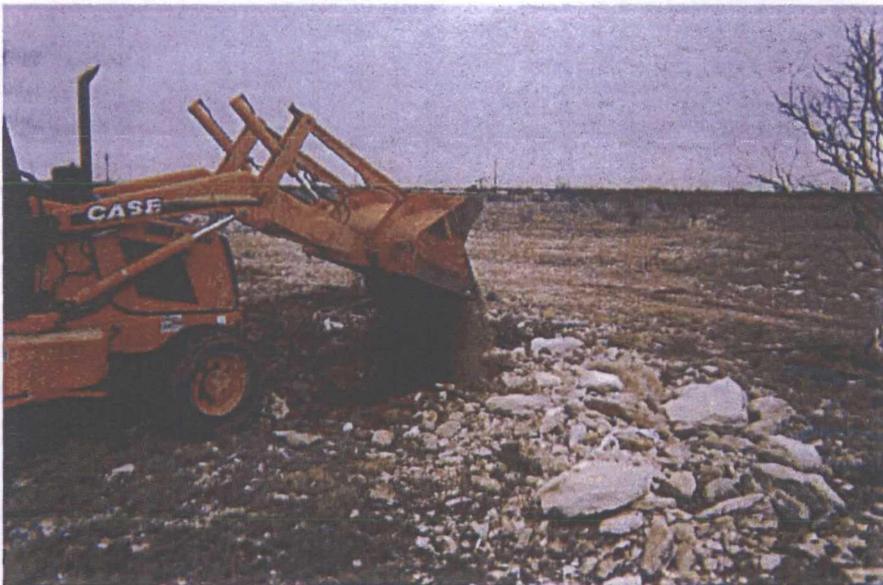
2/08/2010

Backfilling excavation

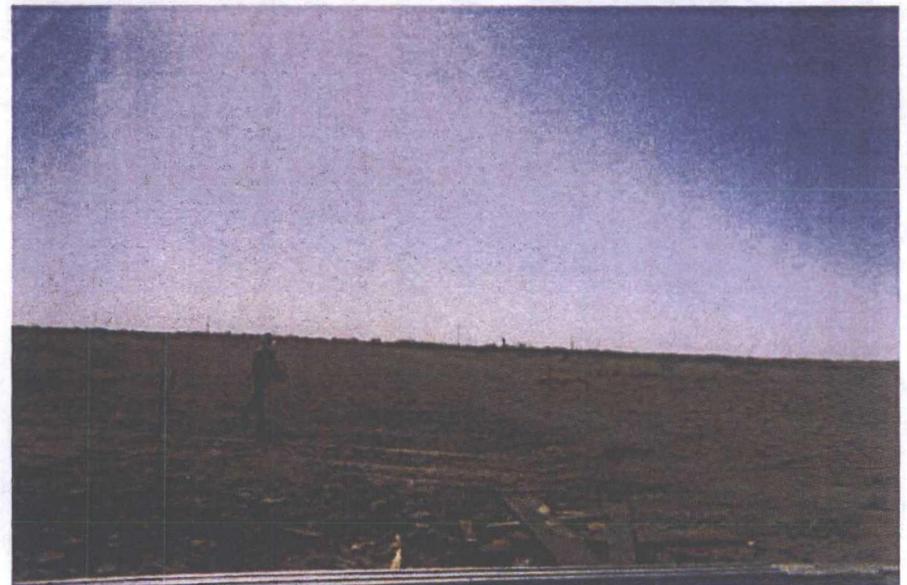
2/17/2010

Seeding excavation

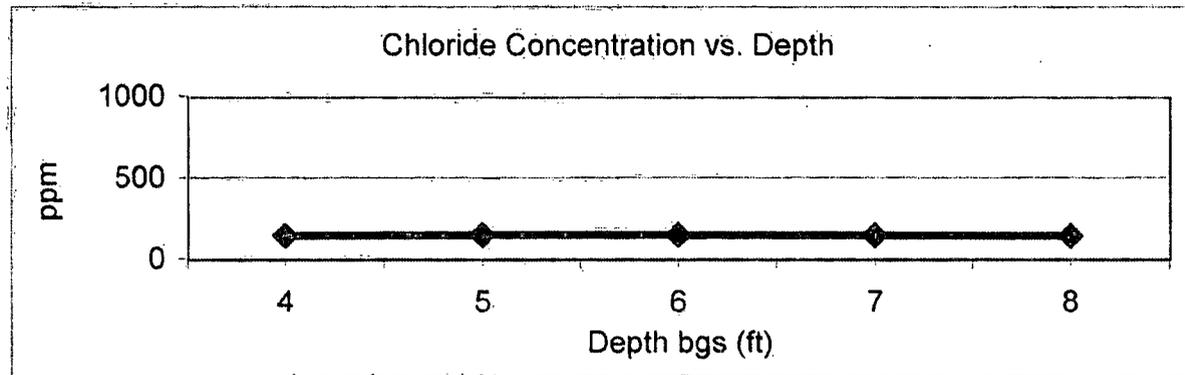
CHLORIDE CONCENTRATION CURVE

Backhoe samples at the junction (source)

Groundwater = 37 ft.

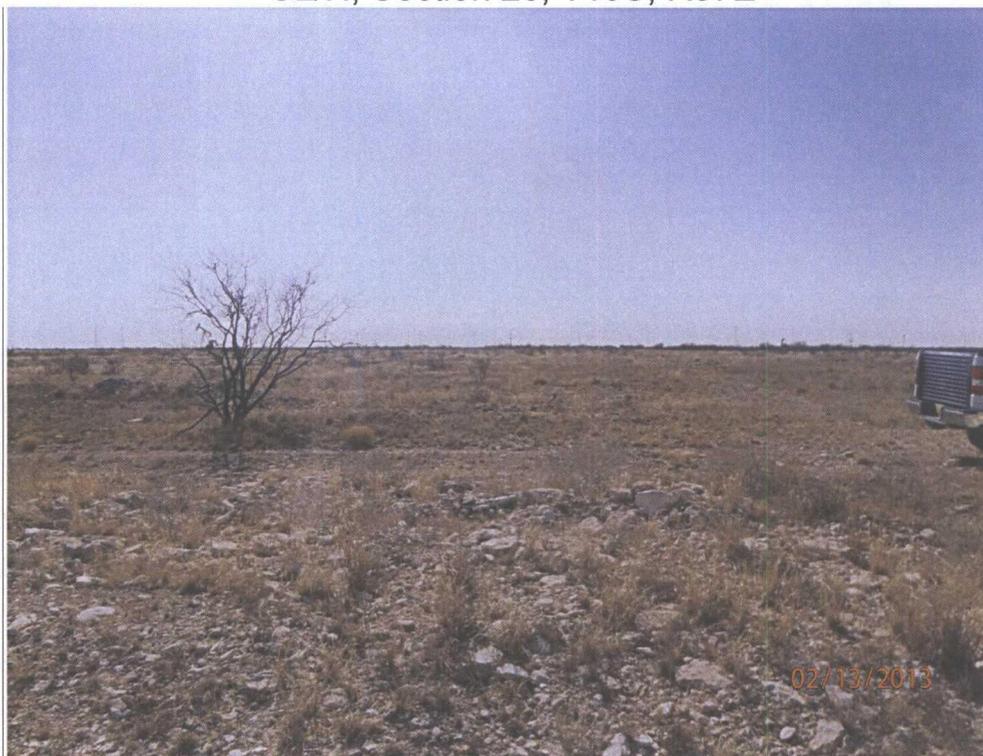
2/13/2013

Facing west

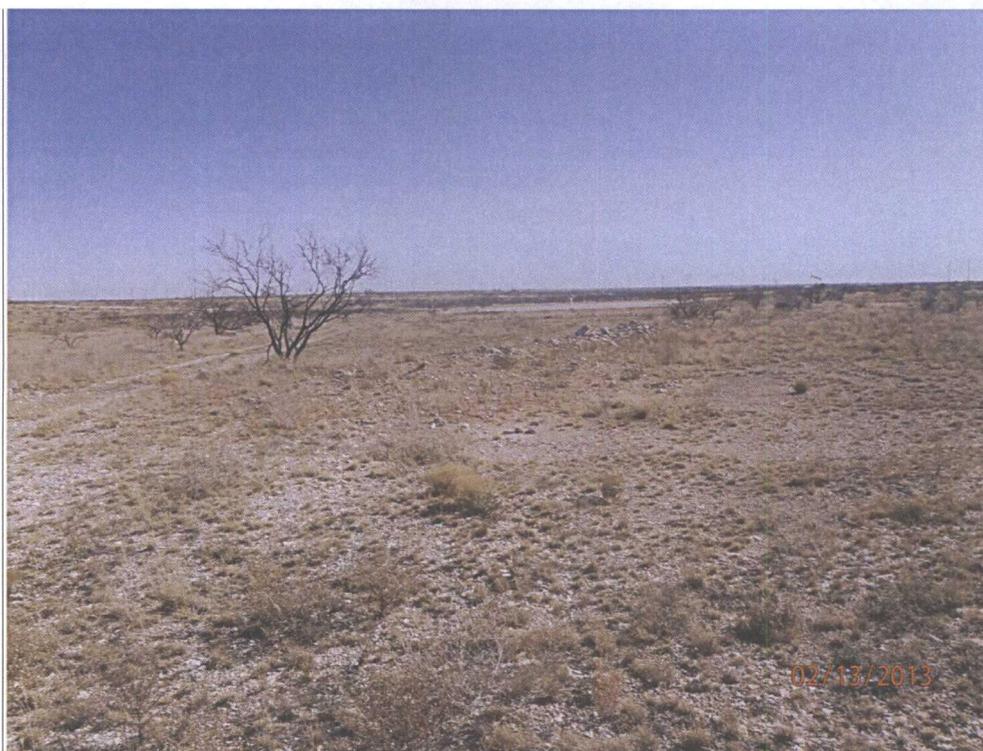
2/13/2013

Facing south
