**RE: Corrective Action Plan Report and Termination Request
for the Rice Operating Company's
EME Jct G-14 Site
Unit Letter G, Section 14, T20S, R36E, NMPM, Lea County, New Mexico
Remediation Plan (1R427-366) Termination**

**RE: Corrective Action Plan (CAP) Report and Termination Request
Rice Operating Company – EME SWD System
EME jct. G-14 (1R427-366): UL/G sec. 14 T20S R36E**

EME Jct. G-14 (1R427-366)

UL/G, Section 14, T20S, R36E

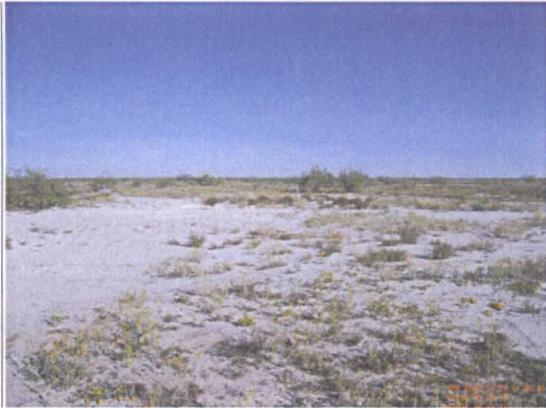
10/29/2012

Site Prior, facing east

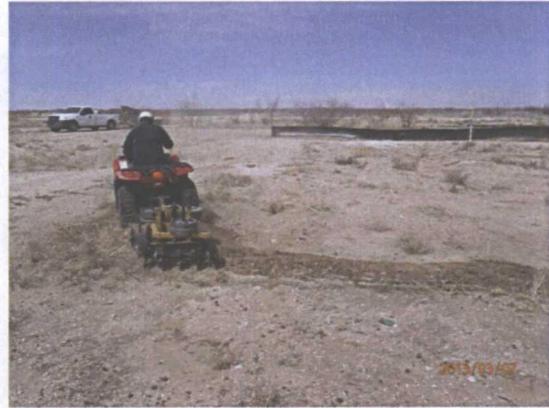
3/7/2013

Disking site prior to spreading amendments, facing north

On March 7th, 2013, RECS personnel were on site to prepare and seed the area. The site was disked, and soil amendments were added. The site was then seeded with a blend of native vegetation. The site re-vegetation form and photos of these activities can be found in Appendix A.

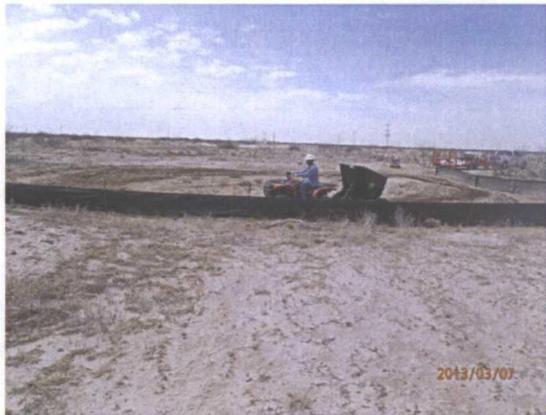
3/7/2013

Spreading amendments, facing west

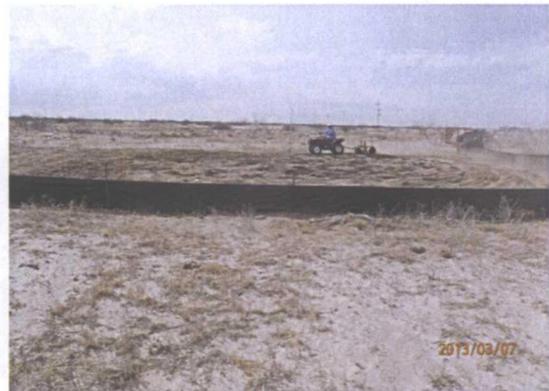
3/7/2013

Disking site preparing for seed, facing west

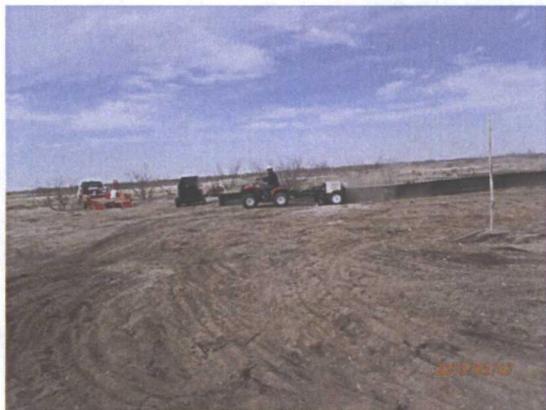
3/7/2013

Seeding site, facing north

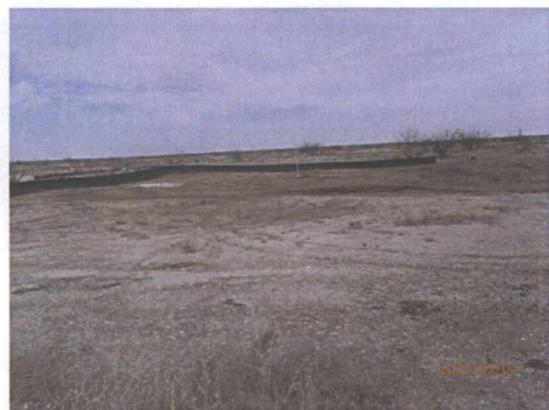
3/7/2013

Site complete, facing east

ROC has completed the corrective actions as approved by NMOCD on September 17th, 2012. Therefore, ROC requests 'remediation termination' or similar closure status of the site.
