EME P-20 EOL

CLOSURE

RE: Termination Request
EME P-20 EOL: UL/P, Sec. 20, T19S, R37E
RICE Operating Company – Eunice Monument Eumont SWD System

**RICE OPERATING COMPANY
JUNCTION BOX FINAL REPORT**

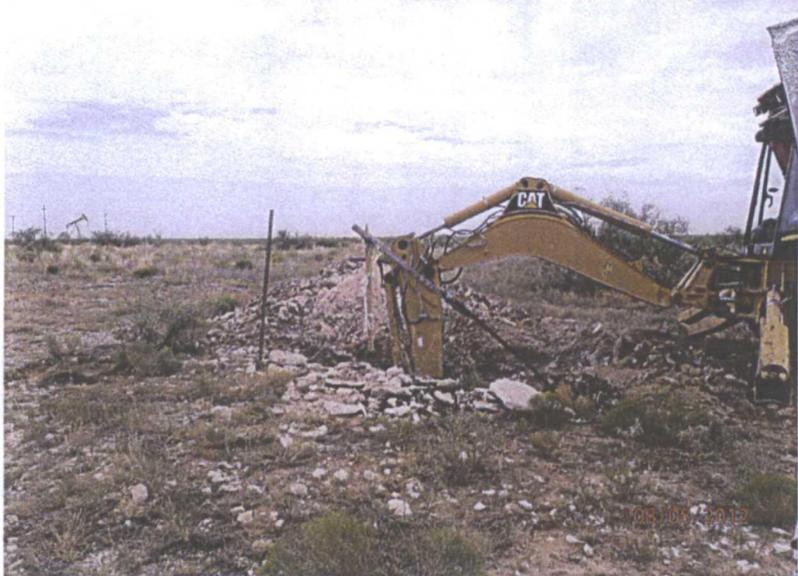
8/8/2012

Excavating Site

General Description of Remedial Action: This junction and line were eliminated during the pipeline replacement/upgrade program. After the former junction box was removed, an investigation was conducted using a backhoe to collect soil samples at regular intervals, creating a 3x7x6 ft. deep excavation. Chloride field tests performed on each sample yielded elevated concentrations. Organic vapors were measured using a PID which yielded low concentrations. The deepest sample, 6 ft. below ground surface (BGS) was sent to a commercial laboratory for analysis of chloride and TPH, which confirmed low concentrations of each. The excavation was backfilled with excavated soil to ground surface and contoured to the surrounding area. On 8/9/2012, the site was seeded with a blend of native vegetation and is expected to return to a productive capacity at a normal rate.

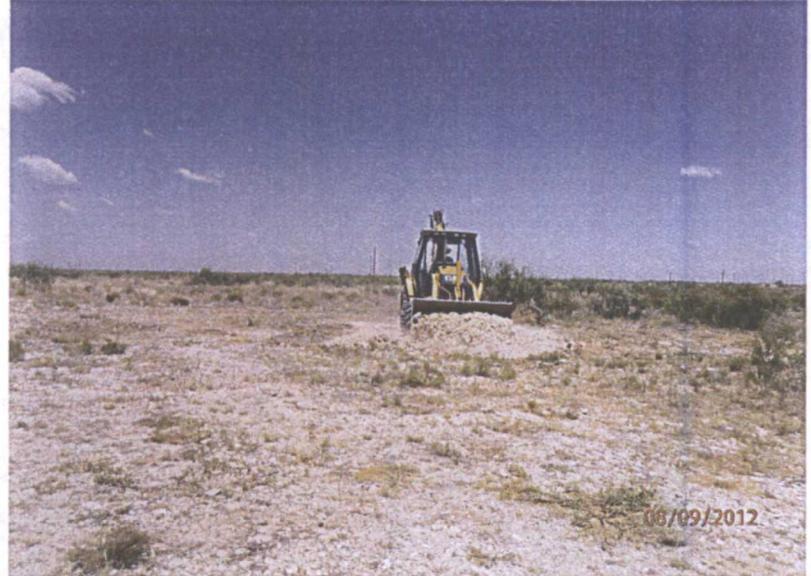
8/9/2012

Backfilling site

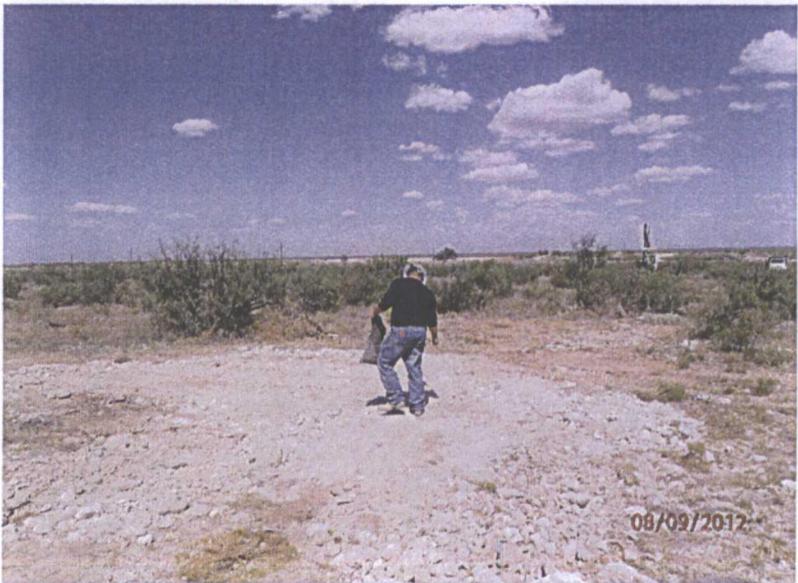
Seeding site

Custom seed mix <input checked="" type="checkbox"/>	Prescribed mix <input type="checkbox"/>	Seed mix name: 0.5 lb. Blue Grama	Seeding date: 8/9/2012
Broadcast <input checked="" type="checkbox"/>			
Method: Hand broadcast			
Soil conditions during seeding: Dry <input checked="" type="checkbox"/> Damp <input type="checkbox"/> Wet <input type="checkbox"/>			
Photos attached <input type="checkbox"/>	Observations:		
Number of photos:

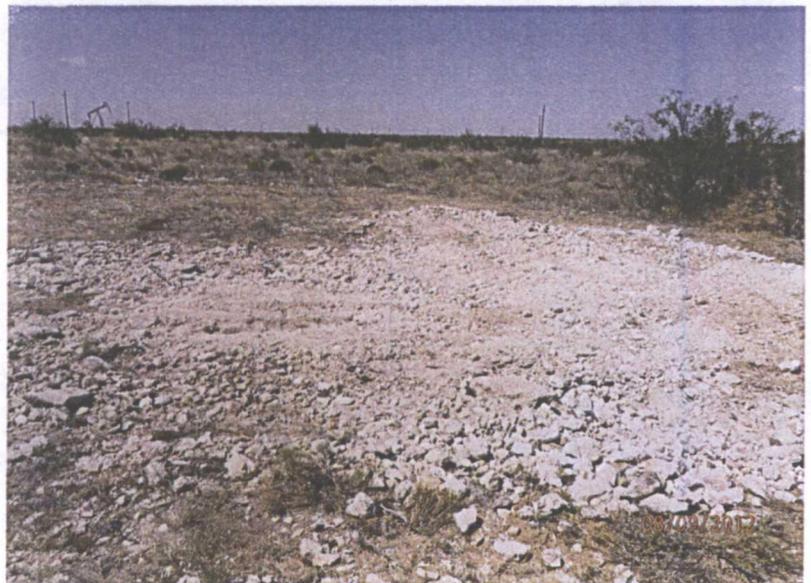
8/9/2012

Site complete

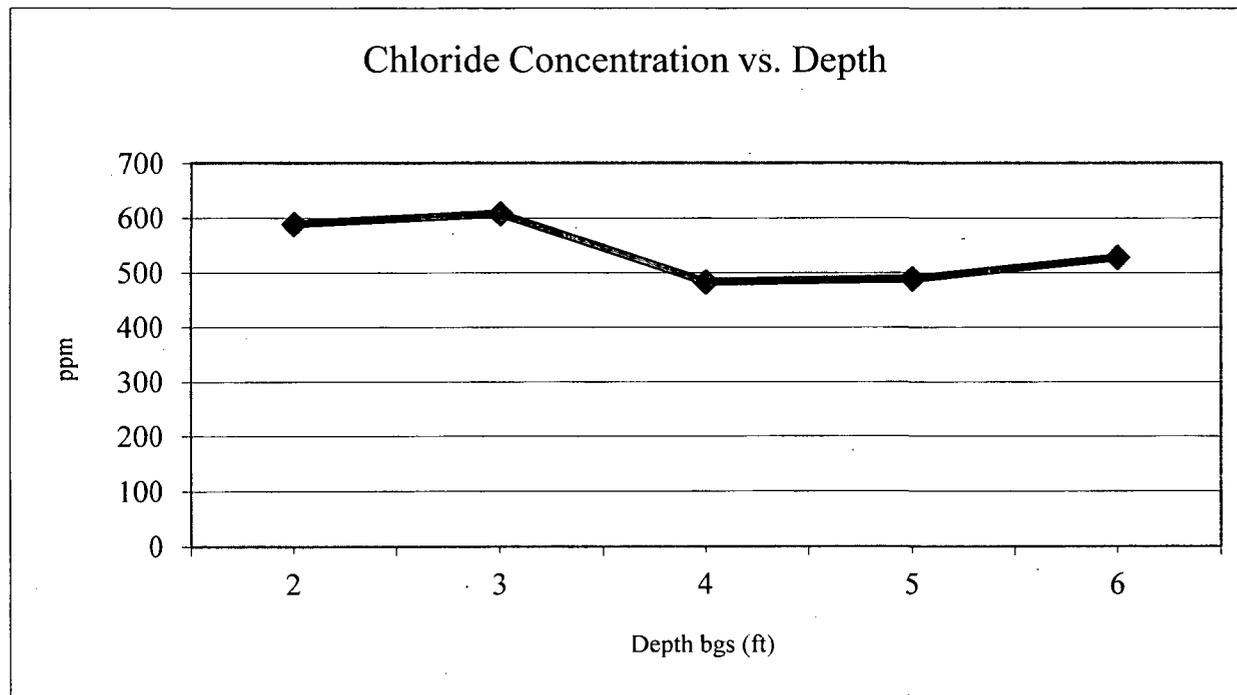
EME P-20 EOL

Backhoe samples at junction (source)

Depth bgs (ft)	[Cl ⁻] ppm
2	589
3	608
4	483
5	489
6	528

Groundwater = 41 ft

CHLORIDE FIELD TESTS		
LOCATION	DEPTH	mg/kg
background	6"	117
vertical delineation trench at the junction (source)	2'	589
	3'	608
	4'	483
	5'	489
	6'	528
