EME H-9 EOL

RICE OPERATING COMPANY
JUNCTION BOX DISCLOSURE* REPORT

BOX LOCATION							Conservation Division		
SWD SYSTEM	JUNCTION	UNIT	SECTION	TOWNSHIP	RANGE	COUNTY	BOX DIMENSIONS FEET		
Eunice Monument Eumont (EME)	H-9 EOL	H	9	21S	36E	Lea	Length	Width	Depth
							Eliminated

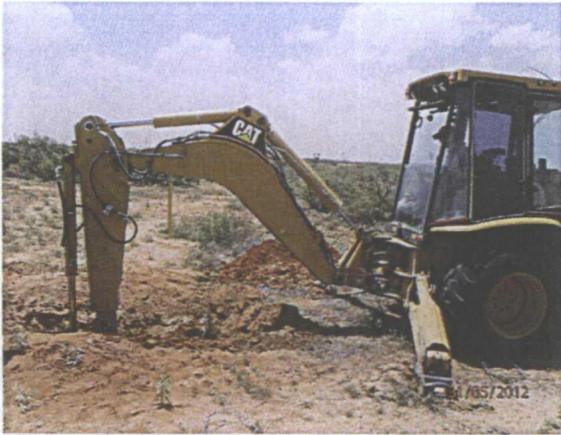
5/31/2012

Excavating site

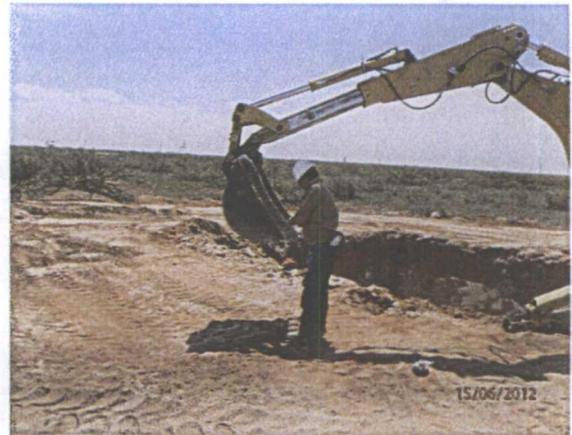
6/15/2012

Collecting sample

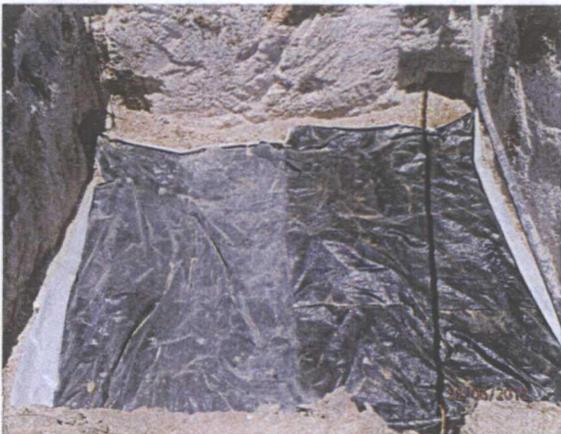
6/22/2012

Installing 25'x25' liner at 12' bgs

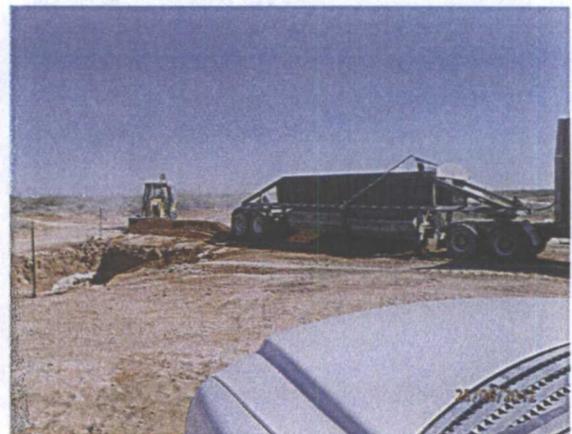
6/25/2012

Importing soil

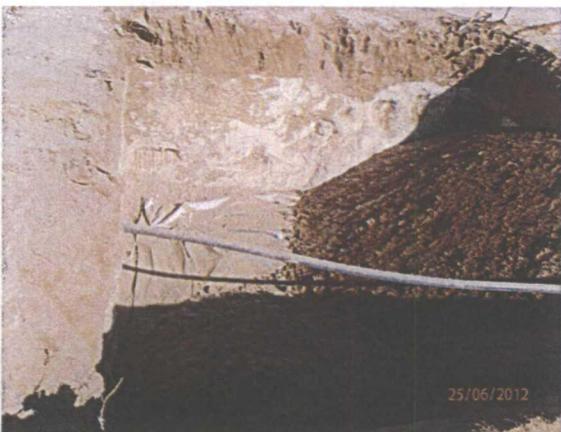
6/25/2012

Backfilling site above liner

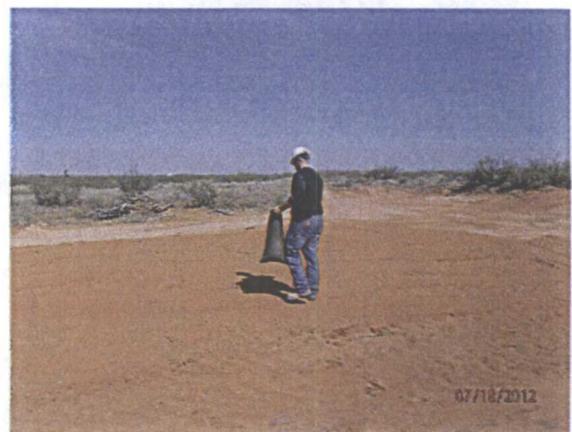
7/18/2012

Seeding site

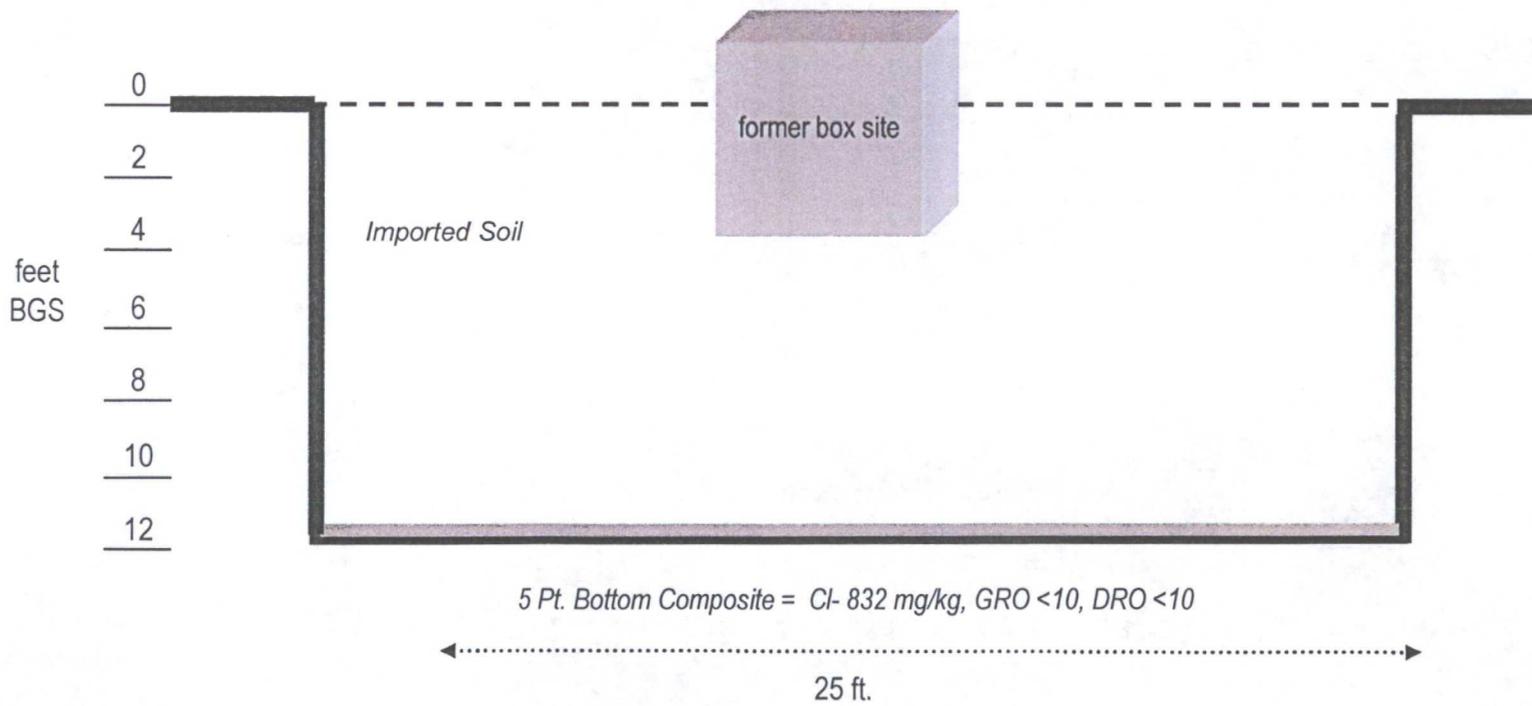
Excavation Cross-Section

EME H-9 EOL
Unit 'H', Sec. 9, T21S, R36E

General Description of Remedial Action: This junction box and line were eliminated during the pipeline replacement/upgrade program. After the former junction box was removed, an investigation was conducted using a backhoe to collect soil samples at regular intervals, producing a 25 x 25 x 12 ft deep excavation. Chloride field tests performed on soil samples did not decrease with depth. The excavated soil was blended on site and representative composite samples of the excavation bottom, the excavation walls, and the blended backfill were sent to a commercial laboratory for analysis of chloride and TPH. A total of 396 yards of blended backfill (all excavated soil) was transported to a NMOCD approved disposal facility. On 6/22/2012, a 20-mil reinforced plastic liner was installed at 12 ft. BGS. The remaining excavation was backfilled with clean imported soil to ground surface and contoured to the surrounding area. On 7/18/2012, the site was seeded with a blend of native vegetation and is expected to return to a productive capacity at a normal rate. NMOCD was notified of potential groundwater impact on 1/30/2013.

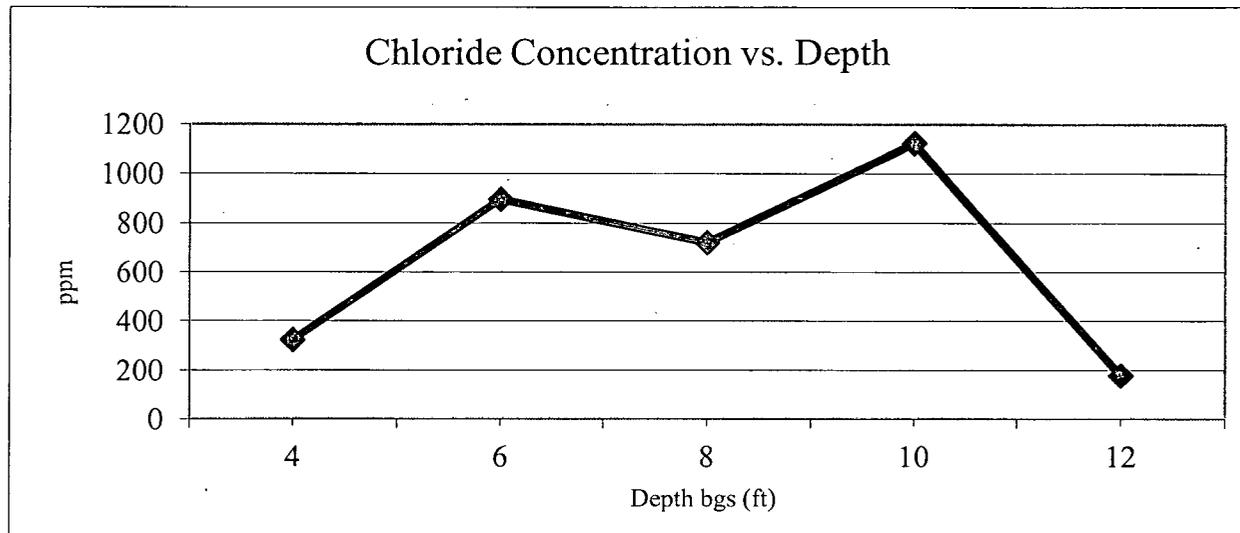
Backhoe samples at 10'E of the junction (source)

Depth bgs (ft)	[Cl], ppm
4	324
6	897
8	721
10	1124
12	178

Groundwater = 198 ft

CHLORIDE FIELD TESTS		
LOCATION	DEPTH	mg/kg
background	6"	150
4-WALL Comp	n/a	584
Bottom Comp	12'	785
Vertical delineation trench at 10' E of the former junction (source)	4'	897
	6'	721
	8'	1124
	12'	1612
