## RICE OPERATING COMPANY JUNCTION BOX DISCLOSURE\* REPORT

BOX LOCATION							Oil Conservation Division		
SWD SYSTEM	JUNCTION	UNIT	SECTION	TOWNSHIP	RANGE	COUNTY	BOX DIMENSIONS - FEET		
Eunice Monument Eumont (EME)	Jct. F-32	F	32	19S	37E	Lea	Length 6.5	Width 37.5	Depth 2
							Eliminated

# EME Jct. F-32

UL/F, Section 32 (T19S, R37E)

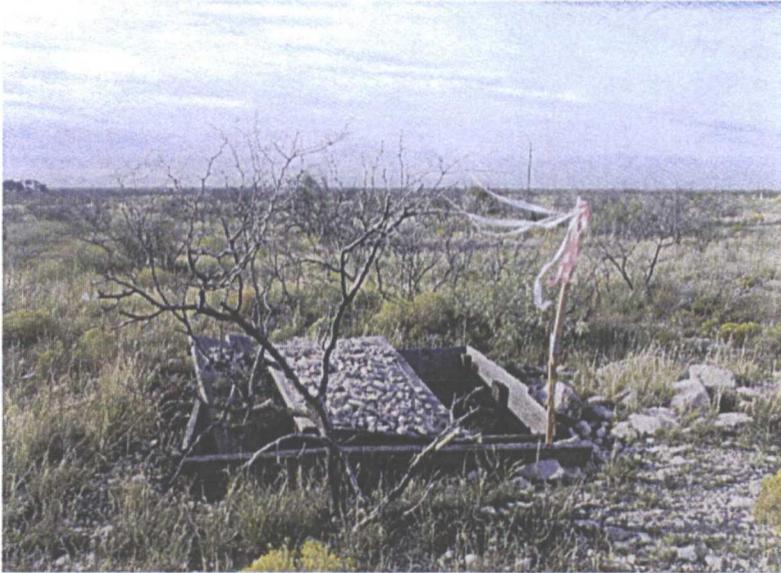
Site prior, facing south

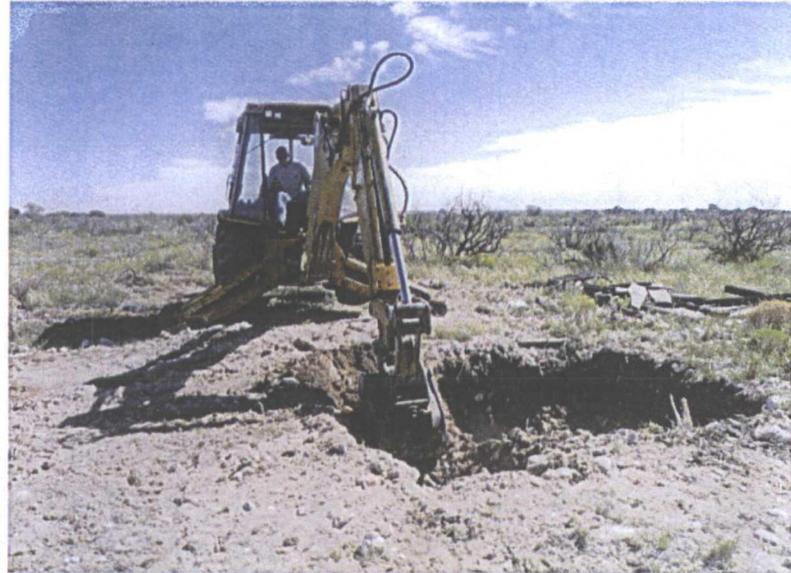
Excavating site, facing north

**General Description of Remedial Action:** This junction box was eliminated during the pipeline replacement/upgrade program. After the former junction box was removed, an investigation was conducted using a backhoe to collect soil samples at regular intervals, producing a 30x30x12 ft deep excavation. Chloride field tests performed on soil samples did not decrease with depth. Organic vapors were measured using a PID which yielded low concentrations. The excavated soil was blended on site and representative composite samples of the excavation bottom, the excavation walls, blended backfill and top soil were sent to a commercial laboratory for analysis of chloride and TPH. A total of 584 yards of blended backfill was transported to a NMOCD approved disposal facility. On 11/9/2012, a 30x30 ft. 20 mil reinforced liner was installed at 6 ft. below ground surface (BGS). On 11/13/2012, the excavation was backfilled with clean imported soil to ground surface and contoured to the surrounding area. On 11/13/2012 the site was seeded with a blend of native vegetation and is expected to return to a productive capacity at a normal rate. NMOCD was notified of potential groundwater impact on 3/4/2013.

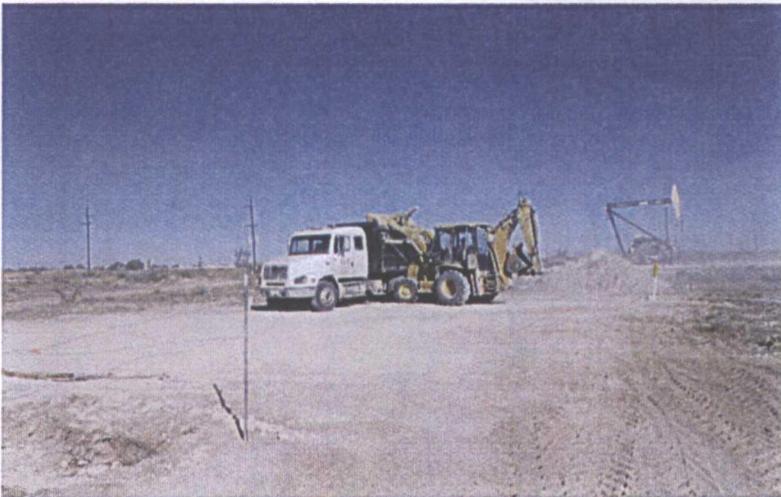
Exporting soil, facing northwest

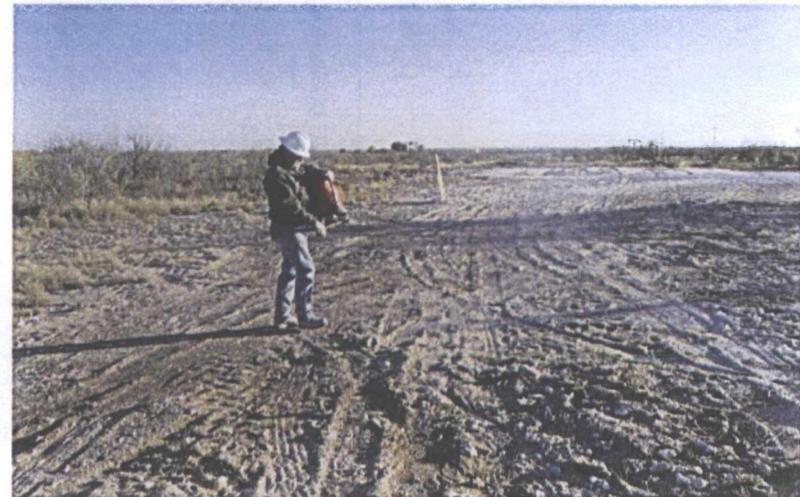
Seeding site, facing south

Custom seed mix <input checked="" type="checkbox"/>	Prescribed mix <input type="checkbox"/>	Seed mix name: Side Oats and Black Grama
Seeding date: 11/13/2012		
Broadcast <input checked="" type="checkbox"/>		
Method: Mechanical Hand Seeder		
Soil conditions during seeding: Dry <input checked="" type="checkbox"/> Damp <input type="checkbox"/> Wet <input type="checkbox"/>		
Photos attached <input type="checkbox"/>	Observations: 25 lbs Side Oats and Black Grama	
Number of photos:

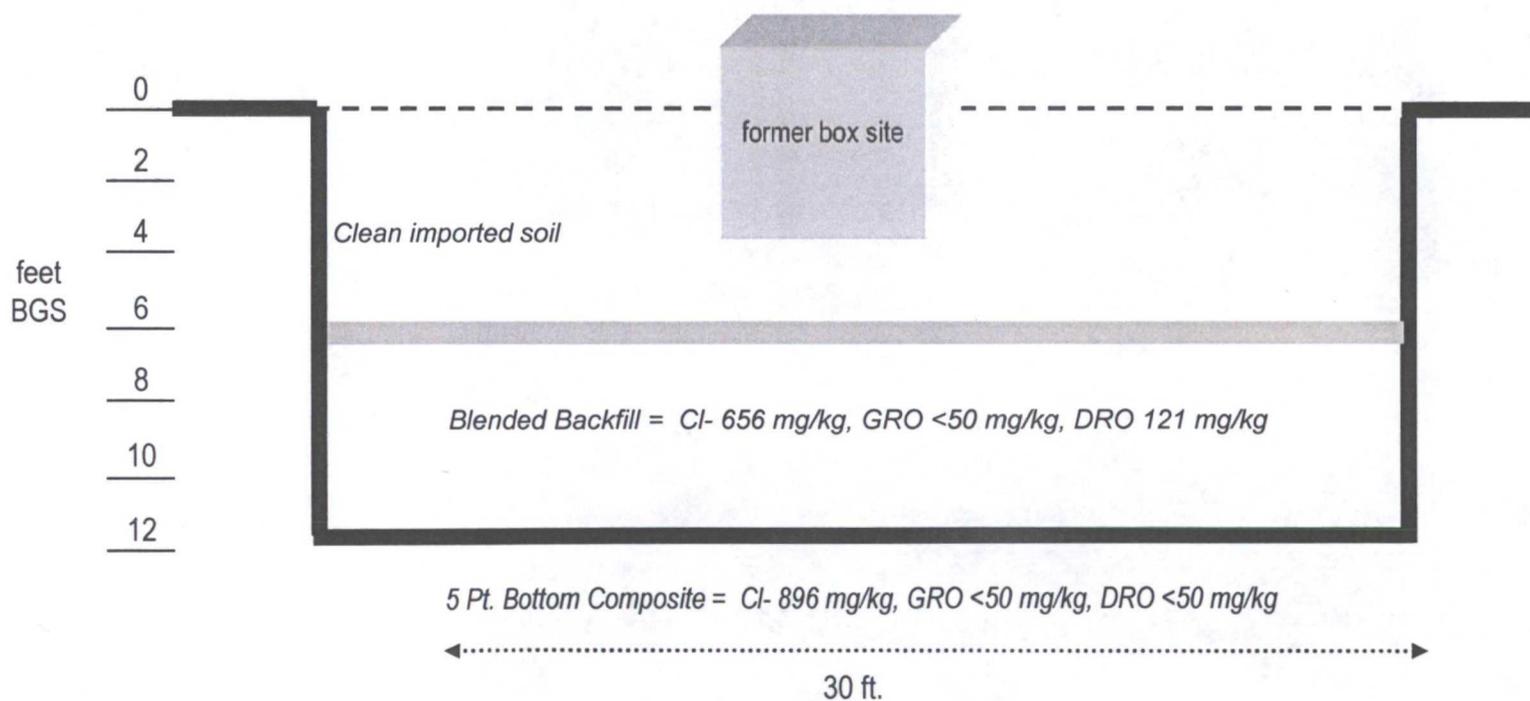
### Excavation Cross-Section

EME Jct. F-32  
Unit 'F', Sec. 32, T19S, R37E

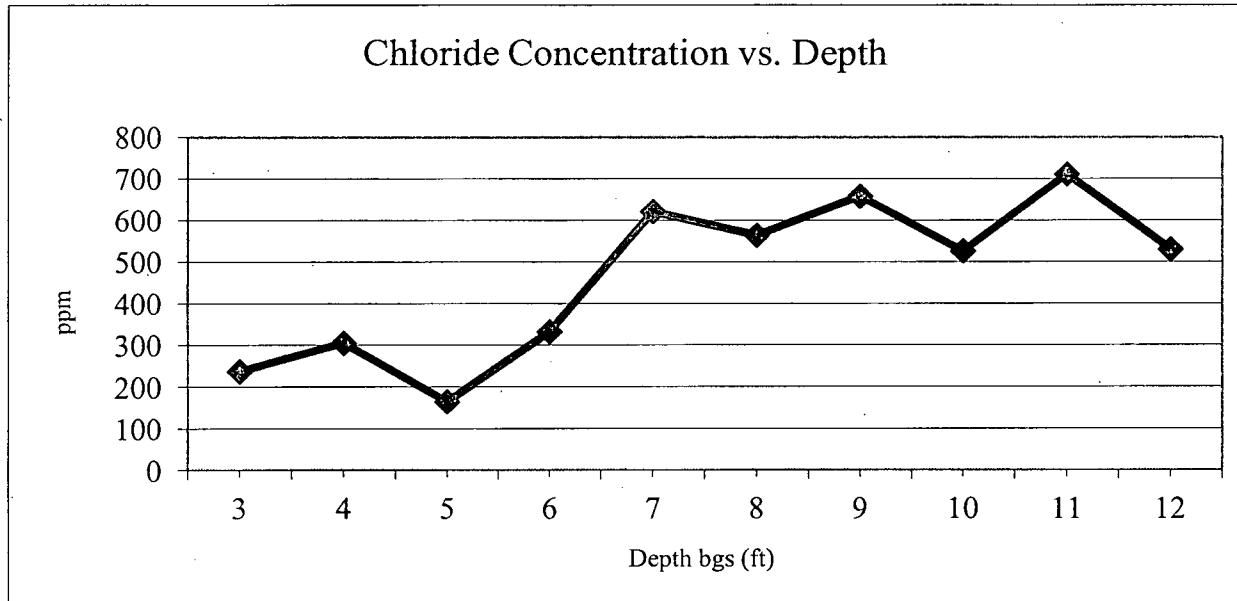
*Backhoe samples at junction (source)*

Depth bgs. (ft)	[Cl <sup>-</sup> ] ppm
3	237
4	305
5	165
6	332
7	621
8	564
9	658
10	526
11	711
12	530

Groundwater = 27 ft.

CHLORIDE FIELD TESTS		
LOCATION	DEPTH	mg/kg
background	6"	139
4-WALL Comp	n/a	746
Bottom Comp	12'	563
Blended Backfill	n/a	140
Vertical delineation trench at the former junction (source)	3'	237
	4'	305
	5'	165
	6'	332
	7'	621
	8'	564
	9'	658
	10'	526
	11'	711
	12'	530
