EME Jct. J-4

RICE OPERATING COMPANY
JUNCTION BOX DISCLOSURE* REPORT

EME JCT J-4

UL J SECTION 4
T-20-S R-37-E
LEA COUNTY, NM

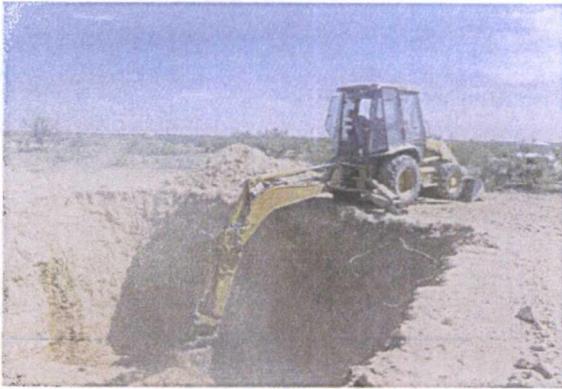
Excavating site, facing south 9/24/2012

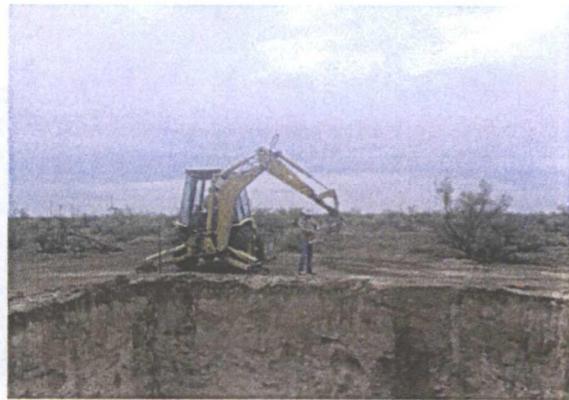
Collecting sample, facing north 9/27/2012

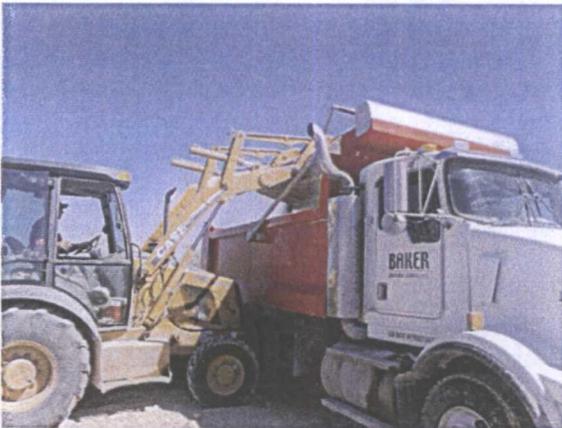
Exporting soil, facing east 10/3/2012

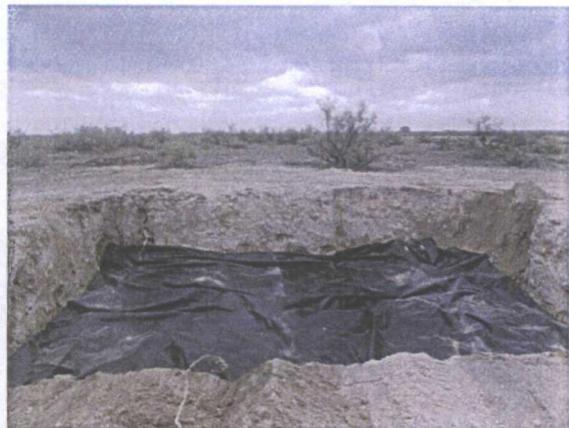
Installing 30'x30' 20 mil plastic liner @ 6' bgs
10/12/2012

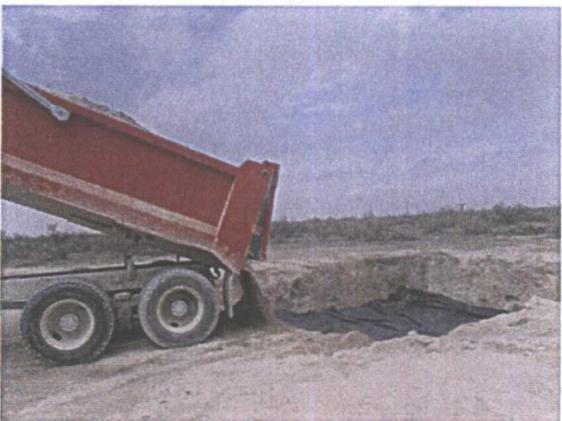
Backfilling with imported soil 10/12/2012

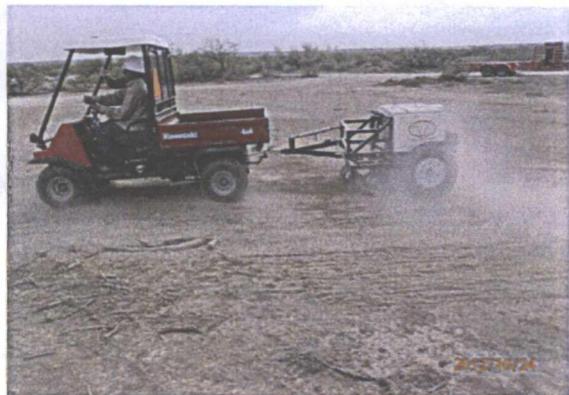
Seeding site, facing south 10/24/2012

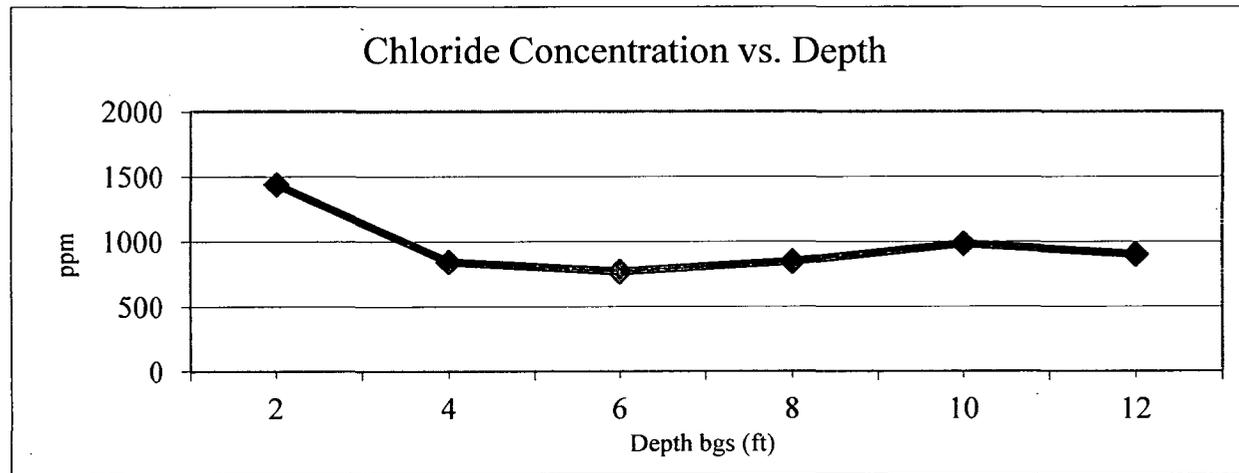
EME Jct. J-4

Backhoe samples at 10' N of the junction (source)

Depth bgs (ft)	[Cl ⁻] ppm
2	1442
4	845
6	771
8	848
10	985
12	903

Groundwater = 33 ft.

CHLORIDE FIELD TESTS		
LOCATION	DEPTH	mg/kg
Background	6"	86
Bottom Comp	n/a	672
North wall	n/a	770
South wall	n/a	824
East wall	n/a	720
West wall	n/a	718
Blended backfill	n/a	475
Vertical delineation trench at 10' N of the former junction (source)	2'	1442
	4'	845
	6'	771
	8'	848
	10'	985
	12'	903
