WORKPLANS

**RE: Corrective Action Plan (CAP)
Rice Operating Company – BD SWD System
BD jct. C-23-1 (1R426-279): UL/C sec. 23 T22S R37E**

BD jct. C-23-1

NMOCD Case #: 1R426-279

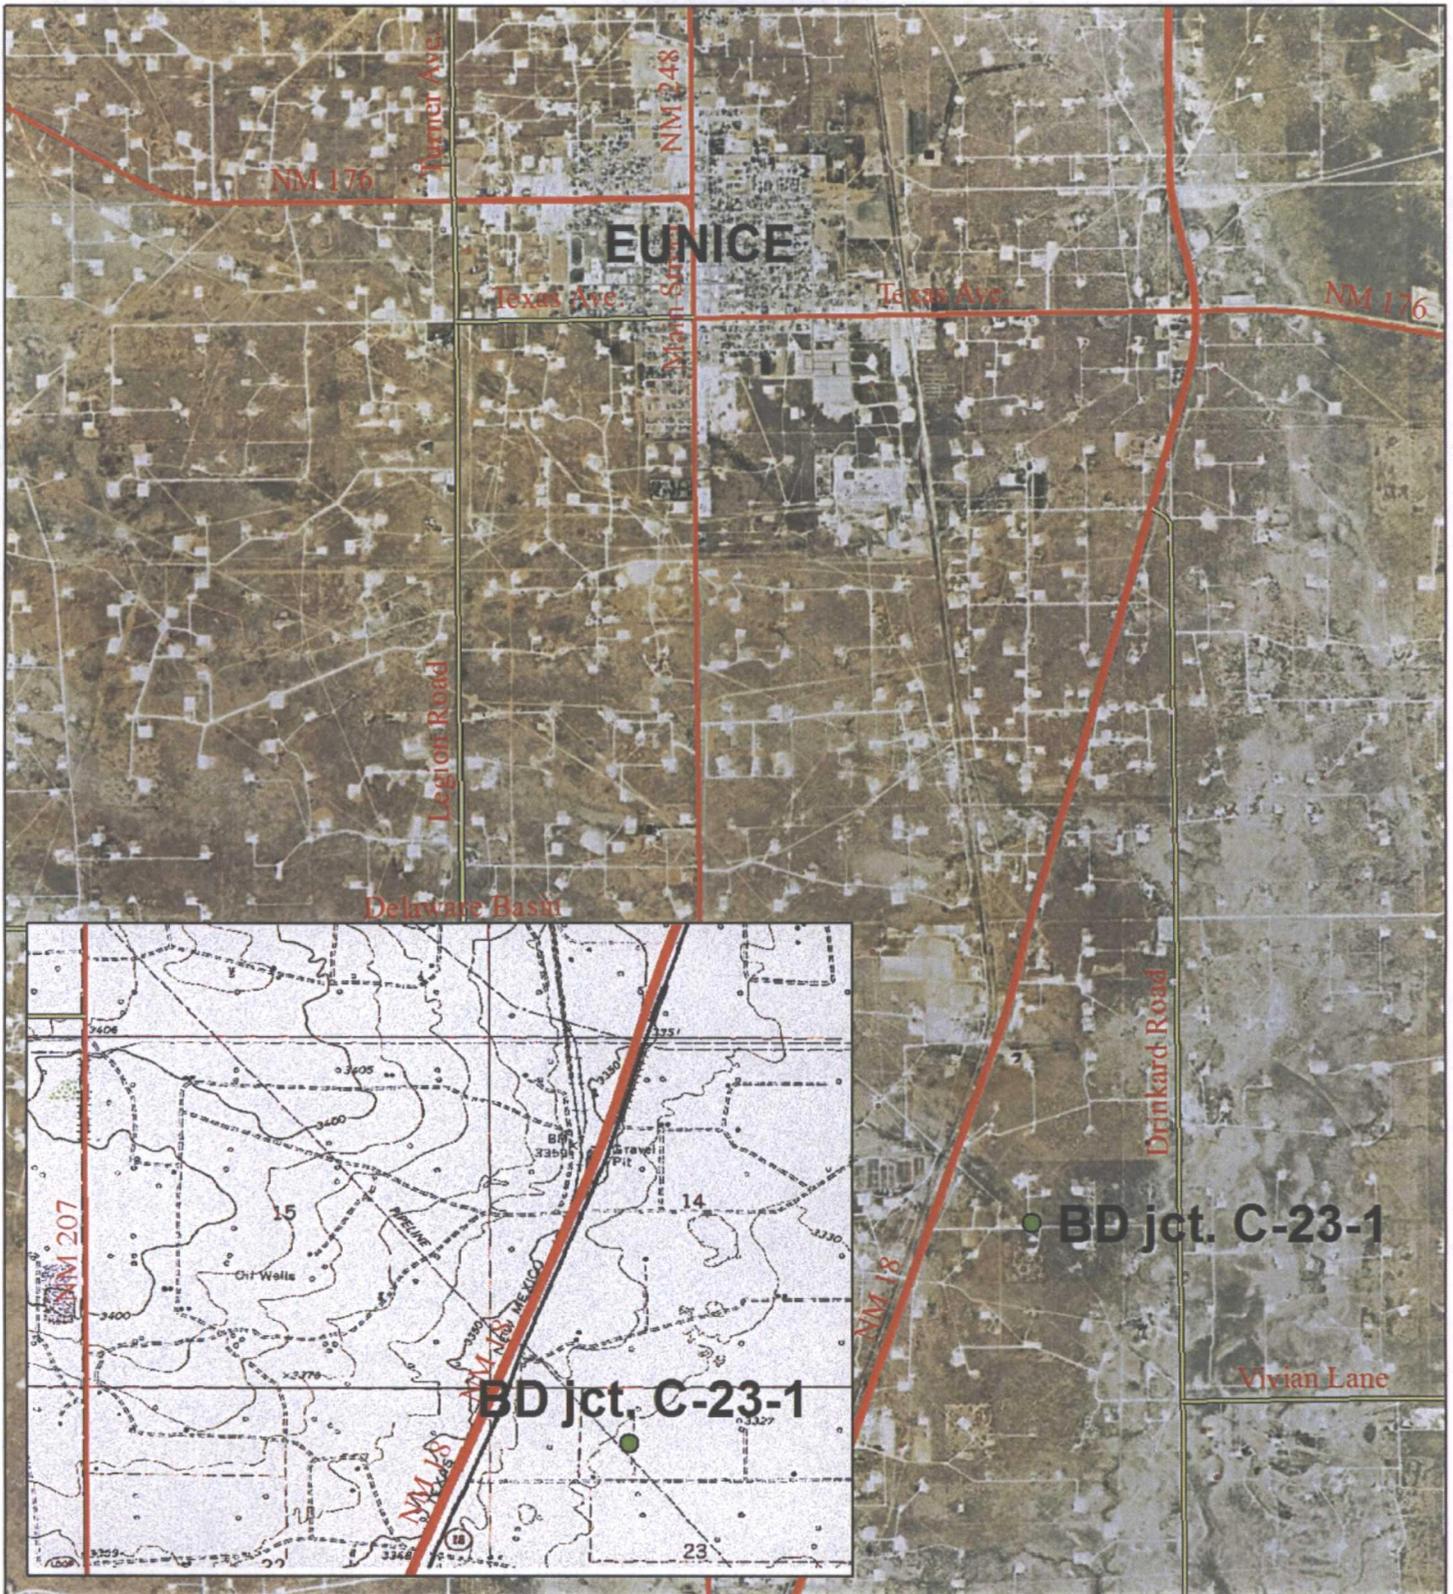
Figure 1

The site is located approximately 4 miles southeast of Eunice, New Mexico at UL/C sec. 23 T22S R37E as shown on the Site Location Map (Figure 1). NM OSE records indicated that groundwater would likely be encountered at a depth of approximately 59 +/- feet. However, monitor well installation at the site shows that there is little to no groundwater at the site.

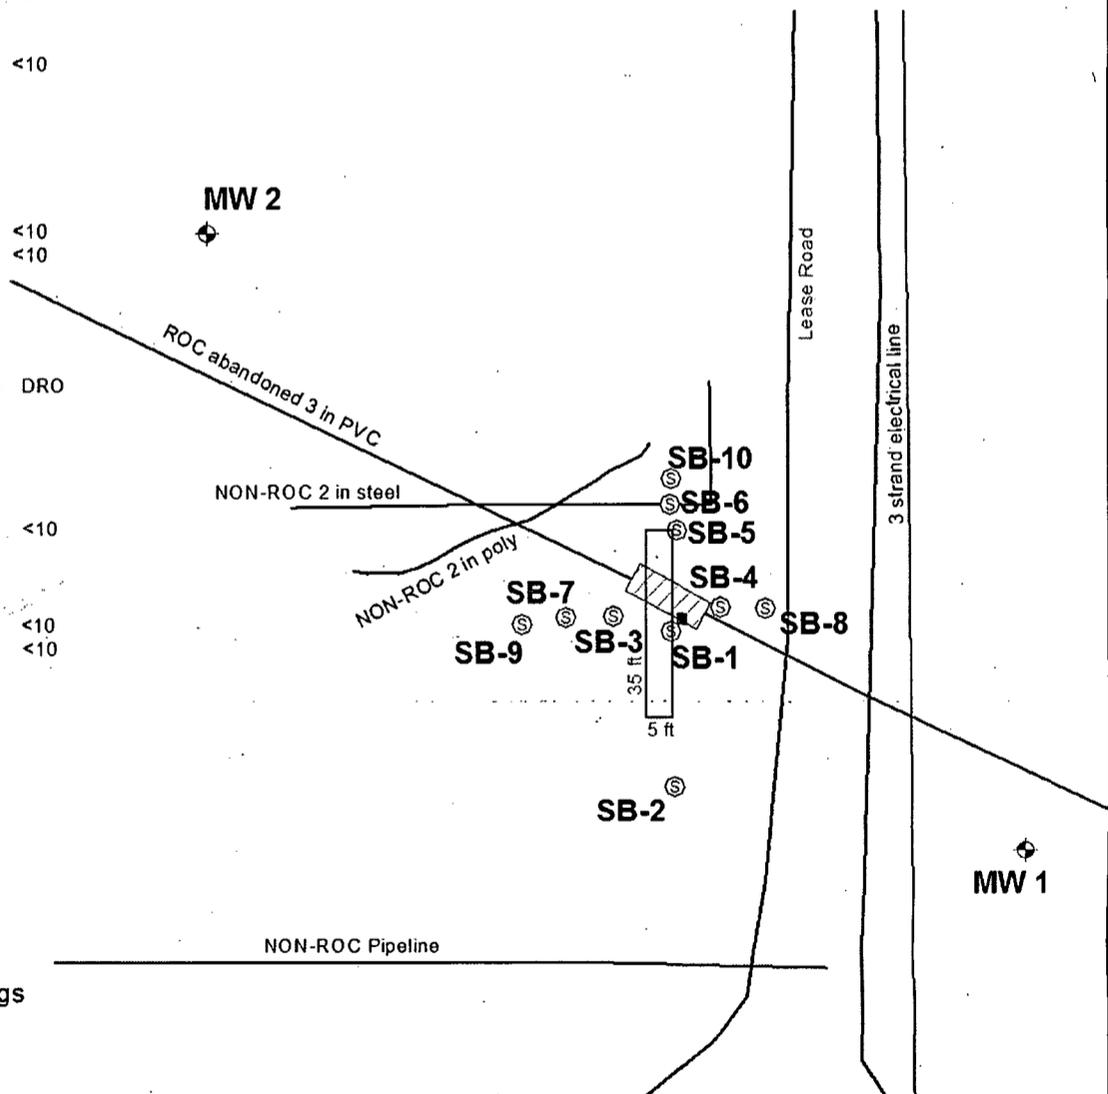
Figure 2

On February 12th, 2013, RECS personnel were on site to install three additional soil bores and two monitor wells. SB-8 delineated the eastern edge of the site, SB-9 delineated the western most edge of the site and SB-10 delineated the northern most edge of the site (Figure 2). As the three soil bores were being installed, soil samples were taken and field tested for both chlorides and hydrocarbons. Representative samples from each bores

were taken to a commercial laboratory for confirmation of field numbers. SB-8 returned chloride values of 1,040 mg/kg at 20 ft bgs, which decreased to 244 mg/kg at 30 ft bgs. SB-9 returned chloride values of 2,270 mg/kg at 15 ft bgs and 2,260 mg/kg at 50 ft bgs. SB-10 returned chloride values of 1,550 mg/kg at 10 ft bgs, 3,880 mg/kg at 45 ft bgs and 4,360 mg/kg at 50 ft bgs. GRO and DRO at all depths in all bores were non-detect (Appendix A).

Two monitor wells were installed at the site on February 12th, 2013. MW-1 was installed 71 ft southeast of the former junction box site and MW-2 was installed 92 ft northwest of the former junction box site (Figure 2). No sampling was conducted as MW-1 was installed. MW-2 was field sampled to determine background soil concentrations of chlorides and hydrocarbons. Representative samples from the bore were taken to a commercial laboratory for analysis. Background concentrations in MW-2 showed chloride values of 208 mg/kg at 25 ft bgs, 3,880 mg/kg at 45 ft bgs and 2,680 mg/kg at 50 ft bgs. GRO and DRO values at all depth were non-detect.

DGW: NONE

Therefore, RECS recommends that ROC prepare the site for seeding by tilling the site, adding soil amendments as necessary and seeding the site with a blend of native vegetation. Vegetation will act as an evapo-transpiration barrier that will also inhibit the downward migration of chlorides and hydrocarbons. Plants capture water through their roots and so reduce the amount of water infiltrating below the root zone.
