From: Hansen, Edward J., EMNRD
Sent: Tuesday, April 23, 2013 10:13 AM
To: Hack Conder (hconder@riceswd.com)
Cc: Leking, Geoffrey R, EMNRD; Laura Pena (lpena@riceswd.com); Katie Jones <kjones@riceswd.com> (kjones@riceswd.com); Lara Weinheimer (lweinheimer@rice-ecs.com); Scott Curtis (scurtis@riceswd.com)
Subject: Remediation Plan (1R427-13) Termination - ROC EME K-11 Site

RE: **Termination Request**
Rice Operating Company – EME SWD System
EME K-11 (1R427-13): Unit Letter K, Sec. 11, T21S, R36E

**EME K-11 (1R427-13)
Unit K, Section 11, T21S, R36E**

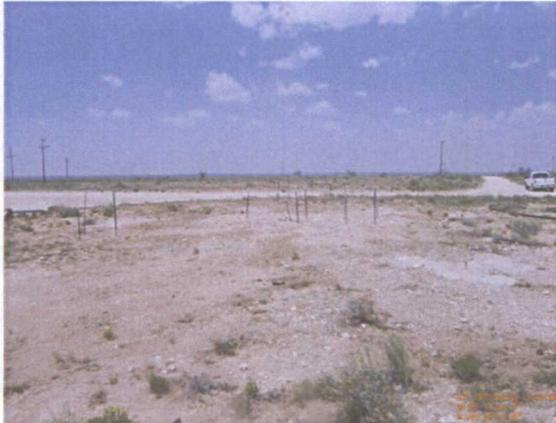
site prior to scraping, facing north
6/28/2012

Beginning September 14th, 2012, approximately 4,000 ft² of the site was scraped to a depth of approximately 6 inches bgs. 152 yards³ of scraped soil was properly disposed of at an NMOCD approved facility. The site was backfilled with clean, imported soil and silt net fencing was installed surrounding the site. The area was then seeded with a blend of native vegetation. The site revegetation form and photos of these activities can be found in Appendix A.

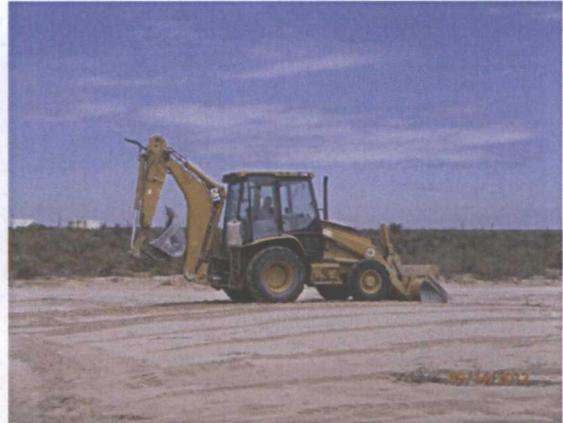
scraping the site
9/14/2012

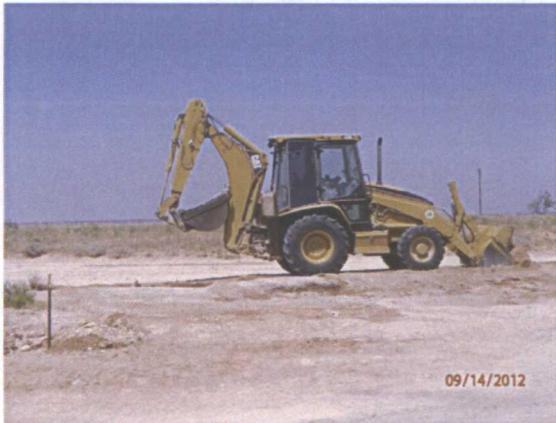
scraping the site
9/14/2012

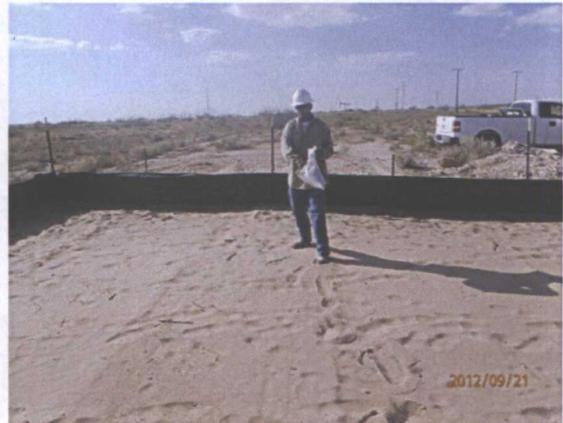
seeding the backfilled site, facing south
9/21/2012

Custom seed mix <input checked="" type="checkbox"/>	Prescribed mix <input type="checkbox"/>	Seed mix name: 5 lbs. Blue Grama and 5 lbs. Lea County Mix Seeding date: 9/21/2012
Broadcast <input type="checkbox"/>		
Method: Hand Broadcast and raked into soil		
Soil conditions during seeding: Dry <input checked="" type="checkbox"/> Damp <input type="checkbox"/> Wet <input type="checkbox"/>		
Photos attached <input type="checkbox"/>	Observations:	
Number of photos:

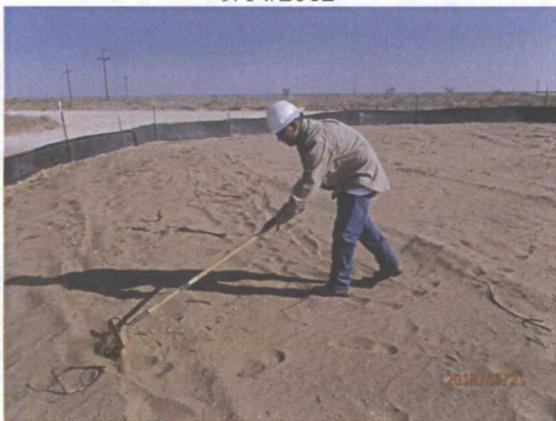
raking in the seed, facing north
9/21/2012

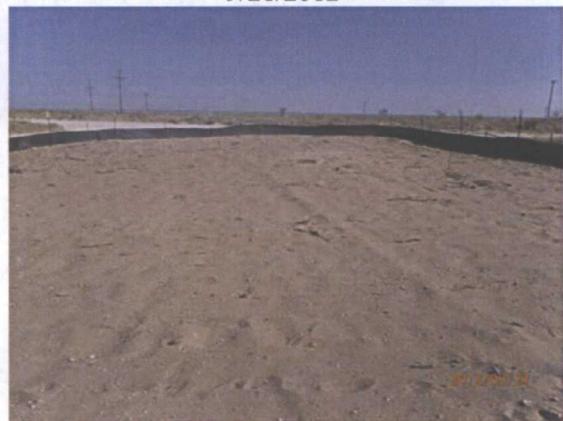
site complete, facing north
9/21/2012
