RICE OPERATING COMPANY JUNCTION BOX DISCLOSURE* REPORT

| SWD SYSTEM | JUNCTION | UNIT | SECTION | TOWNSHIP | RANGE | COUNTY | BOX-DIMENSIONS IN FEET | | |
|---|---|---|---|---|---|---|---|---|---|
| Blinebry-Drinkard (BD) | O-32 vent | O | 32 | 22S | 38E | Lea | 6' | 6' | 5' |

BD O-32 Vent

UL/O Sec.32 (T22S-R38E)

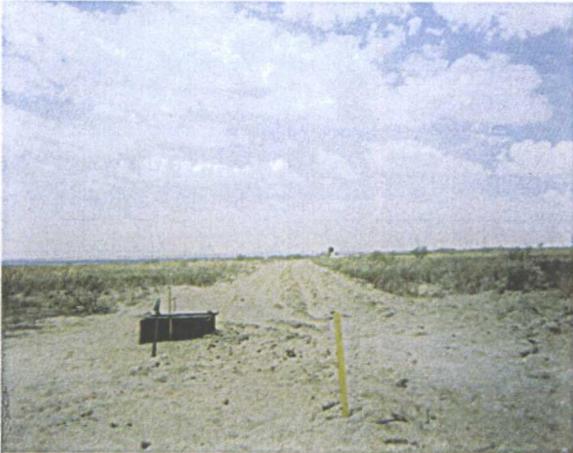
Site prior, facing west 7/20/2011

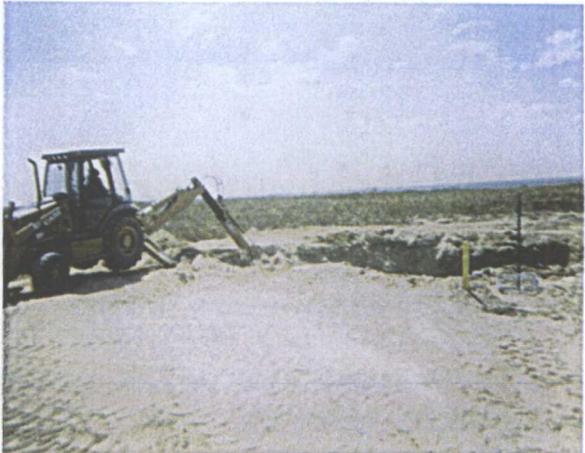
Excavating site, facing northwest 7/20/2011

General Description of Remedial Action: This junction box was eliminated during the pipeline replacement/upgrade program. After the former junction box was removed, an investigation was conducted using a backhoe to collect soil samples at regular intervals producing a 30x30x12 ft deep excavation. Chloride field tests performed on soil samples did not decrease with depth. Organic vapors were measured using a PID which yielded slightly elevated concentrations. The excavated soil was blended on site and representative composite samples of the excavation bottom, the excavation walls and the blended backfill were sent to a commercial laboratory for analysis of chloride and TPH. A total of 236 yards of blended backfill was transported to a NMOCD approved disposal facility. The excavation was backfilled to 6 ft. below ground surface (BGS). On 2/29/12, a 35x30 ft. 20-mil reinforced liner was installed at 6 ft. BGS and the remainder of the excavation was backfilled with clean imported soil to ground surface and contoured to the surrounding area. On 8/21/12, the site was seeded with a blend of native vegetation and is expected to return to a productive capacity at a normal rate. NMOCD was notified of potential groundwater impact on 2/20/2013.

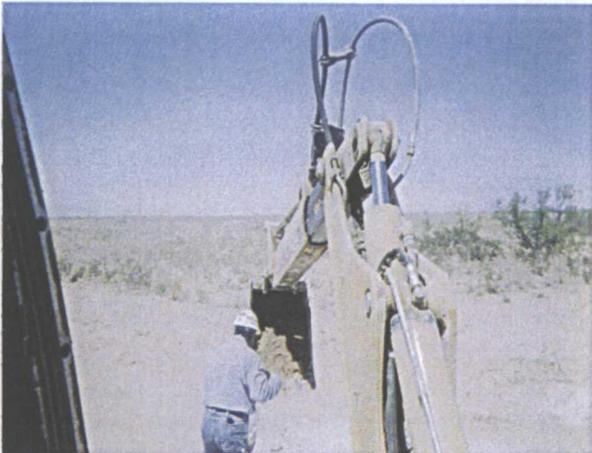
Collecting sample, facing southwest 7/20/2011

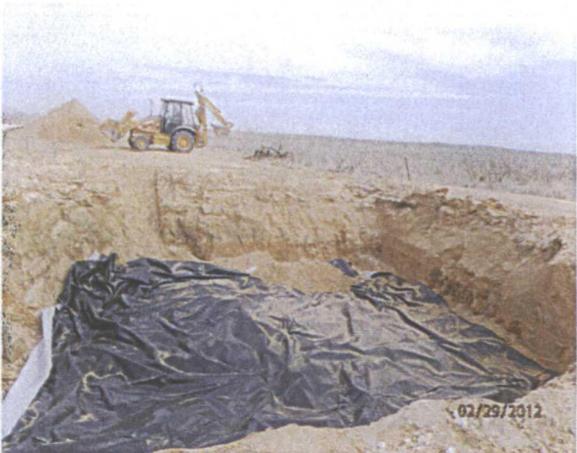
Installing liner, facing east 2/29/2012

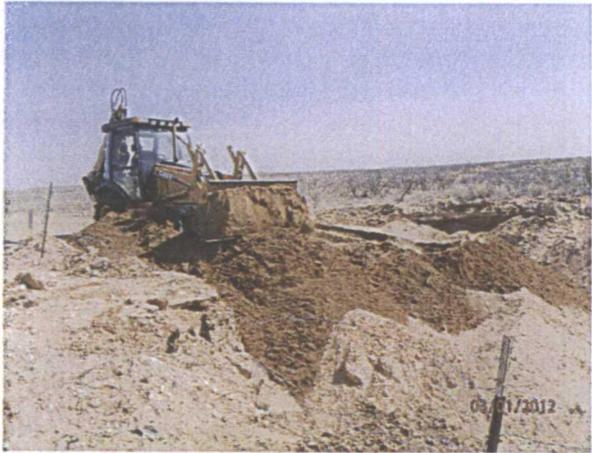
Backfilling site, facing south 3/1/2012

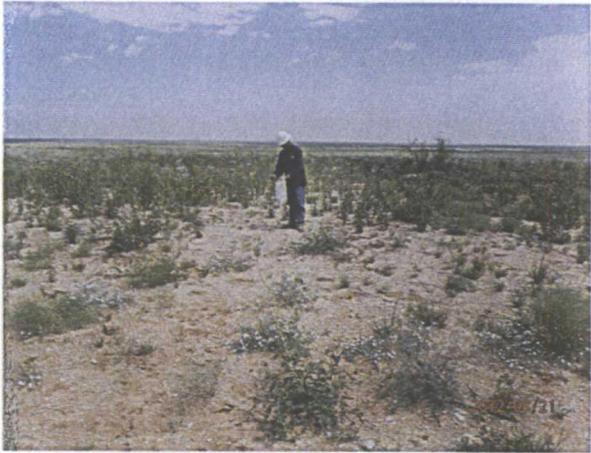
Seeding site, facing east 8/21/2012

| Number of photos: | SEED WAS RAKED INTO SOIL | |

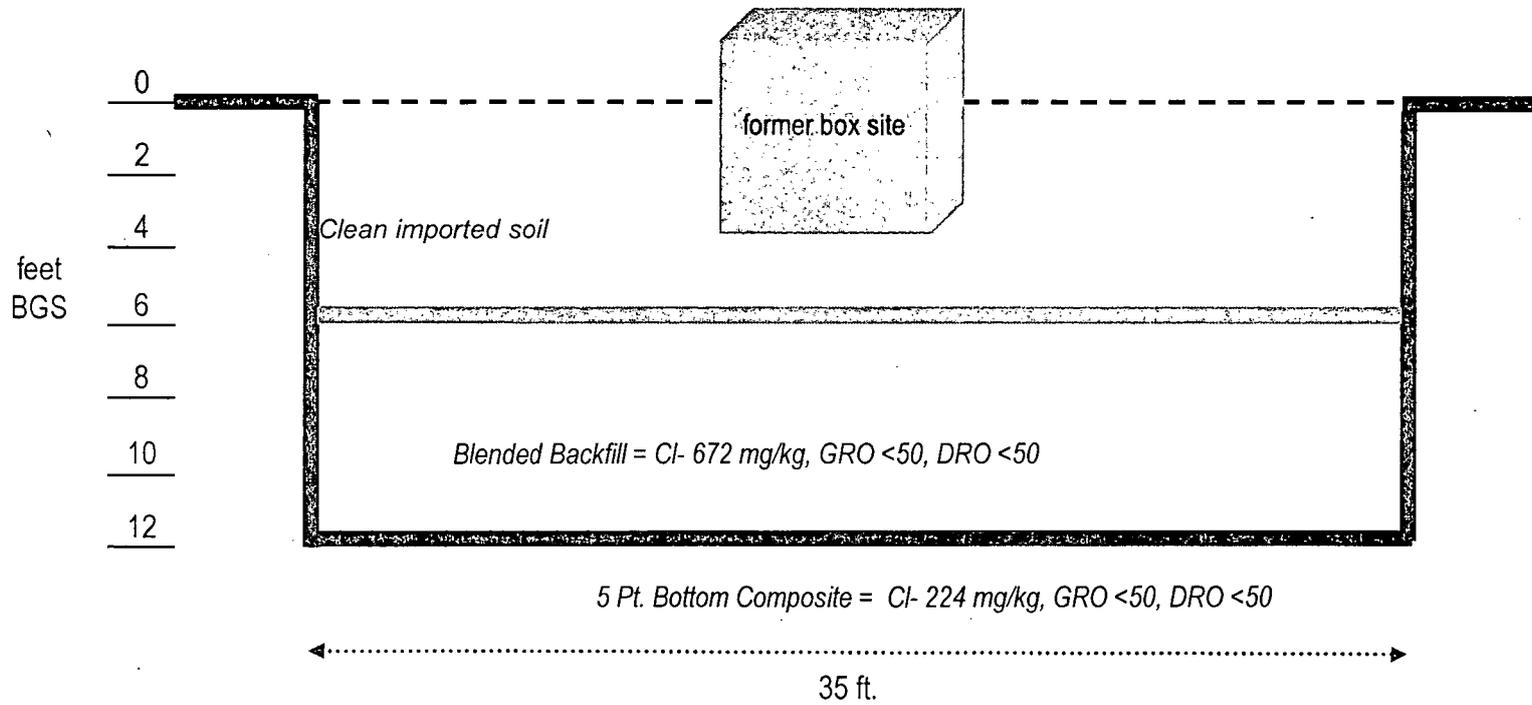
Excavation Cross-Section

BD O-32 vent
Unit 'O', Sec. 32, T22S, R38E

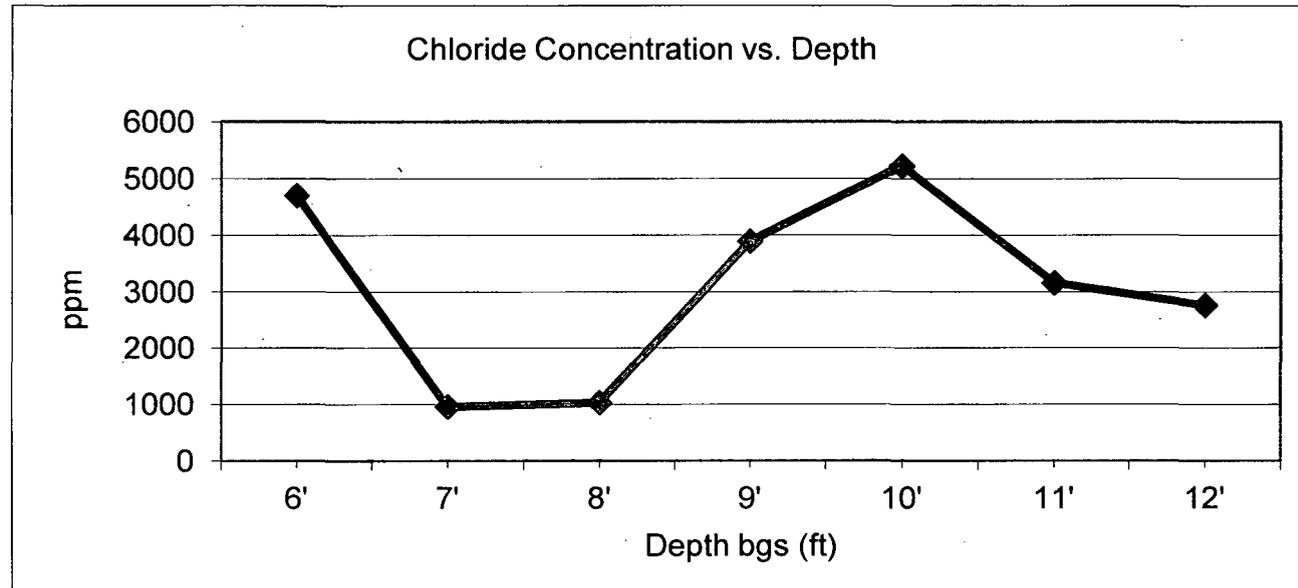
Backhoe samples at the junction (source)

Groundwater = 154 ft
